COLUMBIA

ACCIDENT INVESTIGATION BOARD

REPORT VOLUME I
AUGUST 2003

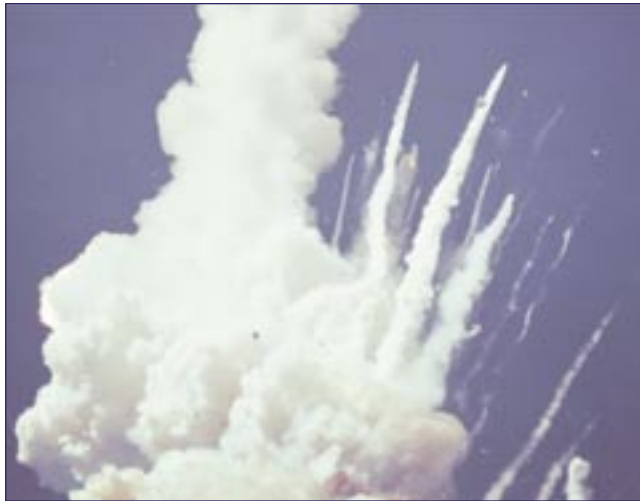
Figure 1.5-1. the Space Shuttle Challenger was lost during ascent on January 28, 1986, when an O-ring and seal in the left Solid Rocket Booster failed.

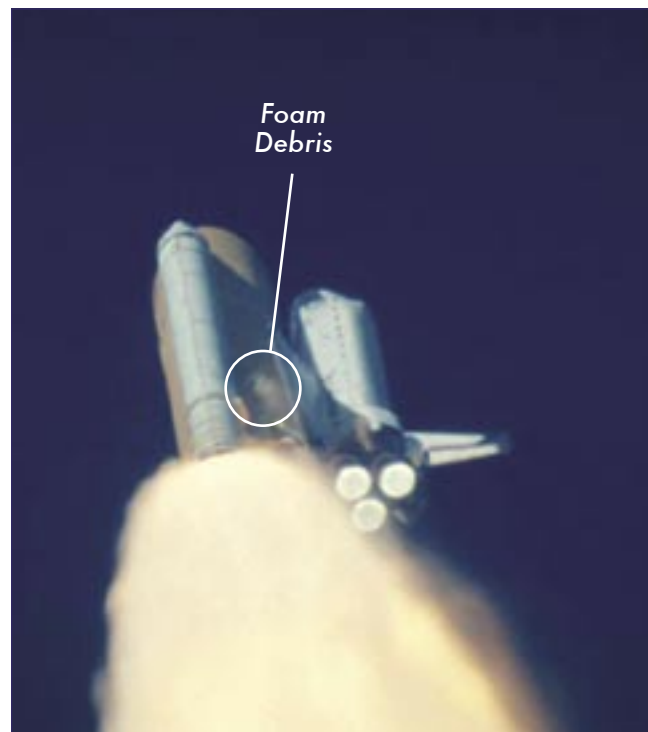
Figure 2.3-2. A shower of foam debris after the impact on *Columbia's* left wing. The event was not observed in real time.

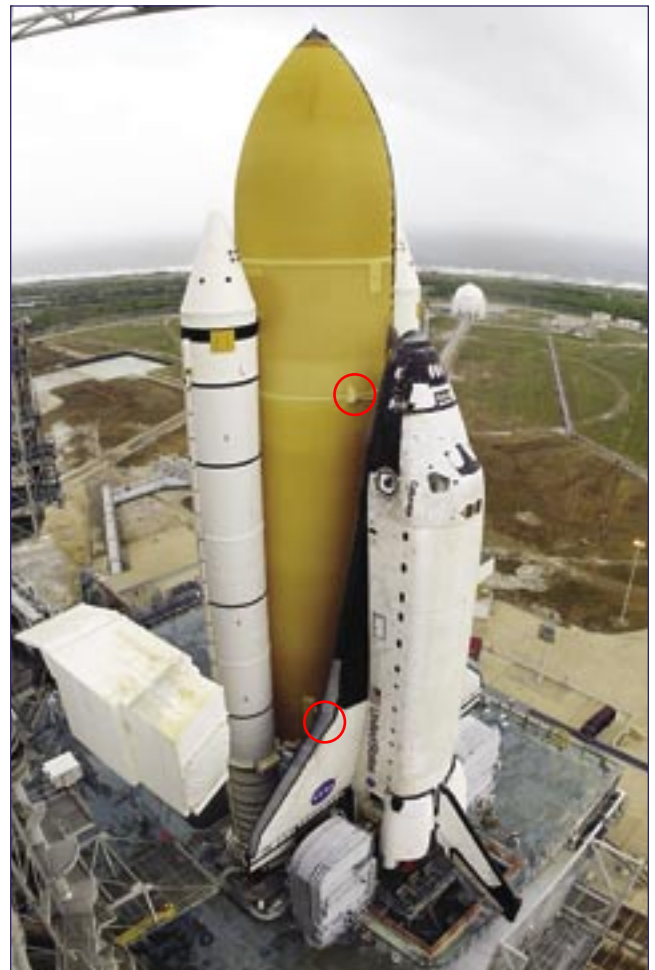
Figure 3.1-1. Columbia sitting at Launch Complex 39-A. The upper circle shows the left bipod (-Y) ramp on the forward attach point, while the lower circle is around RCC panel 8-left.

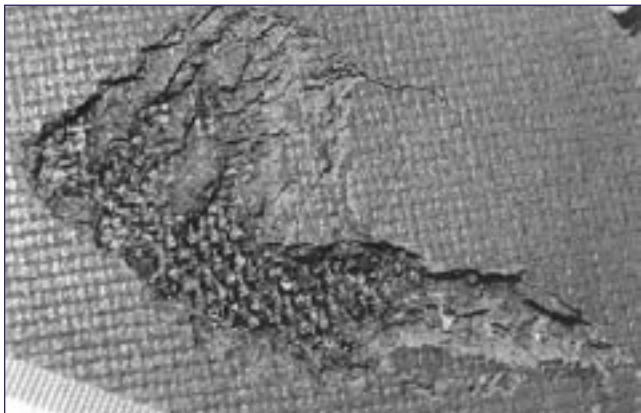
Figure 3.3-2. Damage on the outer surface of RCC panel 10-right from *Atlantis* after STS-45.

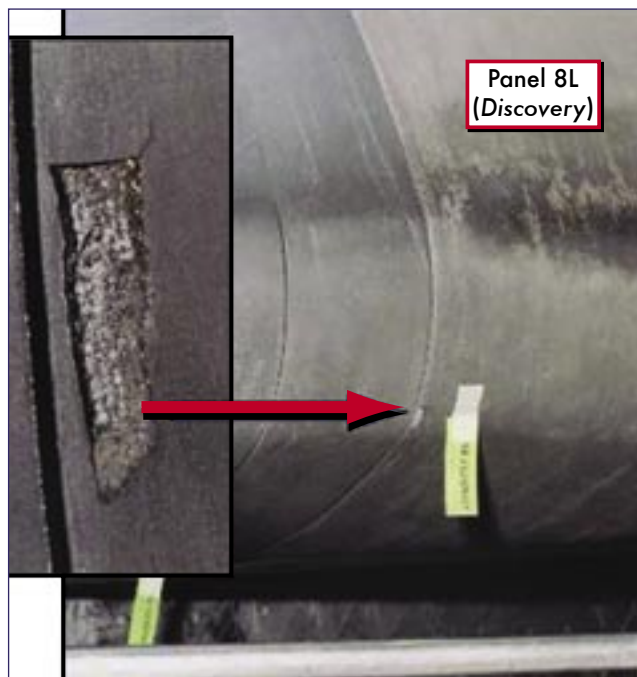
Figure 3.3-5. RCC panel 8-left from *Discovery* had to be scrapped after STS-103 because of the damage shown here.

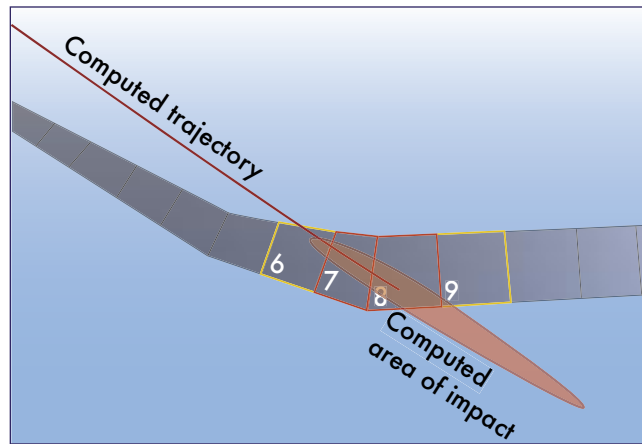
Figure 3.4-3: The best estimate of the site of impact by the center of the foam.

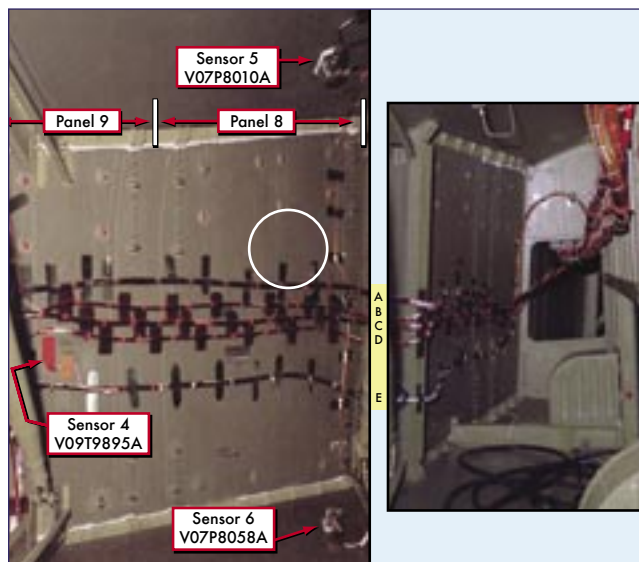
Figure 3.6-8. The left photo above shows the wiring runs on the backside of the wing leading edge behind RCC panel 8 – the circle marks the most likely area where the burn through of the wing leading edge spar initially occurred at EI+487 seconds. The right photo shows the wire bundles as they continue forward behind RCC panels 7 and 6. The major cable bundles in the upper right of the right photo carried the majority of the sensor data inside the wing. As these bundles were burned, controllers on the ground began seeing off-nominal sensor indications.

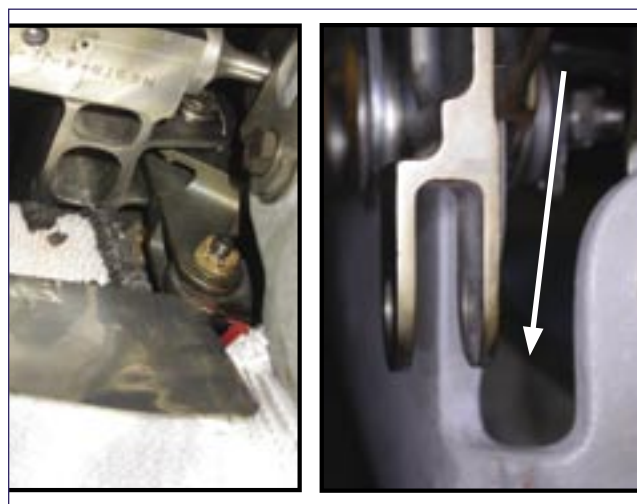
Figure 3.7-2. Each RCC panel has a U-shaped slot (see arrow) in the back of the panel. Once superheated air entered the breach in RCC panel 8, some of that superheated air went through this slot and caused substantial damage to the Thermal Protection System tiles behind this area.

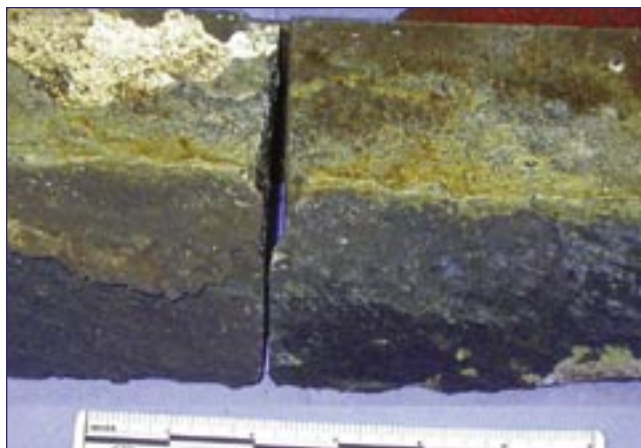
Figure 3.7-3. Superheated airflow caused erosion in tiles around the RCC panel 8 and 9 interface. The tiles shown are from behind the area where the superheated air exited from the slot in Figure 3.7-2. These tiles showed much greater thermal damage than other tiles in this area and chemical analysis showed the presence of metals only found in wing leading edge components.

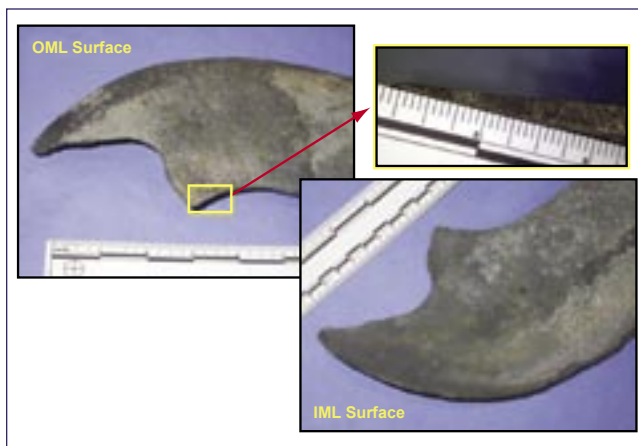
Figure 3.7-4. The outboard rib of panel 8 and the inboard rib of panel 9 showed signs of extreme heating and erosion. RCC erosion of this magnitude was not observed in any other location on the Orbiter.

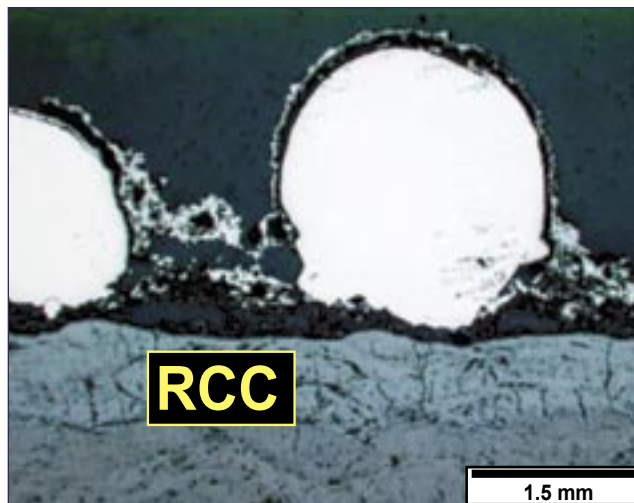
Figure 3.7-8. Spheroids of Inconel 718 and Cerachrome were deposited directly on the surface of RCC panel 8-left. This slag deposit pattern was not seen on any other RCC panels.

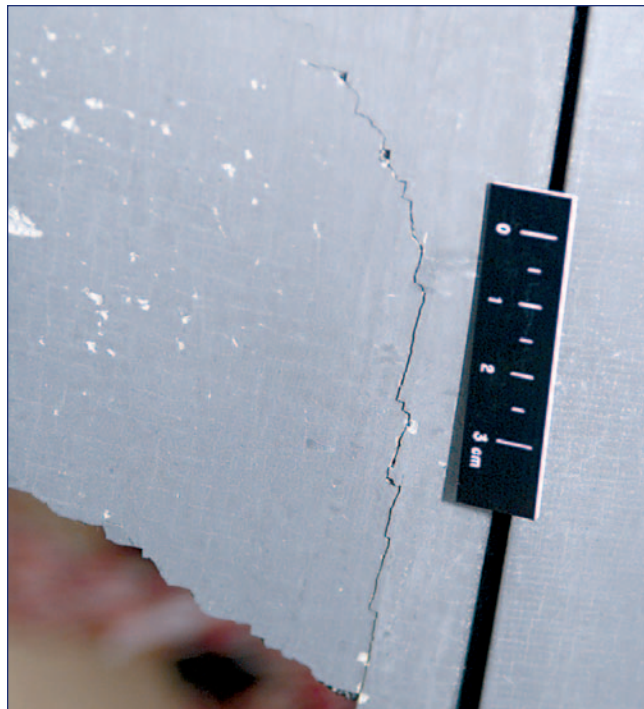
Figure 3.8-10. Numerous cracks were also noted in RCC Panel 8.

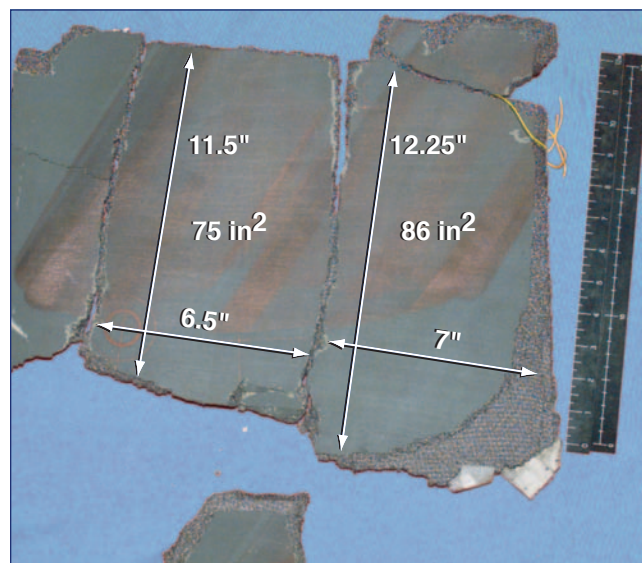
Figure 3.8-11. Three large pieces of debris from the panel face sheet were lodged within the hollow area behind the RCC panel.

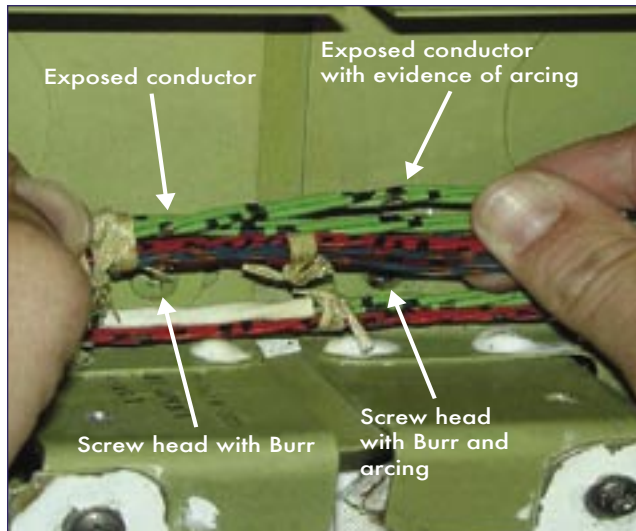
Figure 4.2-2. Arc tracking damage in Kapton wiring.

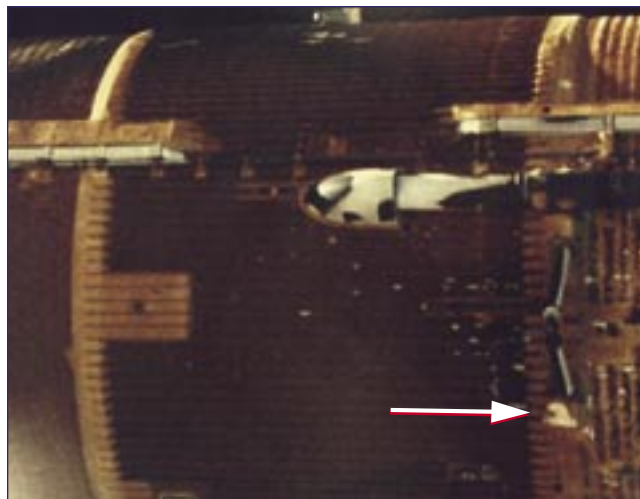
Figure 6.1-2. The first known instance of bipod ramp shedding occurred on STS-7 which was launched on June 18, 1983.

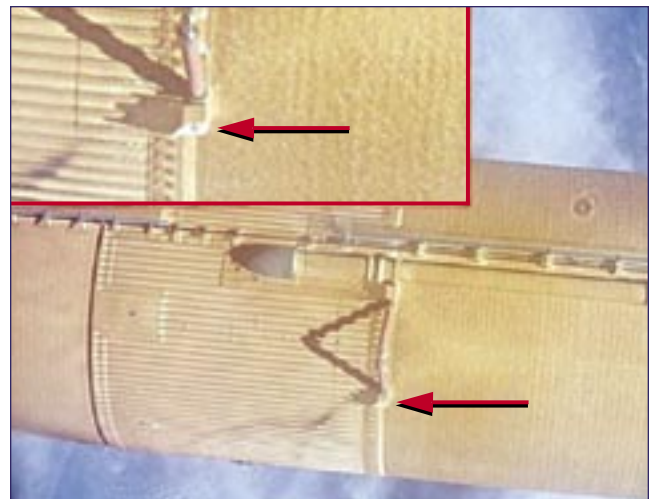
Figure 6.1-3. Only three months before the final launch of Columbia, the bipod ramp foam had come off during STS-112.
