COLUMBIA

ACCIDENT INVESTIGATION BOARD

REPORT VOLUME IV
OCTOBER 2003

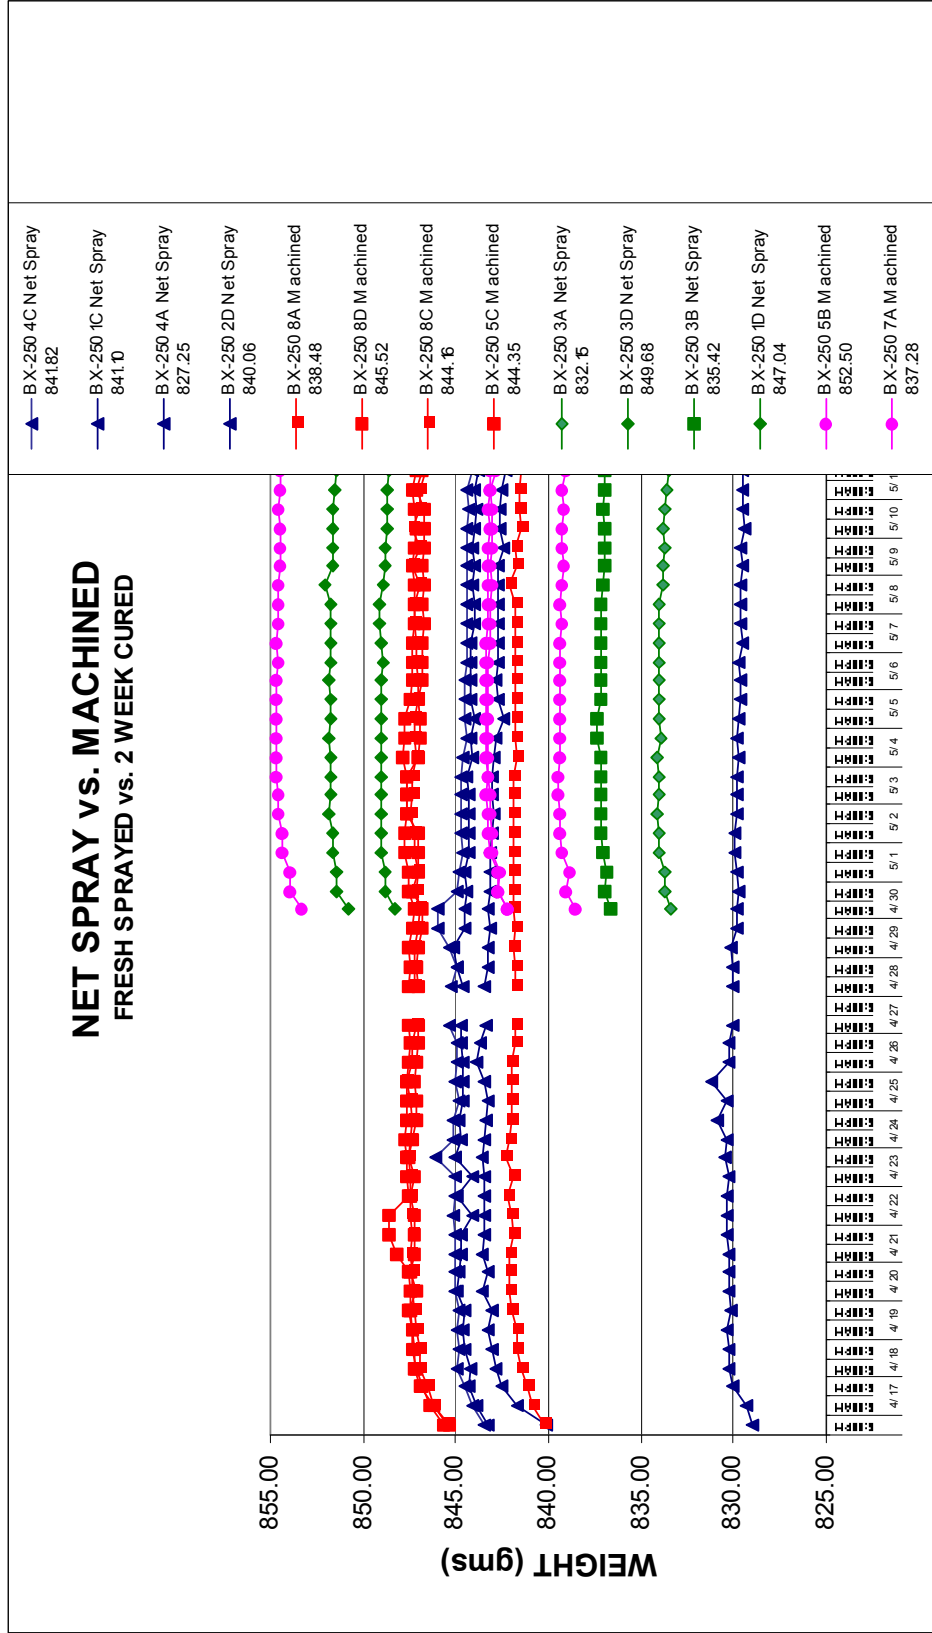
Figure 4. Accelerated Moisture Conditioning (32 °F/76% RH)

- Conclusions:
 - Data confounded by the measurement of combined mass of aluminum substrate and foam
 - Approximately no absorption observed in 32 °F/76% RH conditioning for both just-sprayed and two-week cured materials. See [Figure 4](#).

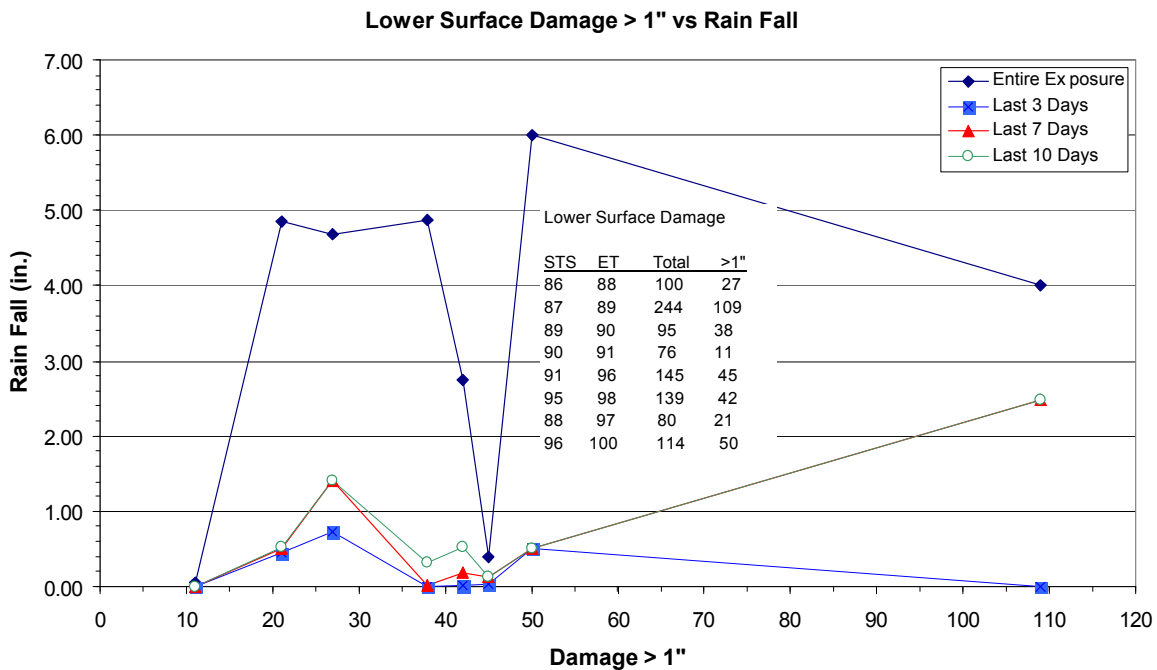
Figure 6. Correlation of On-Pad Rainfall to Orbiter Lower Surface Tile Damage.

- Date: April 1999
- Test Conductor: Chris Bourgeois/LMC
- Scope: Analyze the correlation of on-pad rainfall to orbiter hit count to support investigation and corrective action of IFA-87.
- Conclusions:
 - Limited positive correlation between KSC Prelaunch Dew Point and Bipod foam loss from STS-108 to STS-107 (7 flights spanning 12/01 to 1/03). See [Table 2](#).
 - Limited absence of correlation between on-pad rainfall and orbiter lower-surface tile damage (>1”) from STS-86 to STS-96 (8 flights spanning 9/97 to 5/99). See [Figure 6](#).
- Reference:
 - “ET Weather Report 11”, Jeff Kolodziejczak, February 2003.
 - “KSC ET Exposure Environments”, Chris Bourgeois, April 1999.

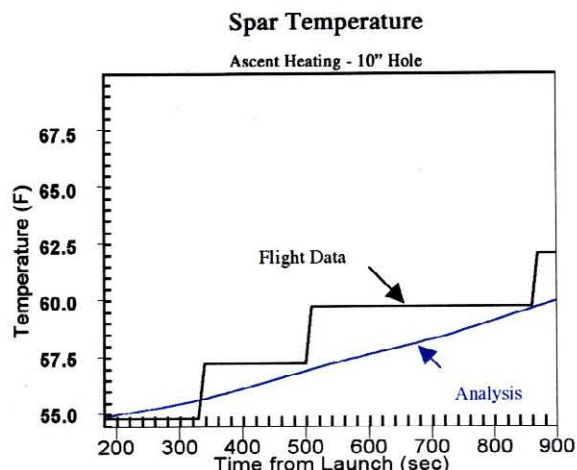
Figure 7: Data from OEX Thermocouple VO 9T9895 and Thermal Analysis by NASA (Reference 12).

One piece of evidence that corroborates that there was a breach in the wing at EI comes from the MADS/OEX thermocouple located behind the spar at the Panel 9 location. As discussed in References 4 and 12, there was “out-of-family” heating at this location during the STS 107 ascent. Figure 7 shows the time history of the measured thermocouple signal and the comparison of NASA’s thermal analysis (Reference 12) of the ascent event. As indicated on the figure, the “stepped” curve is the flight data while the blue-colored, smooth curve is the result of the NASA analysis. Note that the temperature readings are not large, owing to the facts that ascent heating is small, relative to that for entry, and that the thermocouple is behind the spar and the spar insulation. Detail of thermocouple locations will be discussed later.

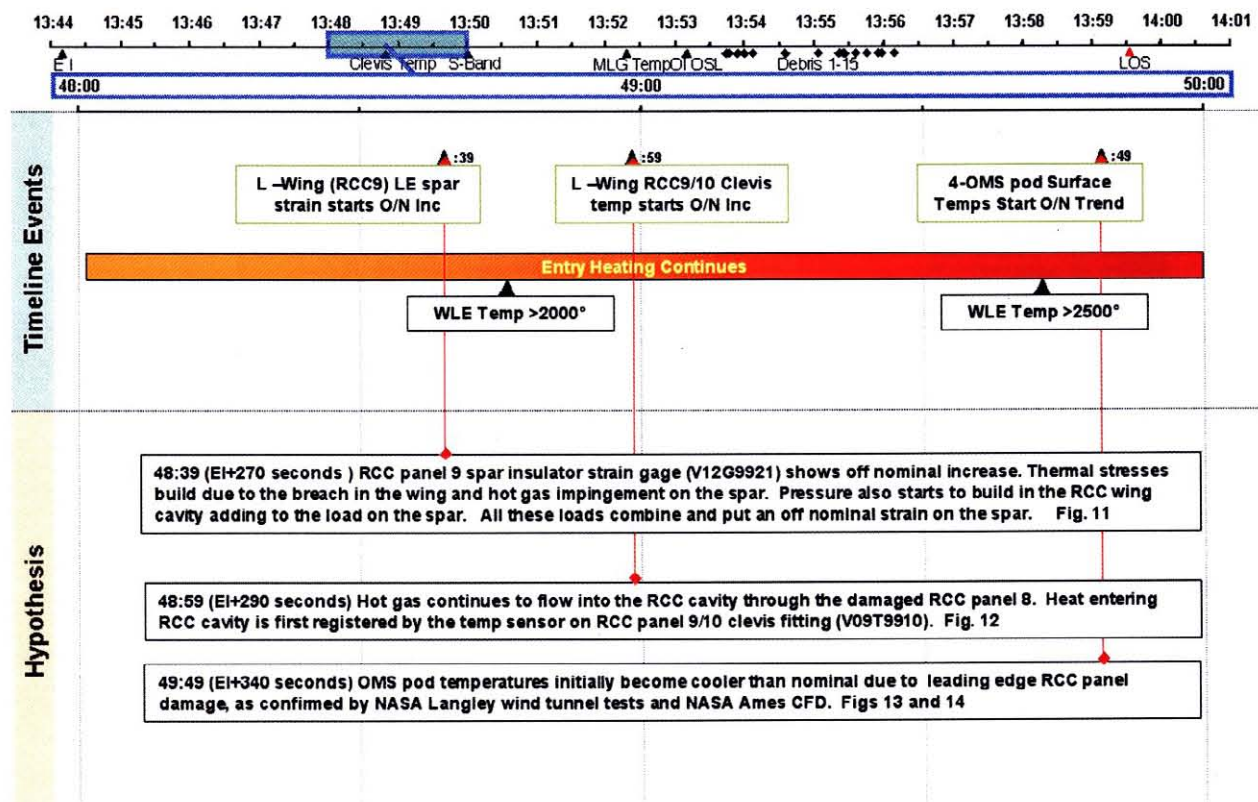
Figure 15: Timeline Versus Hypothesized Events 13:48:00 -> 13:50:00.

Figure 15 graphically depicts the timing of events recorded by the OEX sensors. The captions are self-explanatory. The MADS/OEX off-nominal data in the wing leading edge and spar are additional evidence that a breach existed in the RCC at the EL. The below nominal temperature on the OMS pod is consistent with the hypothesized damage in the wing leading edge in the RCC Panel 5 - 8 area.

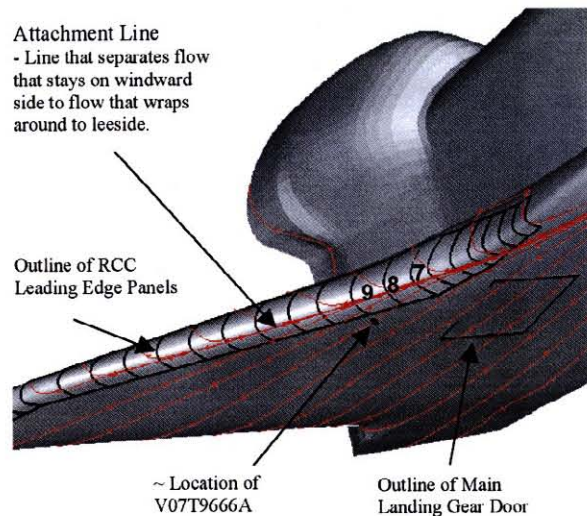
Figure 19: Orbiter Surface Streamlines. 13:50:53 (EI + 404), Mach: 24.9, Altitude: 243 k ft and Location of Thermocouple in Tile. CFD Solution from NASA (Reference 18).

As shown in Figure 19, thermocouple V07T9666A is in the flow area affected by Panel 8 (Reference 18). Specifically, as shown in the figure, the streamline, which passes over the junction of the lower Panel 8/9, also intersects the approximate location of this thermocouple. As will be discussed below, the forensic analysis shows compelling evidence that there was an outflow from the aforementioned 8/9 RCC lower panel junction that probably caused the above nominal readings of V07T9666A that started at EI + 370 seconds and continued till the spar breach occurred. This CFD solution by Gnoffo, Alter and Thompson (Reference 18), was the starting point of studies of flow into the breach, as will be discussed below.

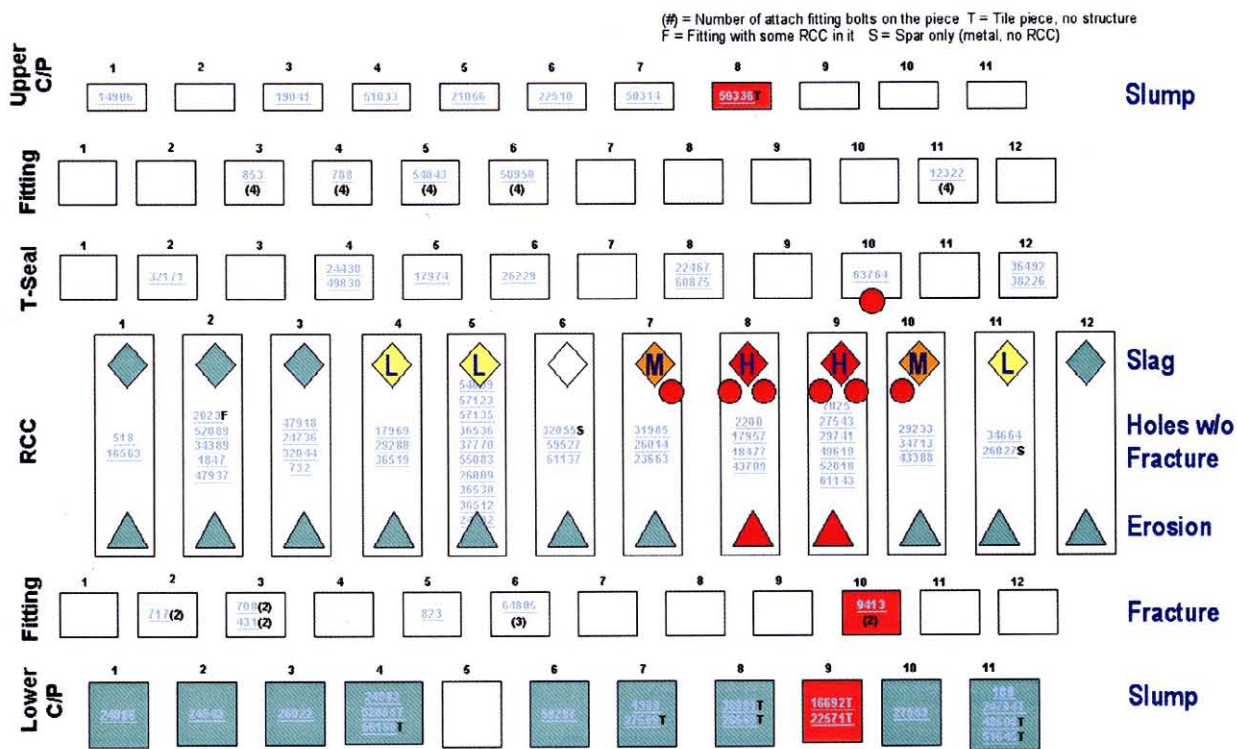
Figure 27: Left Hand Wing Debris Points to Breach in RCC Panel 8/9 Area (Reference 20).

For "Slag" the diamond symbol was used: Red (H) means heavy slag, Orange (M) means medium slag, Yellow (L) means light slag, Green (no letter) means none or very light slag. "Holes without fractures" refers to the unbroken holes in the RCC, interpreted as evidence that the Inconel fasteners melted out. Here, red circles indicate that prolonged heating occurred. Red triangles depict significant RCC erosion. Green triangles indicate no RCC erosion. "Fractures" indicate the possible evidence of hot-shortcracking of the A286 carrier panel attach bolts (as evidenced by intergranular fracture) as an indicator of prolonged high temperature exposure (Reference 20/Appendix, by L. Korb). The red square represents the only such finding among these debris.

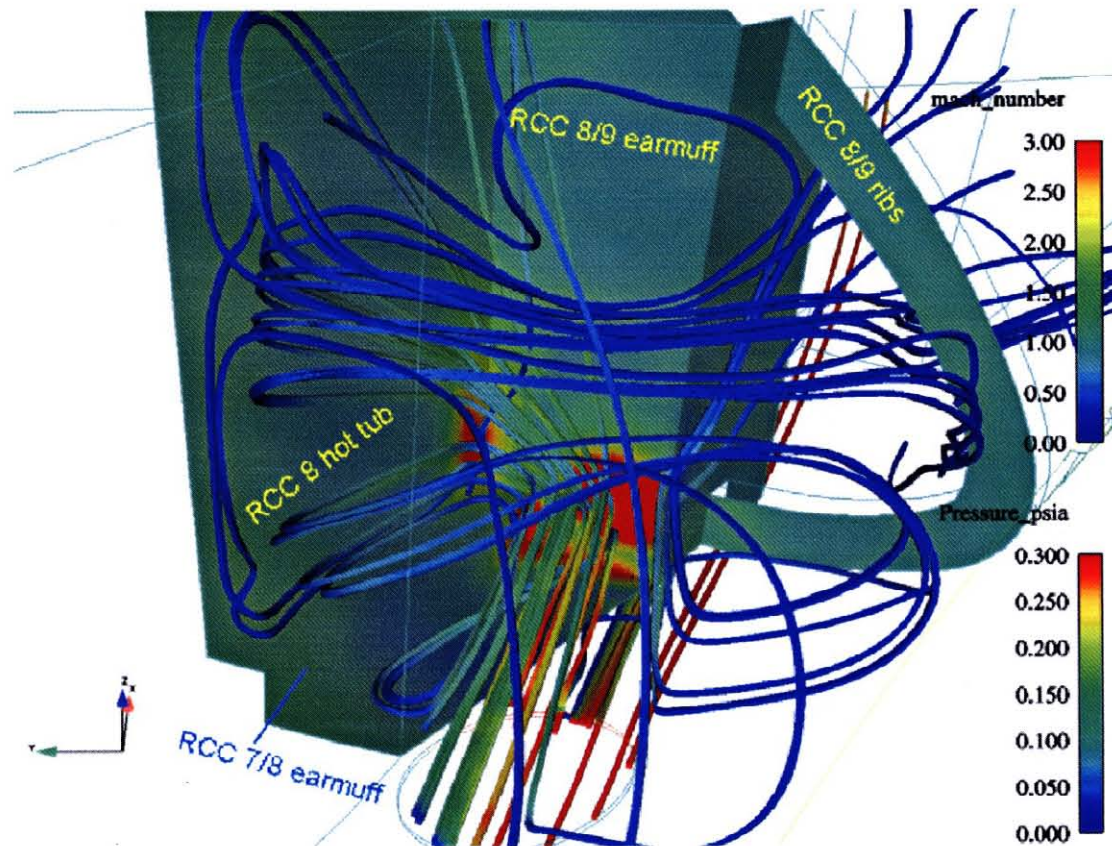
Figure 37 depicts a view of the CFD results (Reference 22) from the front of the leading edge with the acreage of the panels rendered transparent. The hole in RCC Panel 8 is outlined on the lower left corner of the figure. Streamlines are color coded by Mach number and pressures on the earmuff and spar insulation “hot tub” are displayed by the color-coding shown in the figure. As can be seen, the subsonic flow is complex and the jet creates a significant high-pressure zone on the RCC 8/9 earmuff.

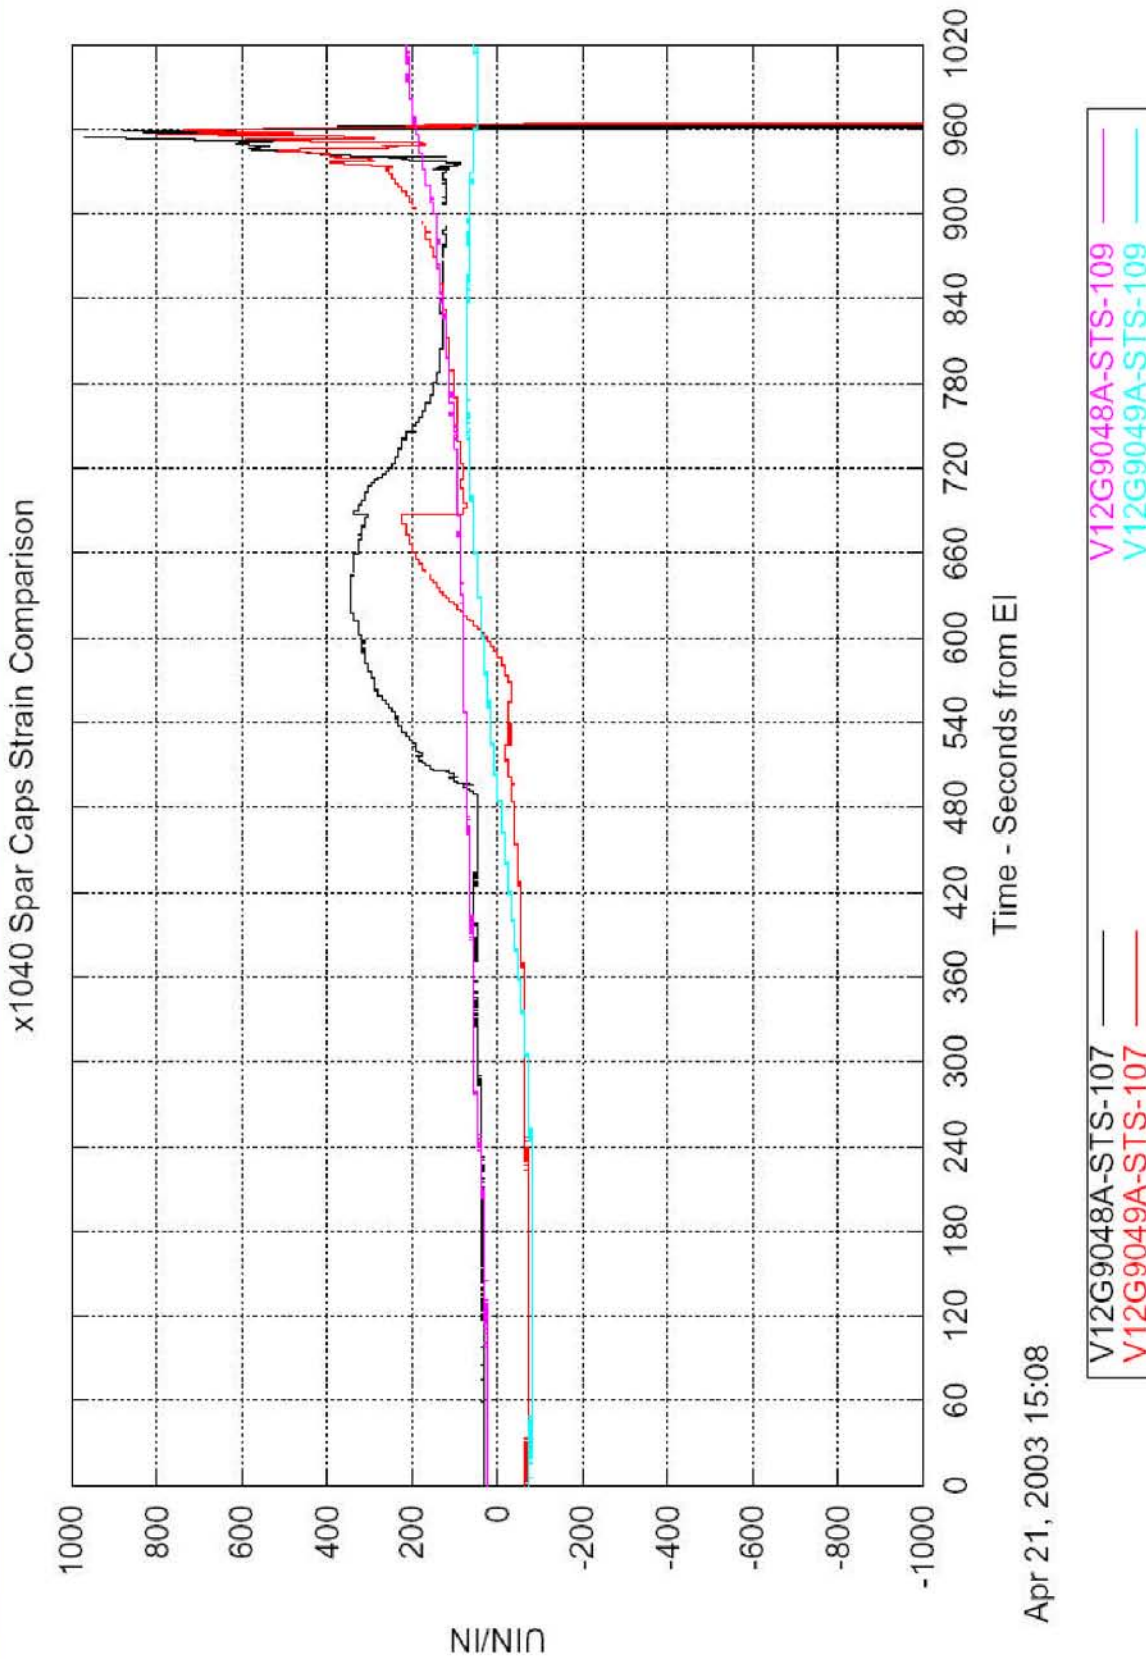
Left Wing X1040 Spar Cap Gauges Show an Anomalous Trend Initiating Between EI +500 and EI +600 Seconds
