COLUMBIA

ACCIDENT INVESTIGATION BOARD

REPORT VOLUME I
AUGUST 2003

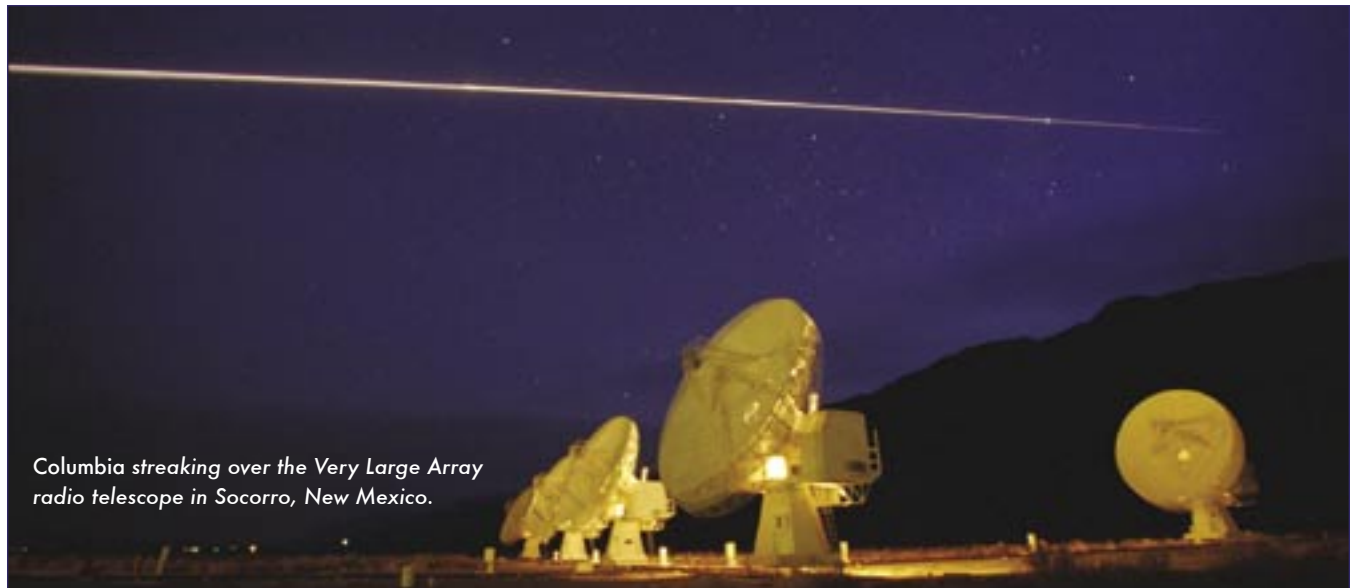
Columbia streaking over the Very Large Array radio telescope in Socorro, New Mexico.

Now crossing California, the Orbiter appeared to observers on the ground as a bright spot of light moving rapidly across the sky. Signs of debris being shed were sighted at 8:53:46 a.m. (EI+577), when the superheated air surrounding the Orbiter suddenly brightened, causing a noticeable streak in the Orbiter's luminescent trail. Observers witnessed another four similar events during the following 23 seconds, and a bright flash just seconds after *Columbia* crossed from California into Nevada airspace at 8:54:25 a.m. (EI+614), when the Orbiter was traveling at Mach 22.5 and 227,400 feet. Witnesses observed another 18 similar events in the next four minutes as *Columbia* streaked over Utah, Arizona, New Mexico, and Texas.

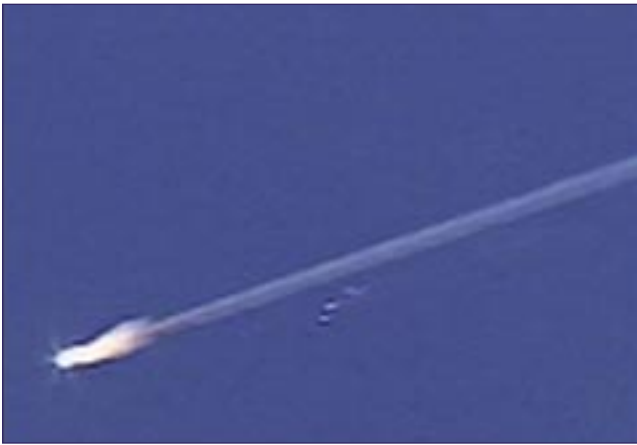
The Orbiter has a large glowing field surrounding it in this view taken from Mesquite, Texas, looking south.

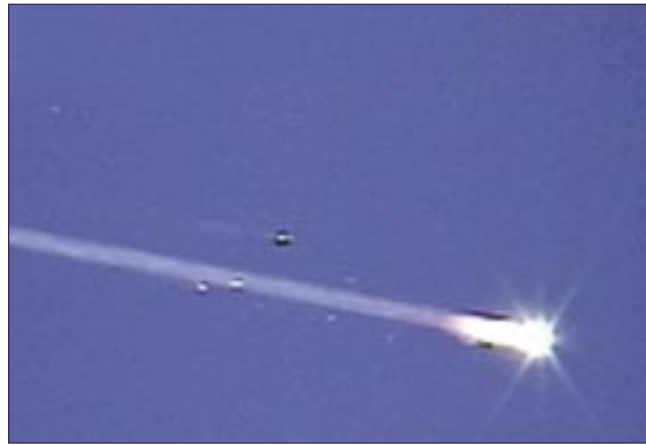
Taken at the same time as the photo at left, but from Hewitt, Texas, looking north.

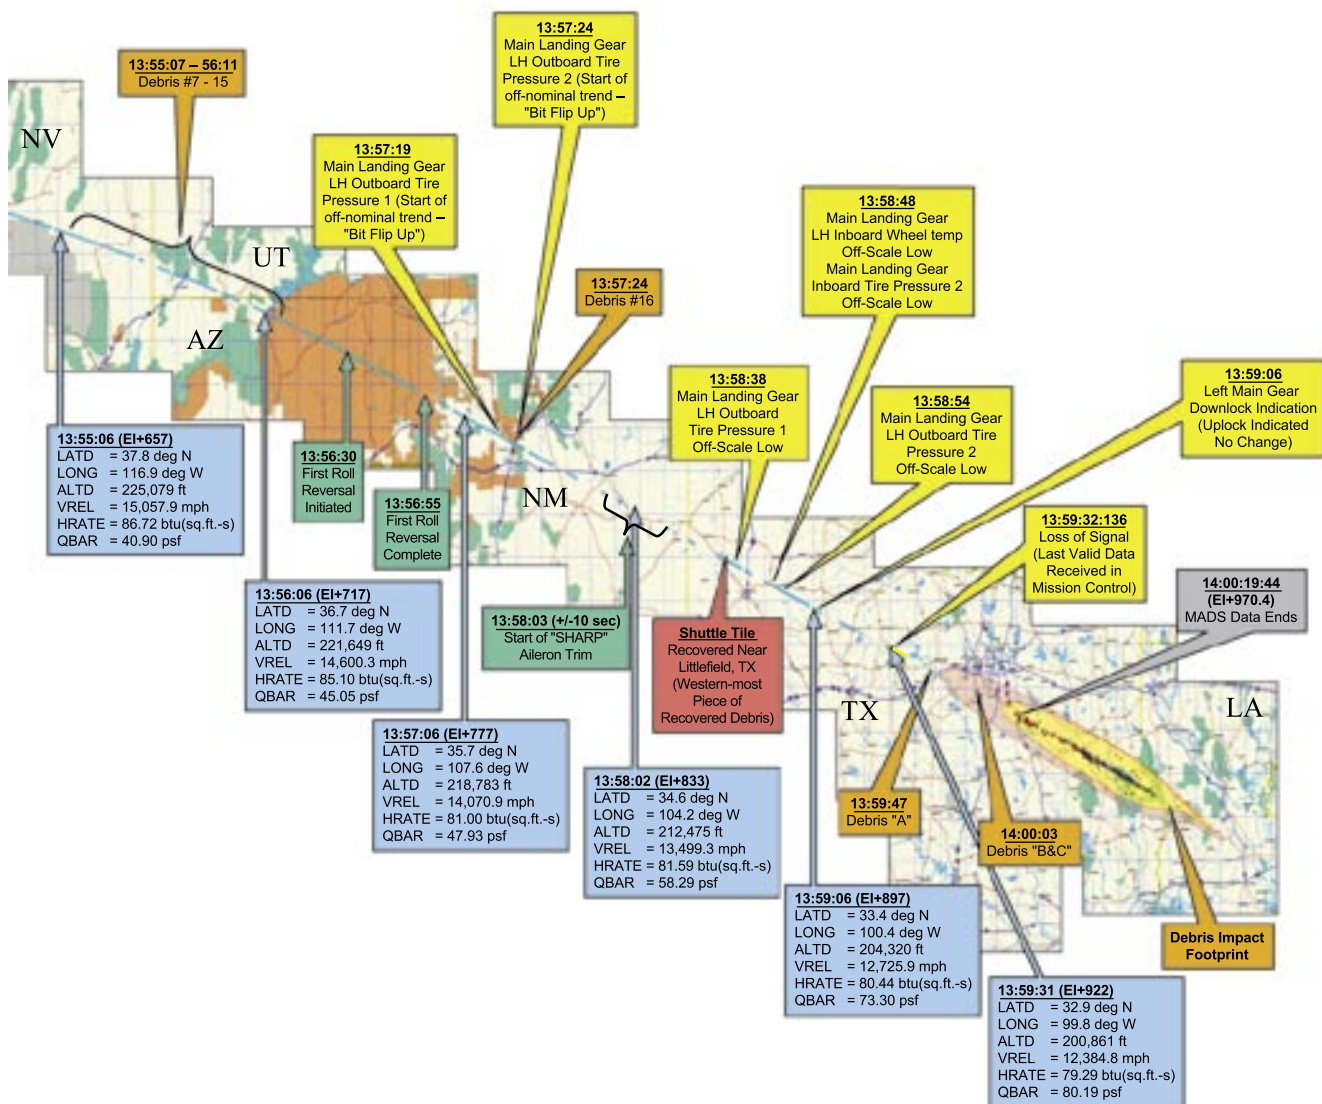
At 8:48:39 a.m. (EI+270), a sensor on the left wing leading edge spar showed strains higher than those seen on previous *Columbia* re-entries. This was recorded only on the Modular Auxiliary Data System, and was not telemetered to ground controllers or displayed to the crew (see Figure 2.6-1).

Figure 2.6-1. This simplified timeline shows the re-entry path of Columbia on February 1, 2003. The information presented here is a composite of sensor data telemetered to the ground combined with data from the Modular Auxiliary Data System recorder recovered after the accident. Note that the first off-nominal reading was a small increase in a strain gauge at the front wing spar behind RCC panel 9-left. The chart is color-coded: blue boxes contain position, attitude, and velocity information; orange boxes indicate when debris was shed from the Orbiter; green boxes are significant aerodynamic control events; gray boxes contain sensor information from the Modular Auxiliary Data System; and yellow boxes contain telemetered sensor information. The red boxes indicate other significant events.

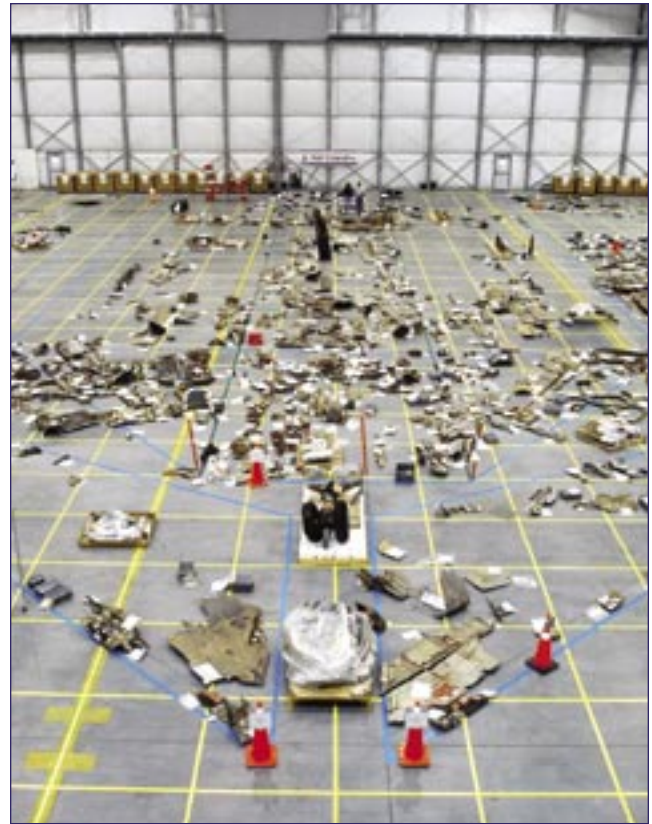
Figure 2.7-4. Recovered debris was returned to the Kennedy Space Center where it was laid out in a large hangar. The tape on the floor helped workers place each piece near where it had been on the Orbiter.

The debris collected (see Figure 2.7-4) by searchers aided the investigation in significant ways. Among the most important finds was the Modular Auxiliary Data System recorder that captured data from hundreds of sensors that was not telemetered to Mission Control. Data from these 800 sensors, recorded on 9,400 feet of magnetic tape, provided investigators with millions of data points, including temperature sensor readings from *Columbia's* left wing leading edge. The data also helped fill a 30-second gap in telemetered data and provided an additional 14 seconds of data after the telemetry loss of signal.

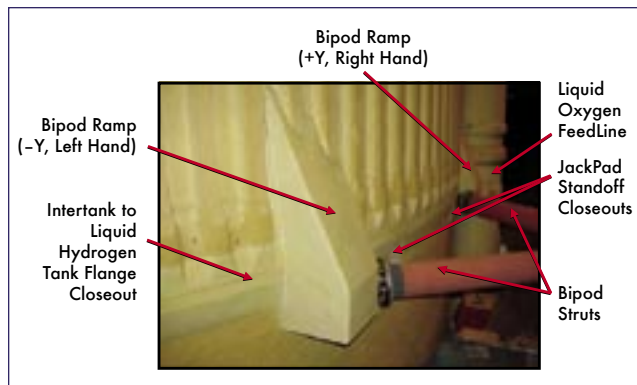
Figure 3.2-2. The exterior of the left bipod attachment area showing the foam ramp that came off during the ascent of STS-107.

A combination of factors, rather than a single factor, led to the loss of the left bipod foam ramp during the ascent of STS-107. NASA personnel believe that testing conducted during the investigation, including the dissection of as-built hardware and testing of simulated defects, showed conclusively that pre-existing defects in the foam were a major factor, and in briefings to the Board, these were cited as a necessary condition for foam loss. However, analysis indicated that pre-existing defects alone were not responsible for foam loss.

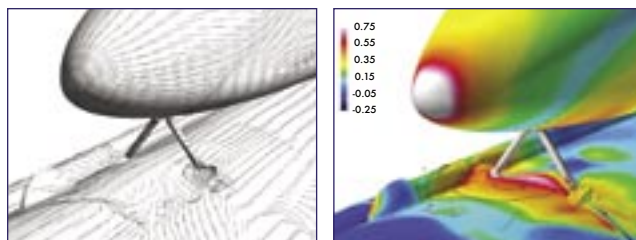
Figure 3.2-5. Computational Fluid Dynamics was used to understand the complex flow fields and pressure coefficients around bipod strut. The flight conditions shown here approximate those present when the left bipod foam ramp was lost from External Tank 93 at Mach 2.46 at a 2.08-degree angle of attack.

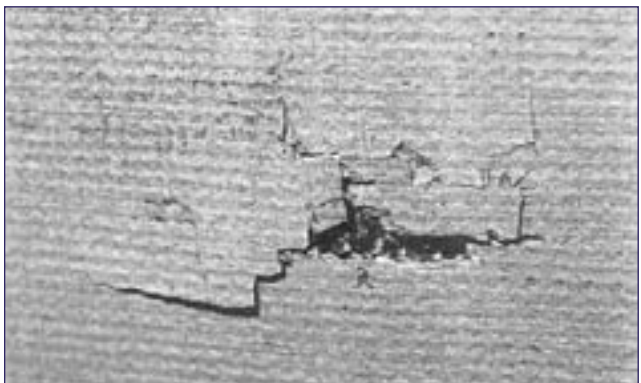
RCC components have been struck by objects throughout their operational life, but none of these components has been completely penetrated. A sampling of 21 post-flight reports noted 43 hypervelocity impacts, the largest being 0.2 inch. The most significant low-velocity impact was to *Atlantis*' panel 10-right during STS-45 in March and April 1992. The damaged area was 1.9 inches by 1.6 inches on the exterior surface and 0.5 inches by 0.1 inches in the interior surface. The substrate was exposed and oxidized, and the panel was scrapped. Analysis concluded that the damage was caused by a strike by a man-made object, possibly during ascent. Figures 3.3-2 and 3.3-3 show the damage to the outer and inner surfaces, respectively.

Figure 3.3-3. Damage on the inner surface of RCC panel 10-right from *Atlantis* after STS-45.

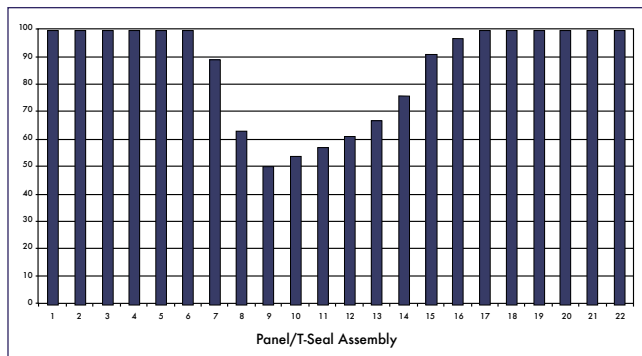
For the first five missions of *Columbia*, the RCC components were not coated with Type A sealant, and had shorter mission service lives than the RCC components on the other Orbiters. (*Columbia*'s panel 9 has the shortest mission service life of 50 flights as shown in Figure 3.3-4.) The predicted life for panel/T-seals 7 through 16 range from 54 to 97 flights.⁷

Figure 3.3-4. The expected mission life for each of the wing leading edge RCC panels on Columbia. Note that panel 9 has the shortest life expectancy.

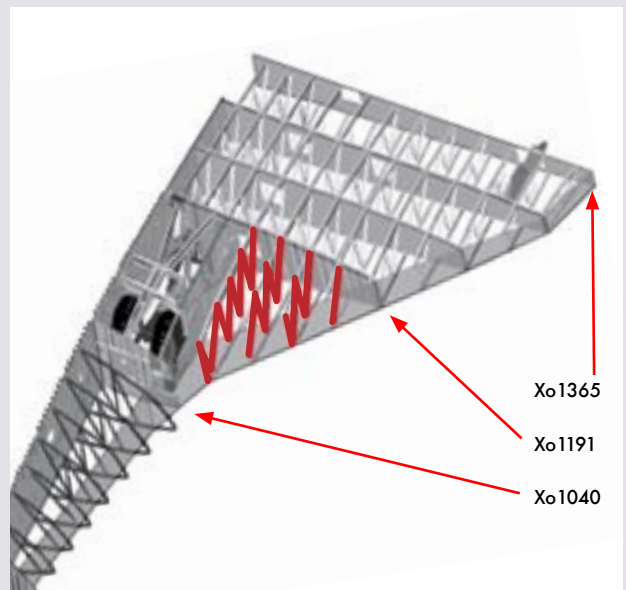
The Wing Leading Edge Structural System on Columbia.

The major internal support structures in the mid-wing are constructed from aluminum alloy. Since aluminum melts at 1,200 degrees Fahrenheit, it is likely these truss tubes in the mid-wing were destroyed and wing structural integrity was lost.

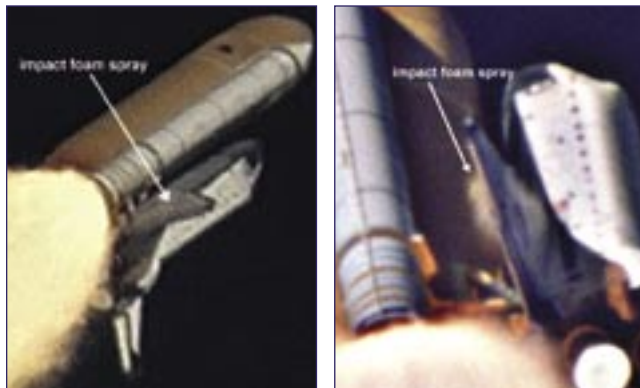
Figure 3.4-1 (color enhanced and "de-blurred" by Lockheed Martin Gaithersburg) and Figure 3.4-2 (processed by the National Imagery and Mapping Agency) are samples of the type of visual data used to establish the time of the impact (81.9 seconds), the altitude at which it occurred (65,860 feet), and the object's relative velocity at impact (about 545 mph relative to the Orbiter).

A 35-mm film camera, E212, which recorded the foam strike from 17 miles away, and video camera E208, which recorded it from 26 miles away, provided the best of the available evidence. Analysis of this visual evidence (see Figures 3.4-1 and 3.4-2) along with computer-aided design analysis, refined the potential impact area to less than 20 square feet in RCC panels 6 through 9 (see Figure 3.4-3), including a portion of the corresponding carrier panels and adjacent tiles. The investigation image analysis team found no conclusive visual evidence of post-impact debris flowing over the top of the wing.

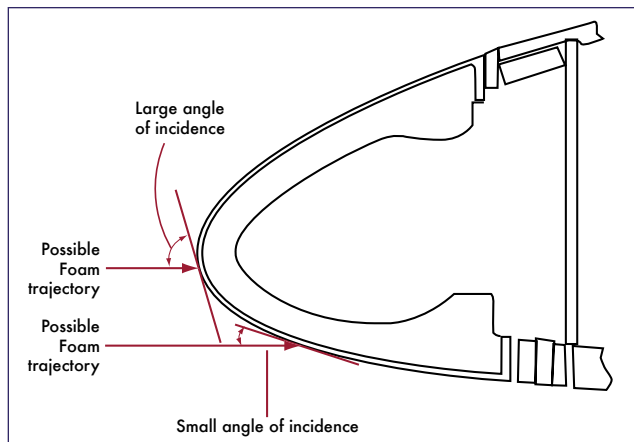
Image analysis determined that the foam was moving almost parallel to the Orbiter's fuselage at impact, with about a five-degree angle upward toward the bottom of the wing and slight motion in the outboard direction. If the foam had hit the tiles adjacent to the leading edge, the angle of incidence would have been about five degrees (the angle of incidence is the angle between the relative velocity of the projectile and the plane of the impacted surface). Because the wing leading edge curves, the angle of incidence increases as the point of impact approaches the apex of an RCC panel. Image and transport analyses estimated that for impact on RCC panel 8, the angle of incidence was between 10 and 20 degrees (see Figure 3.4-4).⁹ Because the total force delivered by the impact depends on the angle of incidence, a foam strike near the apex of an RCC panel could have delivered about twice the force as an impact close to the base of the panel.

Figure 3.4-4. This drawing shows the curve of the wing leading edge and illustrates the difference the angle of incidence has on the effect of the foam strike.

The precise impact location of the foam determined the impact angle because the debris was moving almost parallel to the Orbiter's fuselage at impact. Tile areas would have been hit at very small angles (approximately five degrees), but the curvature of the leading edge created angles closer to 20 degrees (see Figure 3.4-4).

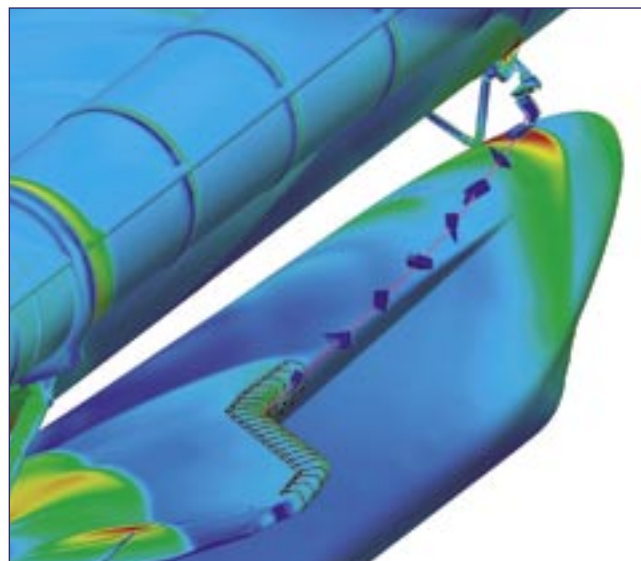
Figure 3.4-6. These are the results of a trajectory analysis that used a computational fluid dynamics approach in a program called CART-3D, a comprehensive (six-degree-of-freedom) computer simulation based on the laws of physics. This analysis used the aerodynamic and mass properties of bipod ramp foam, coupled with the complex flow field during ascent, to determine the likely position and velocity histories of the foam.

The undetermined and yet certainly irregular shape of the foam introduced substantial uncertainty about its estimated aerodynamic characteristics. Appendix D.8 contains an independent analysis conducted by the Board to confirm that the estimated range of ballistic coefficients of the foam in Figure 3.4-6 was credible, given the foam dimension results from the image analyses and the expected range of the foam density. Based on the results in Figure 3.4-7, the physical dimensions of the bipod ramp, and the sizes and shapes of the available barrels for the compressed-gas gun used in the impact test program described later in this chapter, the Board and the NASA Accident Investigation Team decided that a foam projectile 19 inches by 11.5 inches by 5.5 inches, weighing 1.67 pounds, and with a weight density of 2.4 pounds per cubic foot, would best represent the piece of foam that separated from the External Tank bipod ramp and was hit by the Orbiter’s left wing. See Section 3.8 for a full discussion of the foam impact testing.

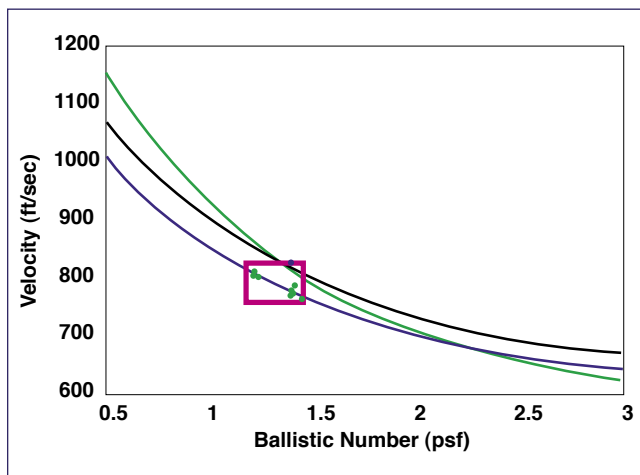
Figure 3.4-7. The results of numerous possible trajectories based on various assumed sizes, shapes, and densities of the foam. Either the foam had a slightly higher ballistic coefficient and the Orbiter struck the foam at a lower speed relative to the Orbiter, or the foam was more compact and the wing struck the foam at a higher speed. The “best fit” box represents the overlay of the data from the image analysis with the transport analysis computations. This data enabled a final selection of projectile characteristics for impact testing.

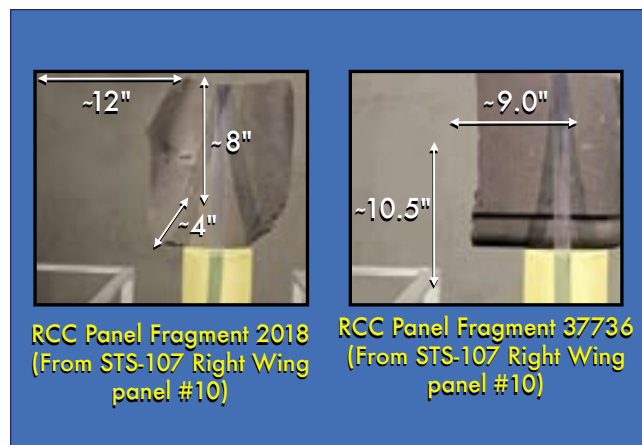
Figure 3.5-1. These representative RCC acreage pieces matched the radar cross-section of the Flight Day 2 object.

In the Advanced Compact Range at the Air Force Research Laboratory in Dayton, Ohio, analysts tested 31 materials from the Orbiter's exterior and payload bay. Additional supercomputer radar cross-section predictions were made for Reinforced Carbon-Carbon T-seals. After exhaustive radar cross-section analysis and testing, coupled with ballistic analysis of the object's orbital decay, only a fragment of RCC panel would match the UHF radar cross-section and ballistic coefficients observed by the Space Surveillance network. Such an RCC panel fragment must be approximately 140 square inches or greater in area to meet the observed radar cross-section characteristics. Figure 3.5-1 shows RCC panel fragments from *Columbia*'s right wing that represent those meeting the observed characteristics of object 2003-003B.¹⁰

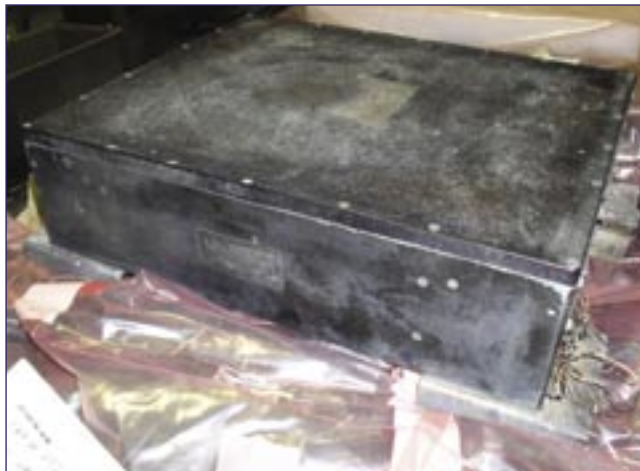
The Modular Auxiliary Data System is a supplemental instrumentation system that gathers Orbiter data for processing after the mission is completed. Inputs are almost exclusively physical sensor readings of temperatures, pressures, mechanical strains, accelerations, and vibrations. The Modular Auxiliary Data System usually records only the mission's first and last two hours (see Figure 3.6-1).

Figure 3.6-1. The Modular Auxiliary Data System recorder, found near Hemphill, Texas. While not designed to withstand impact damage, the recorder was in near-perfect condition when recovered on March 19, 2003.

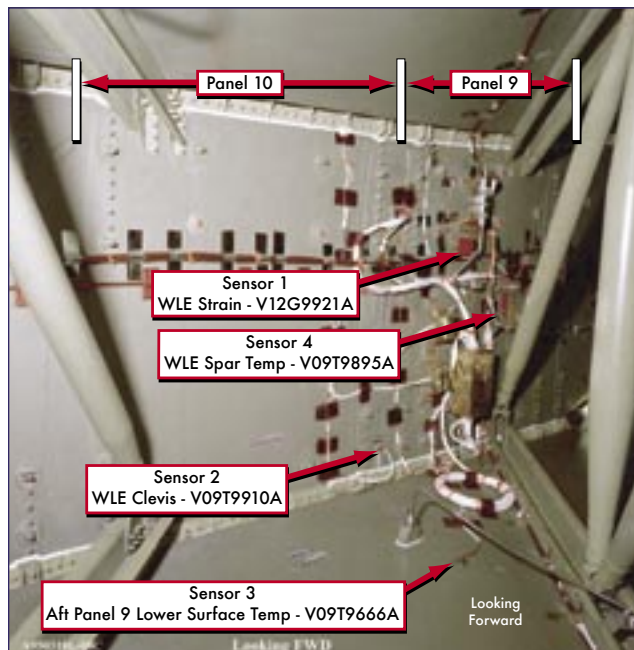
Figure 3.6-2. Location of sensors on the back of the left wing leading edge spar (vertical aluminum structure in picture). Also shown are the round truss tubes and ribs that provided the structural support for the mid-wing in this area.

or outside the wing leading edge spar near Reinforced Carbon-Carbon (RCC) panel 9-left, helped tell the story of what happened on the left wing of the Orbiter early in the re-entry. These four sensors were: strain gauge V12G9921A (Sensor 1), resistance temperature detector V09T9910A on the RCC clevis between panel 9 and 10 (Sensor 2), thermocouple V07T9666A, within a Thermal Protection System tile (Sensor 3), and resistance temperature detector V09T9895A (Sensor 4), located on the back side of the wing leading edge spar behind RCC panels 8 and 9 (see Figure 3.6-2).

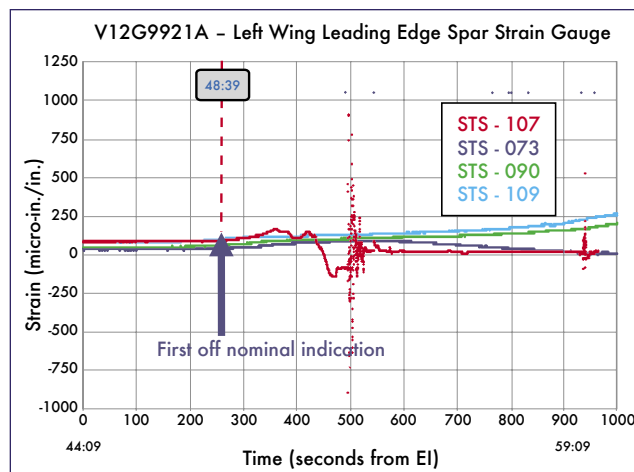
Figure 3.6-3. The strain gauge (Sensor 1) on the back of the left wing leading edge spar was the first sensor to show an anomalous reading. In this chart, and the others that follow, the red line indicates data from STS-107. Data from other *Columbia* re-entries, similar to the STS-107 re-entry profile, are shown in the other colors.

Sensor 1 provided the first anomalous reading (see Figure 3.6-3). From EI+270 to EI+360, the strain is higher than that on previous *Columbia* flights. At EI+450, the strain reverses, and then peaks again in a negative direction at EI+475. The strain then drops slightly, and remains constant and negative until EI+495, when the sensor pattern becomes unreliable, probably due to a propagating soft short, or “burn-through” of the insulation between cable conductors caused by heating or combustion. This strain likely indicates significant damage to the aluminum honeycomb spar. In particular, strain reversals, which are unusual, likely mean there was significant high-temperature damage to the spar during this time.

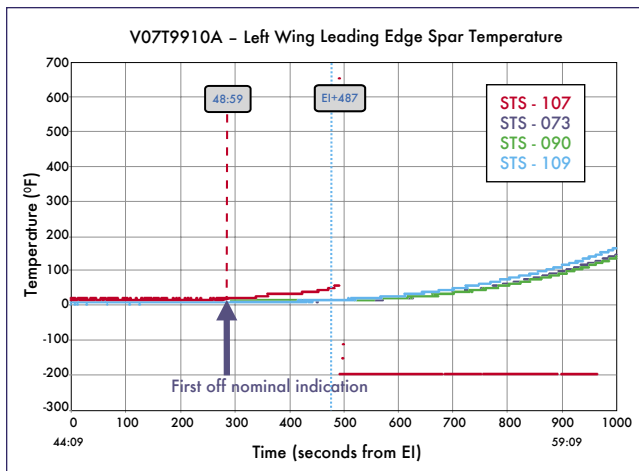
Figure 3.6-4. This temperature thermocouple (Sensor 2) was mounted on the outside of the wing leading edge spar behind the insulation that protects the spar from radiated heat from the RCC panels. It clearly showed an off-nominal trend early in the re-entry sequence and began to show an increase in temperature much earlier than the temperature sensor behind the spar.

left wing leading edge spar, recorded the beginning of a gradual and abnormal rise in temperature from an expected 30 degrees Fahrenheit to 65 degrees at EI+493, when it then dropped to “off-scale low,” a reading that drops off the scale at the low end of the sensor’s range (see Figure 3.6-4). Sensor 2, one of the first to fail, did so abruptly. It had indicated only a mild warming of the RCC attachment clevis before the signal was lost.

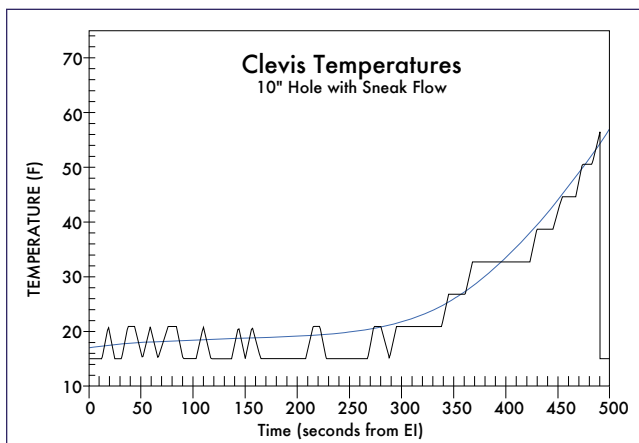
Figure 3.6-5. The analysis of the effect of a 10-inch hole in RCC panel 8 on Sensor 2 from EI to EI+500 seconds. The jagged line shows the actual flight data readings and the smooth line the calculated result for a 10-inch hole with some sneak flow of superheated air behind the spar insulation.

A series of thermal analyses were performed for different sized holes in RCC panel 8 to compute the time required to heat Sensor 2 to the temperature recorded by the Modular Auxiliary Data System. To heat the clevis, various insulators would have to be bypassed with a small amount of leakage, or “sneak flow.” Figure 3.6-5 shows the results of these calculations for, as an example, a 10-inch hole, and demonstrates that with sneak flow around the insulation, the temperature profile of the clevis sensor was closely matched by the engineering calculations. This is consistent with the same sneak flow required to match a similar but abnormal ascent temperature rise of the same sensor, which further supports the premise that the breach in the leading edge of the wing occurred during ascent. While the exact size of the breach will never be known, and may have been smaller or larger than 10 inches, these analyses do provide a plausible explanation for the observed rises in temperature sensor data during re-entry.

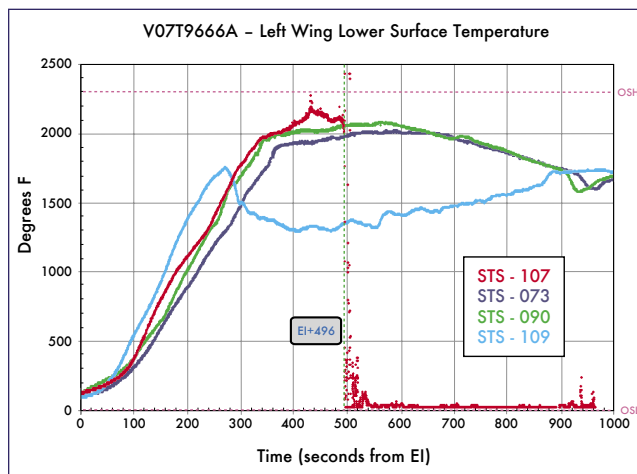
Figure 3.6-6. As early as EI+370, Sensor 3 began reading significantly higher than on previous flights. Since this sensor was located in a thermal tile on the lower surface of the left wing, its temperatures are much higher than those for the other sensors.

The readings of Sensor 3, which was in a thermal tile, began rising abnormally high and somewhat erratically as early as EI+370, with several brief spikes to 2,500 degrees Fahrenheit, significantly higher than the 2,000-degree peak temperature on a normal re-entry (Figure 3.6-6). At EI+496, this reading became unreliable, indicating a failure of the wire or the sensor. Because this thermocouple was on the wing lower surface, directly behind the junction of RCC panel 9 and 10, the high temperatures it initially recorded were almost certainly a result of air jetting through the damaged area of RCC panel 8, or of the normal airflow being disturbed by the damage. Note that Sensor 3 provided an external temperature measurement, while Sensors 2 and 4 provided internal temperature measurements.

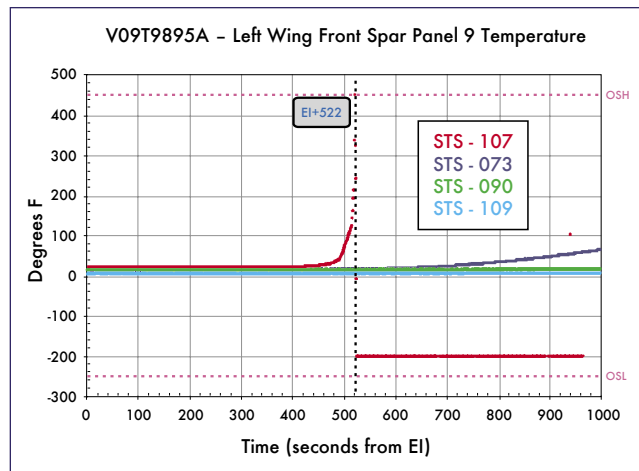
Sensor 4 also recorded a rise in temperature that ended in an abrupt fall to off-scale low. Figure 3.6-7 shows that an abnormal temperature rise began at EI+425 and abruptly fell at EI+525. Unlike Sensor 2, this temperature rise was extreme, from an expected 20 degrees Fahrenheit at EI+425 to 40 degrees at EI+485, and then rising much faster to 120 degrees at EI+515, then to an off-scale high (a reading that climbs off the scale at the high end of the range) of 450 degrees at EI+522. The failure pattern of this sensor likely indicates destruction by extreme heat.

Figure 3.6-7. Sensor 4 also began reading significantly higher than previous flights before it fell off-scale low. The relatively late reaction of this sensor compared to Sensor 2, clearly indicated that superheated air started on the outside of the wing leading edge spar and then moved into the mid-wing after the spar was burned through. Note that immediately before the sensor (or the wire) fails, the temperature is at 450 degrees Fahrenheit and climbing rapidly. It was the only temperature sensor that showed this pattern.

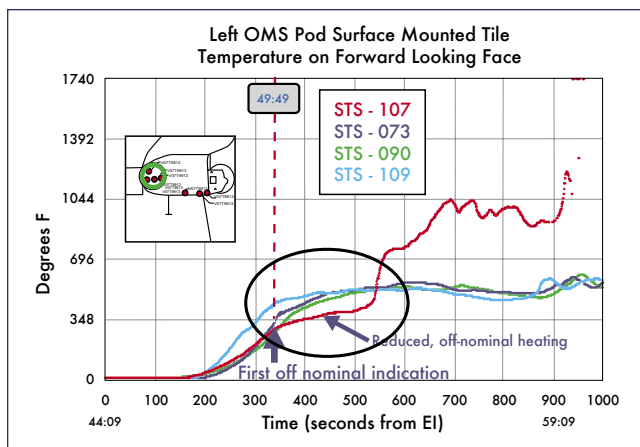
Figure 3.6-9. Orbital Maneuvering System (OMS) pod heating was initially significantly lower than that seen on previous Columbia missions. As wing leading edge damage later increased, the OMS pod heating increased dramatically. Debris recovered from this area of the OMS pod showed substantial pre-breakup heat damage and imbedded drops of once-molten metal from the wing leading edge in the OMS pod thermal tiles.

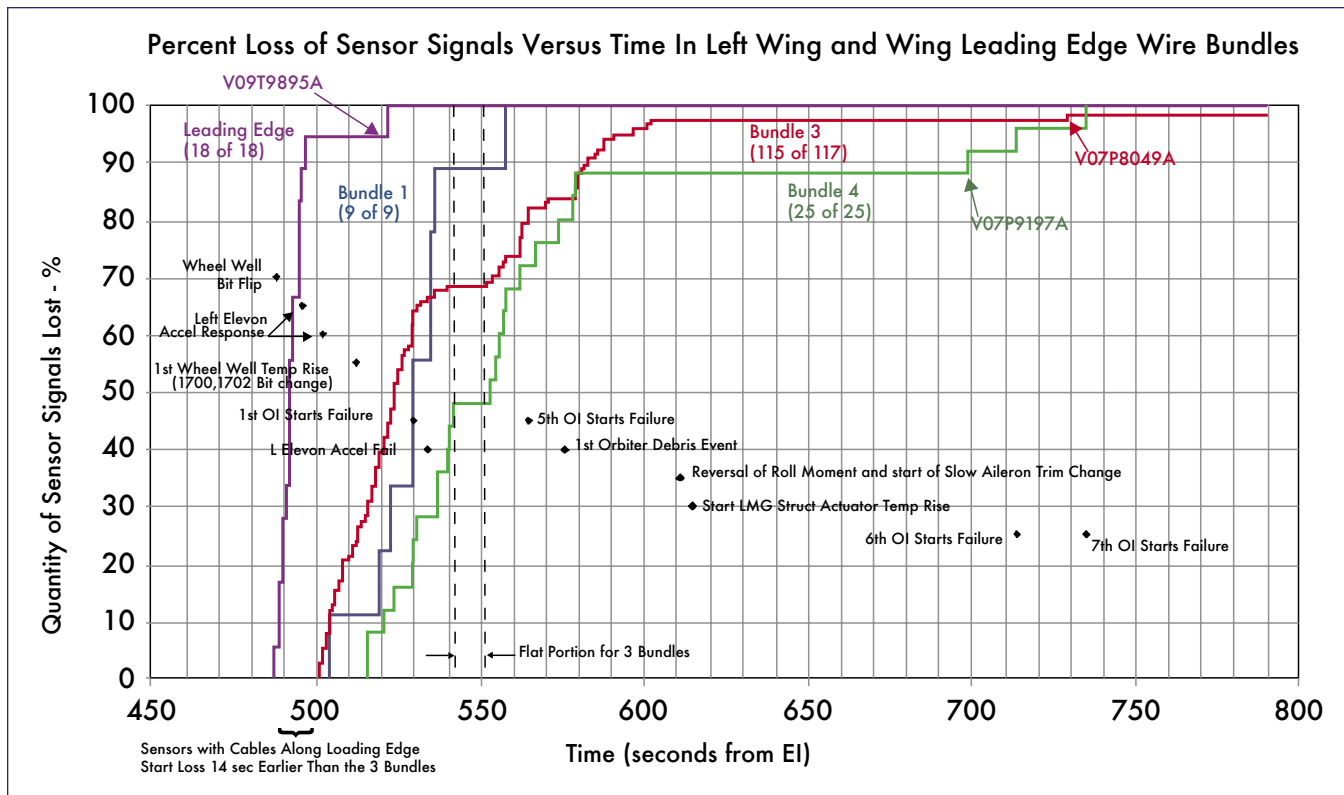
Fourteen seconds after the loss of the first sensor wire on the wing leading edge spar at EI+487, a sensor wire in a bundle of some 150 wires that ran along the upper outside corner of the left wheel well showed a burn-through. In the next 50 seconds, more than 70 percent of the sensor wires in three cables in this area also burned through (see Figure 3.6-10). Investigators plotted the wiring run for every left-wing sensor, looking for a relationship between their location and time of failure.

Figure 3.6-10. This chart shows how rapidly the wire bundles in the left wing were destroyed. Over 70 percent of the sensor wires in the wiring bundles burned through in under a minute. The black diamonds show the times of significant timeline sensor events.

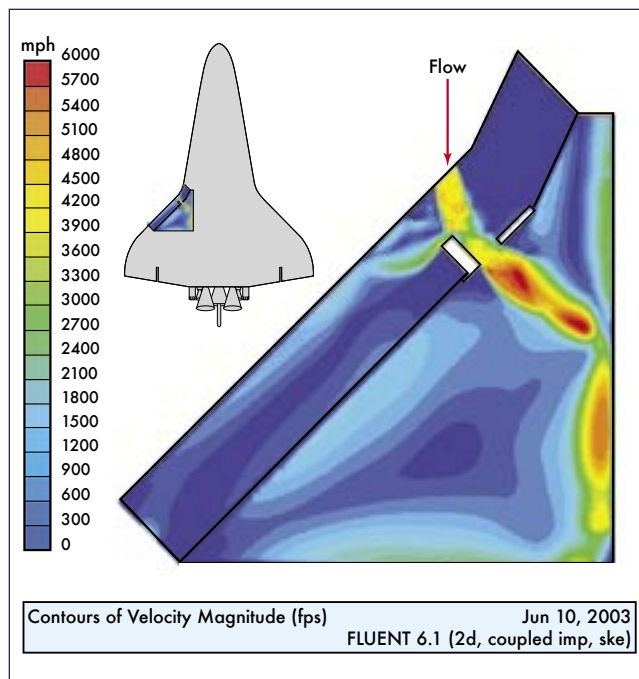
Later computational fluid dynamics analysis of the mid-wing area behind the spar showed that superheated air flowing into a breached RCC panel 8 and then interacting with the internal structure behind the RCC cavity (RCC ribs and spar insulation) would have continued through the wing leading edge spar as a jet, and would have easily allowed superheated air to traverse the 56.5 inches from the spar to the outside of the wheel well and destroy the cables (Figure 3.6-11). Controllers on the ground saw these first anomalies in the telemetry data at EI+613, when four hydraulic sensor cables that ran from the aft part of the left wing through the wiring bundles outside the wheel well failed.

Figure 3.6-11. The computational fluid dynamics analysis of the speed of the superheated air as it entered the breach in RCC panel 8 and then traveled through the wing leading edge spar. The darkest red color indicates speeds of over 4,000 miles per hour. Temperatures in this area likely exceeded 5,000 degrees Fahrenheit. The area of detail is looking down at the top of the left wing.

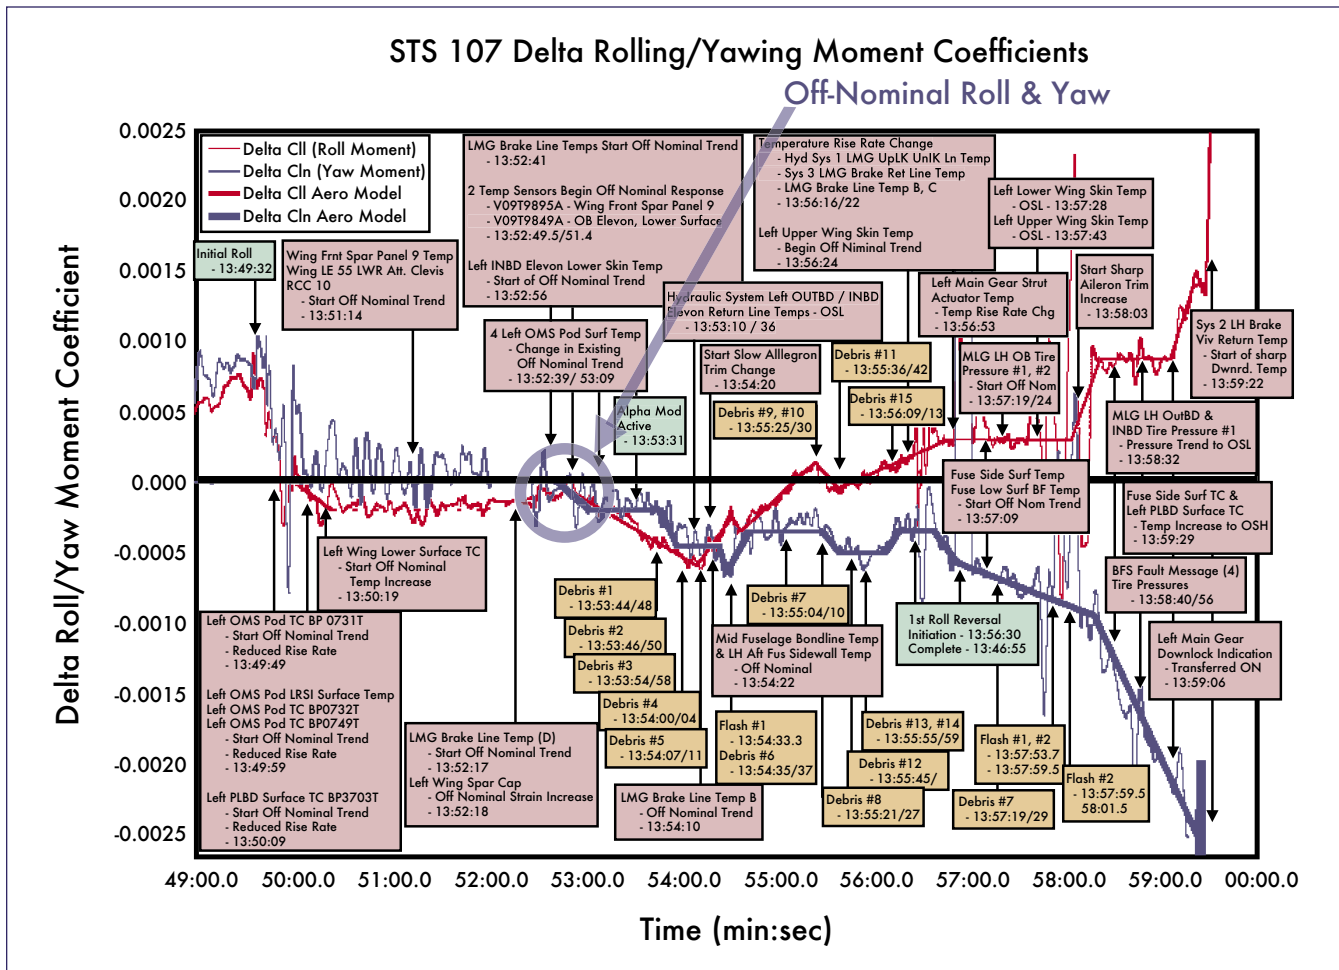
Aerodynamic roll and yaw forces began to differ from those on previous flights at about EI+500 (see Figure 3.6-12). Investigators used flight data to reconstruct the aerodynamic forces acting on the Orbiter. This reconstructed data was then compared to forces seen on other similar flights of *Columbia*

Figure 3.6-12. At approximately EI+500 seconds, the aerodynamic roll and yaw forces began to diverge from those observed on previous flights. The blue line shows the Orbiter's tendency to yaw while the red line shows its tendency to roll. Nominal values would parallel the solid black line. Above the black line, the direction of the force is to the right, while below the black line, the force is to the left.

and to the forces predicted for STS-107. In the early phase of flight, these abnormal aerodynamic forces indicated that *Columbia's* flight control system was reacting to a change in the external shape of the wing, which was caused by progressive RCC damage that caused a continuing decrease in lift and a continuing increase in drag on the left wing.

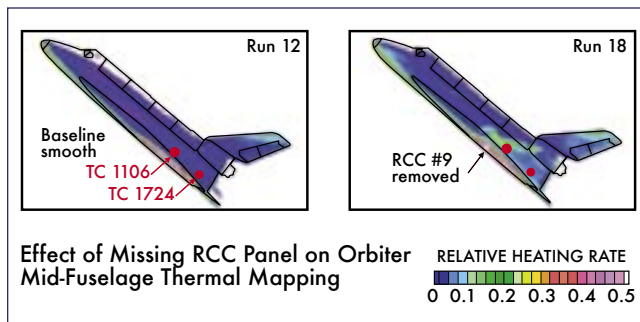
Figure 3.6-13 shows the comparison of surface temperature distribution with an undamaged Orbiter and one with an entire panel 9 removed. With panel 9 removed, a strong vortex flow structure is positioned to increase the temperature on the leading edge of the Orbital Maneuvering System pod. The aim is not to demonstrate that all of panel 9 was missing at this point, but rather to indicate that major damage to panels near panel 9 can shift the strong vortex flow pattern and change the Orbiter's temperature distribution to match the Modular Auxiliary Data System information. Wind tunnel tests also demonstrated that increasing damage to leading edge RCC panels would result in increasing drag and decreasing lift on the left wing.

Figure 3.6-13. The effects of removing RCC panel 9 are shown in this figure. Note the brighter colors on the front of the OMS pod show increased heating, a phenomenon supported by both the OMS pod temperature sensors and the debris analysis.

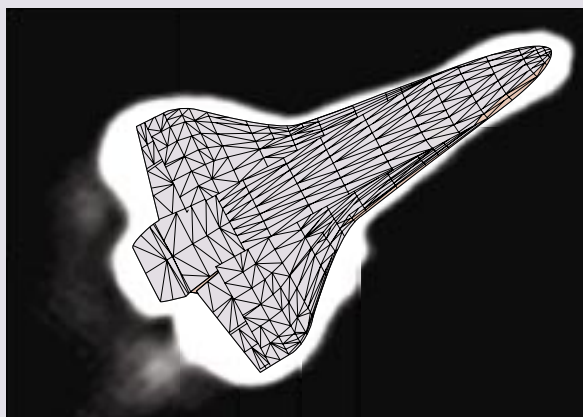
THE KIRTLAND IMAGE

As *Columbia* passed over Albuquerque, New Mexico, during re-entry (around EI+795), scientists at the Air Force Starfire Optical Range at Kirtland Air Force Base acquired images of the Orbiter. This imaging had not been officially assigned, and the photograph was taken using commercial equipment located at the site, not with the advanced Starfire adaptive-optics telescope.

The image shows an unusual condition on the left wing, a leading-edge disturbance that might indicate damage. Several analysts concluded that the distortion evident in the image likely came from the modification and interaction of shock waves due to the damaged leading edge. The overall appearance of the leading-edge damage at this point on the trajectory is consistent with the scenario.

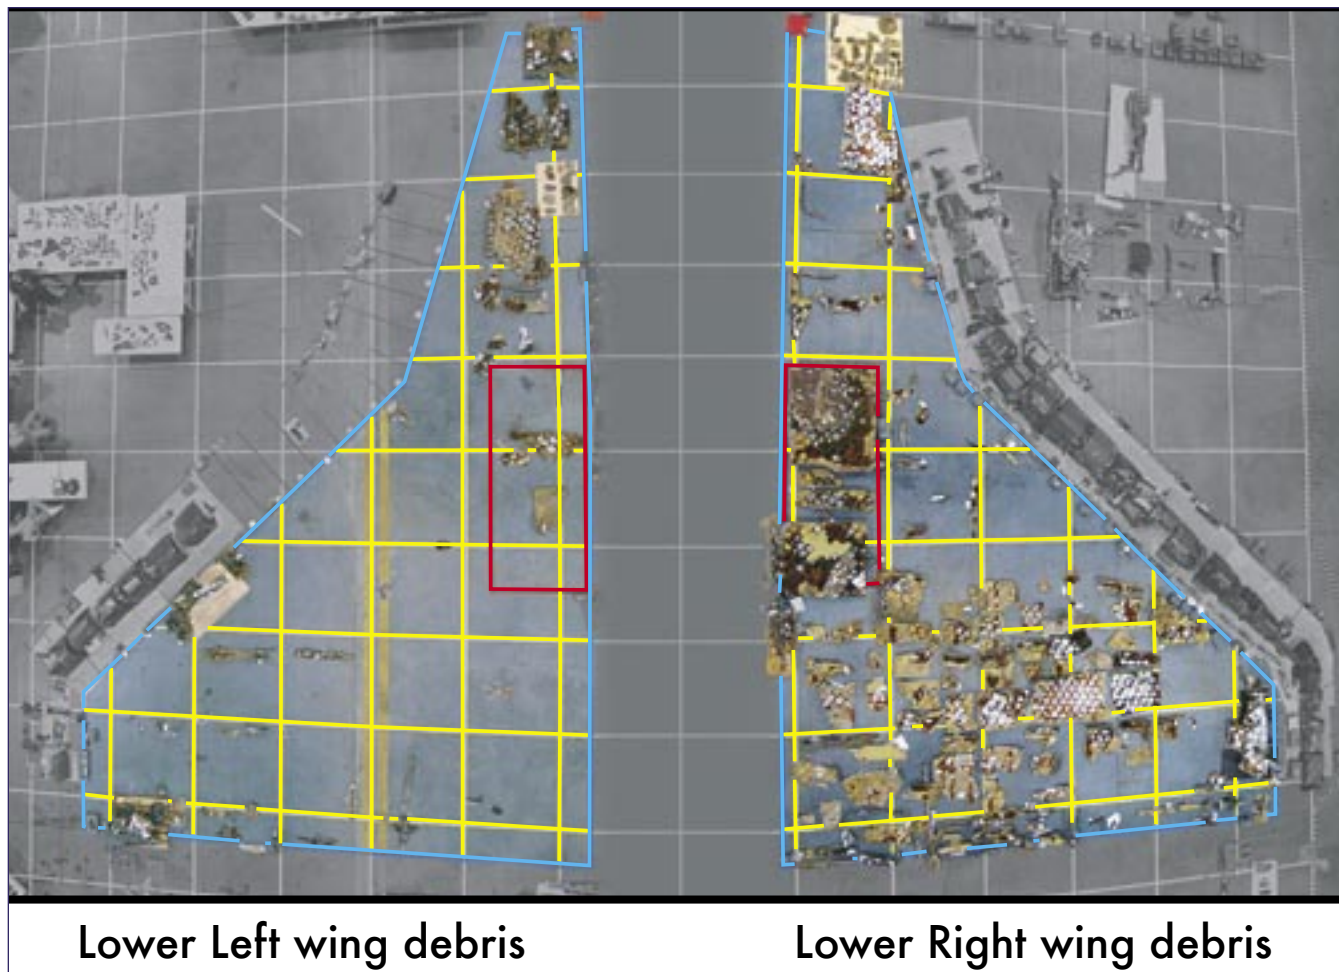
Figure 3.7-1. Comparison of amount of debris recovered from the left and right wings of Columbia. Note the amount of debris recovered from areas in front of the wheel well (the red boxes on each wing) were similar, but there were dramatic differences in the amount of debris recovered aft of each wheel well.

Detailed analysis of the debris revealed unique features and convincing evidence that the damage to the left wing differed significantly from damage to the right, and that significant differences existed in pieces from various areas of the left wing. While a substantial amount of upper and lower right wing structure was recovered, comparatively little of the upper and lower left wing structure was recovered (see Figure 3.7-1).

The difference in recovered debris from the Orbiter's wings clearly indicates that after the breakup, most of the left wing succumbed to both high heat and aerodynamic forces, while the right wing succumbed to aerodynamic forces only. Because the left wing was already compromised, it was the first area of the Orbiter to fail structurally. Pieces were exposed to higher heating for a longer period, resulting in more heat damage and ablation of left wing structural material. The left wing was also subjected to superheated air that penetrated directly into the mid-body of the wing for a substantial period. This pre-heating likely rendered those components unable to absorb much, if any, of the post-breakup heating. Those internal and external structures were likely vaporized during post-breakup re-entry. Finally, the left wing likely lost significant amounts of the Thermal Protection System prior to breakup due to the effect of internal wing heating on the Thermal Protection System bonding materials, and this further degraded the left wing's ability to resist the high heat of re-entry after it broke up.

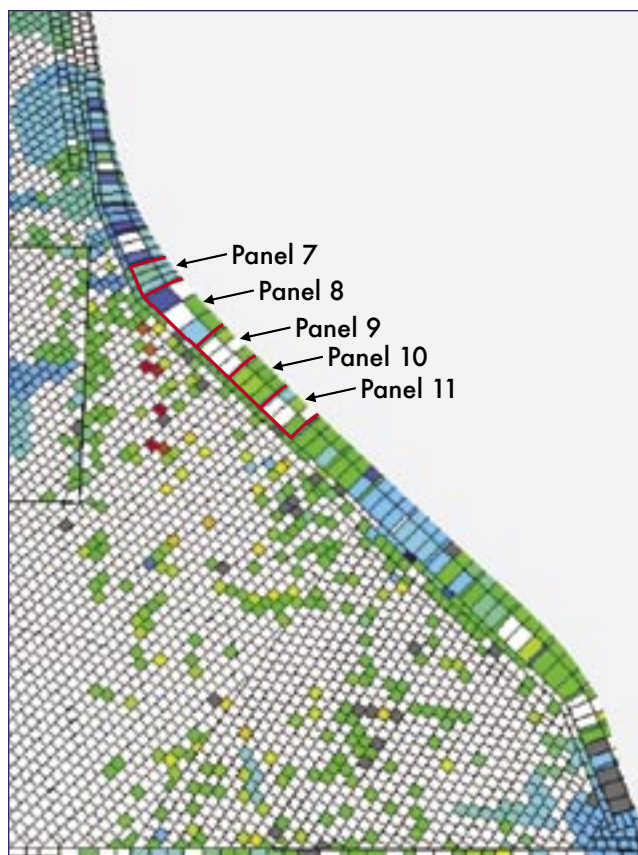
Figure 3.7-6. The tiles recovered farthest west all came from the area immediately behind left wing RCC panels 8 and 9. In the figure, each small box represents an individual tile on the lower surface of the left wing. The more red an individual tile appears, the farther west it was found.

An analysis of where tiles were found on the ground also yielded significant evidence of the breach location. Since most of the tiles are of similar size, weight, and shape, they would all have similar ballistic coefficients and would have behaved similarly after they separated from the Orbiter. By noting where each tile fell and then plotting its location on the Orbiter tile map, a distinctive pattern emerged. The tiles recovered farthest west all came from the area immediately behind the left wing RCC panel 8 and 9 (see Figure 3.7-6), which suggests that these tiles were released earlier than those from other areas of the left wing. While it is not conclusive evidence of a breach in this area, this pattern does suggest unique damage around RCC panels 8 and 9 that was not seen in other areas. Tiles from this area also showed evidence of a brown deposit that was not seen on tiles from any

other part of the Orbiter. Chemical analysis revealed it was an Inconel-based deposit that had come from inside the RCC cavity on the left wing (Inconel is found in wing leading edge attachment fittings). Since the streamlines from tiles with the brown deposit originate near left RCC panels 8 and 9, this brown deposit likely originated as an outflow of superheated air and molten metal from the panel 8 and 9 area.
