COLUMBIA

ACCIDENT INVESTIGATION BOARD

REPORT VOLUME I
AUGUST 2003

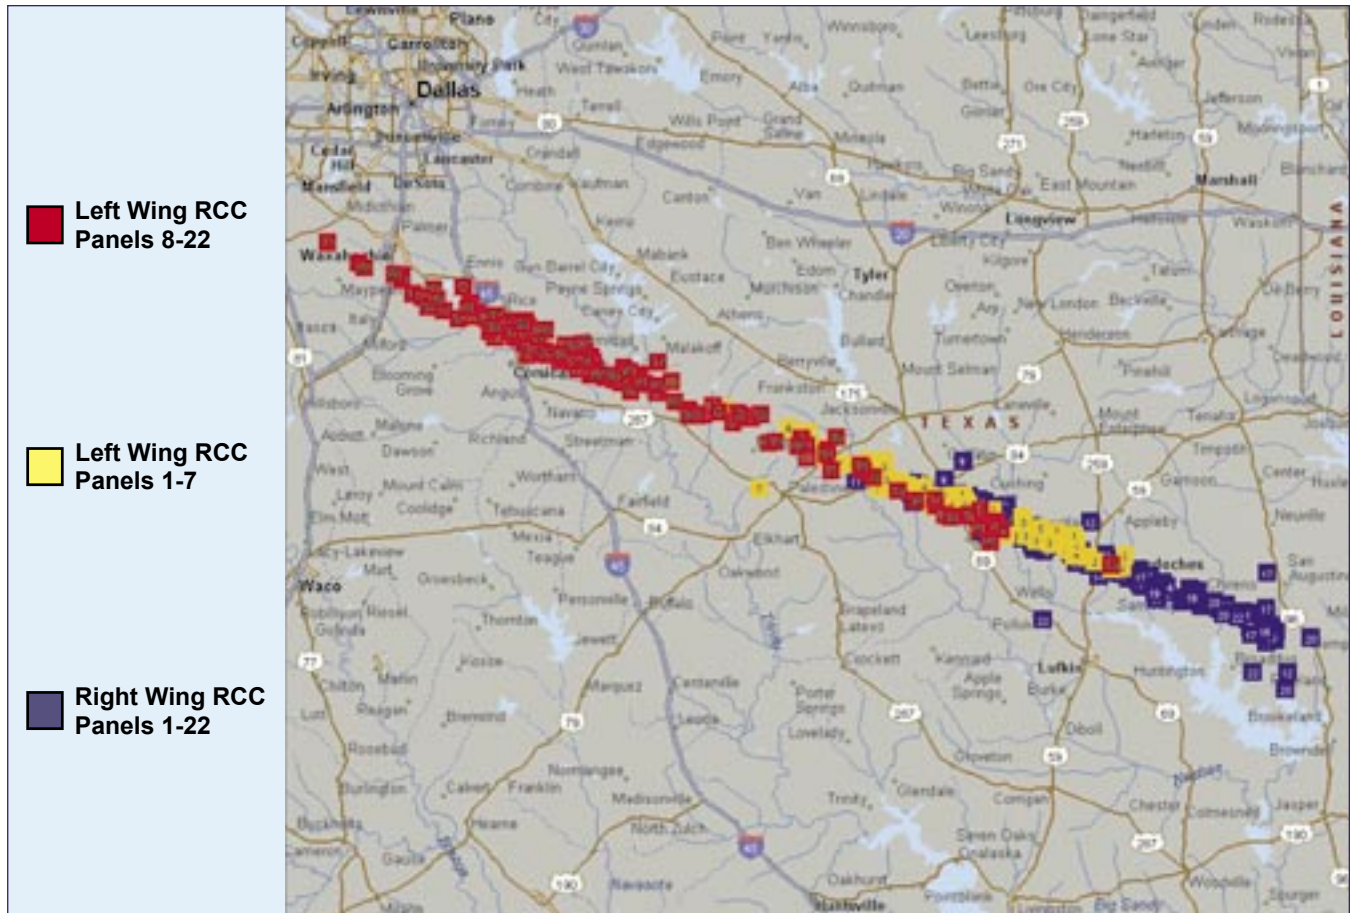
The location of debris on the ground also provided evidence of where the initial breach occurred. The location of every piece of recovered RCC was plotted on a map and labeled according to the panel the piece originally came from. Two distinct patterns were immediately evident. First, it was clear that pieces from left wing RCC panels 9 through 22 had fallen the farthest west, and that RCC from left wing panels 1 through 7 had fallen considerably farther east (see Figure 3.7-5). Second, pieces from left wing panel 8 were

Figure 3.7-5. The location of RCC panel debris from the left and right wings, shown where it was recovered from in East Texas. The debris pattern suggested that the left wing failed before the right wing, most likely near left RCC panels 8 and 9.

found throughout the debris field, which suggested that the left wing likely failed in the vicinity of RCC panel 8. The early loss of the left wing from RCC panel 9 and outboard caused the RCC from that area to be deposited well west of the RCC from the inboard part of the wing. Since panels 1 through 7 were so much farther to the east, investigators concluded that RCC panels 1 through 7 had stayed with the Orbiter longer than had panels 8 through 22.

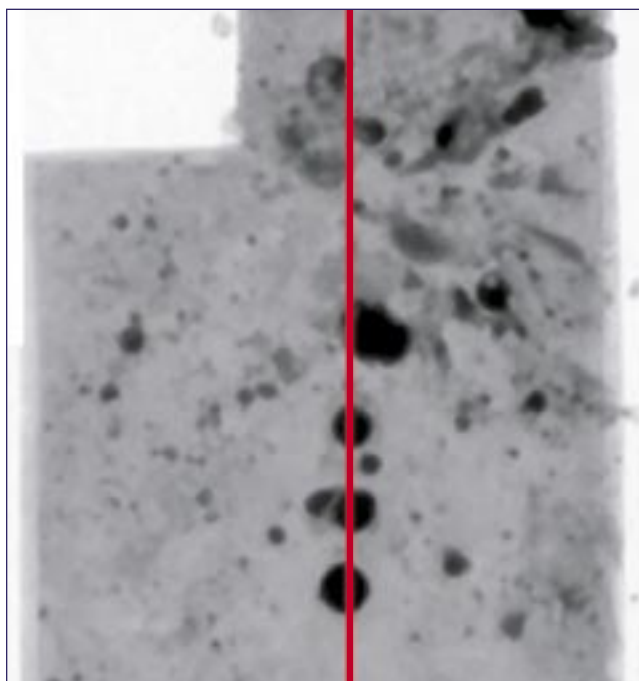
The X-ray analysis of left wing RCC panel 8 (see Figure 3.7-7) showed a bottom-to-top pattern of slag deposits. In some areas, small spheroids of heavy metal were aligned vertically on the recovered pieces, which indicated a superheated airflow from the bottom of the panel toward the top in the area of RCC panel 8-left. These deposits were later determined by chemical analysis to be Inconel 718, probably from the wing leading edge attachment fittings on the spanner beams on RCC panels 8 and 9. Computational fluid dynamics modeling of the flow behind panel 8 indicated that the molten deposits would be laid down in this manner.

Figure 3.7-7. X-ray analysis of RCC panel 8-left showed a bottom-to-top pattern of slag deposits.

The layered deposits on panel 8 were also markedly different from those on all other left- and right-wing panels. There was much more material deposited on RCC panel 8-left. These deposits had a much rougher overall structure, including rivulets of Cerachrome slag deposited directly on the RCC. This indicated that Cerachrome, the insulation that protects the wing leading edge spar, was one of the first materials to succumb to the superheated air entering through the breach in RCC panel 8-left. Because the melting temperature of Cerachrome is greater than 3,200 degrees Fahrenheit, analysis indicated that materials in this area were exposed to extremely

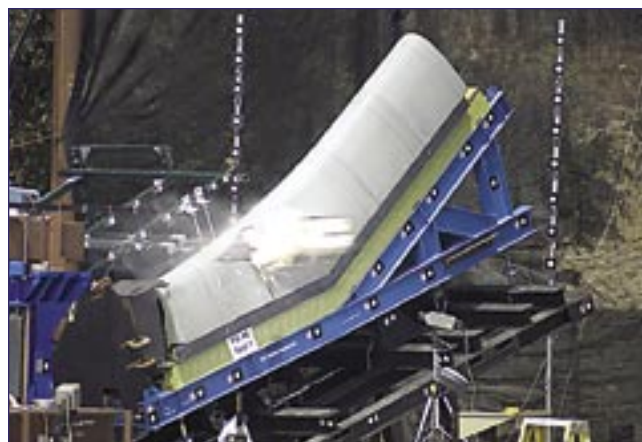
Five engineering tests on fiberglass panels (see Figure 3.8-5) established the test parameters of the impact tests on RCC panels. Details of the fiberglass tests are in Appendix D.12.

Figure 3.8-5. A typical foam strike leaves impact streaks, and the foam projectile breaks into shards and larger pieces. Here the foam is striking Panel 6 on a fiberglass test article.

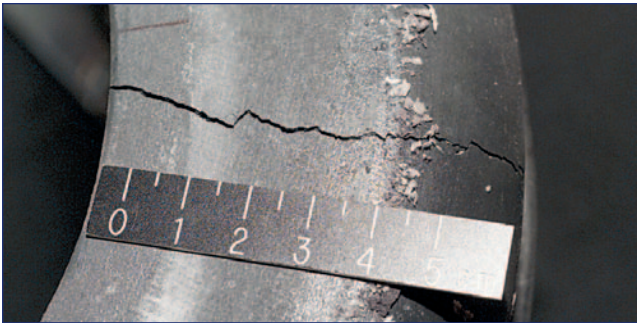
RCC panel 6 was tested first to begin to establish RCC impact response, although by the time of the test, other data had indicated that RCC panel 8-left was the most likely site of the breach. RCC panel 6 was impacted using the same parameters as the test on fiberglass panel 6 and developed a 5.5-inch crack on the outboard end of the panel that extended through the rib (see Figure 3.8-6). There was also a crack through the "web" of the T-seal between panels 6 and 7 (see Figure 3.8-7). As in the fiberglass test, the foam block deflected, or moved, the face of the RCC panel, creating a slit between the panel and the adjacent T-seal, which ripped the projectile and stuffed pieces of foam into the slit (see Figure 3.8-8). The panel rib failed at lower stresses than predicted, and the T-seal failed closer to predictions, but overall, the stress pattern was similar to what was predicted, demonstrating the need to incorporate more complete RCC failure criteria in the computational models.

Without further crack growth, the specific structural damage this test produced would probably not have allowed enough superheated air to penetrate the wing during re-entry to cause serious damage. However, the test did demonstrate that a foam impact representative of the debris strike at 81.9 seconds after launch could damage an RCC panel. Note that

Figure 3.8-6. A 5.5-inch crack on the outboard portion of RCC Panel 6 during testing.

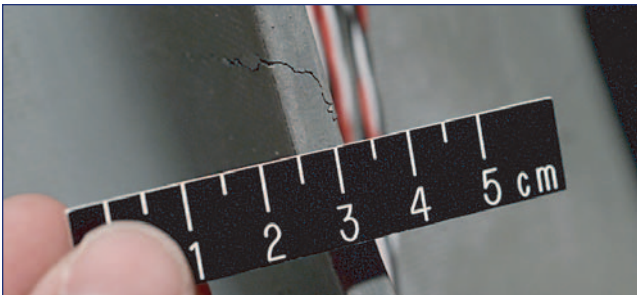
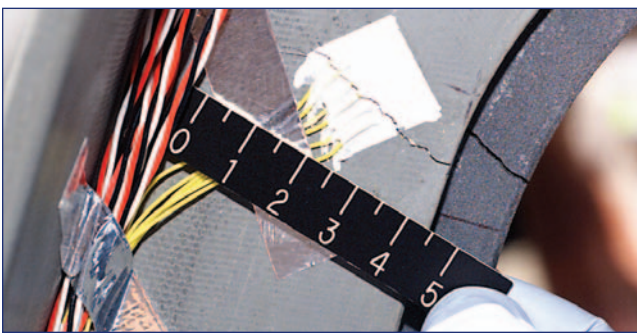
Figure 3.8-7. Two views of the crack in the T-seal between RCC Panels 6 and 7.

the RCC panel 6-left test used fiberglass panels and T-seals in panel 7, 8, 9, and 10 locations. As seen later in the RCC panel 8-left test, this test configuration may not have adequately reproduced the flight configuration. Testing of a full RCC panel 6, 7, and 8 configuration might have resulted in more severe damage.

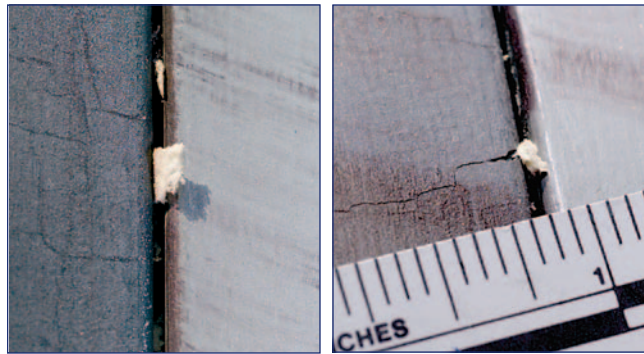
Figure 3.8-8. Two views of foam lodged into the slit during tests.

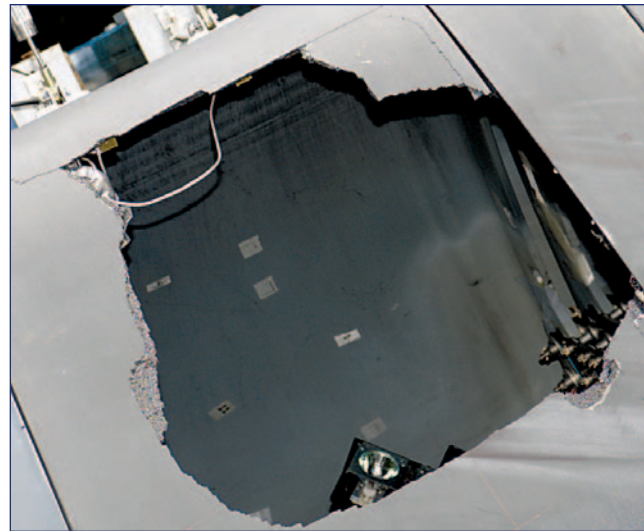
Figure 3.8-9. The large impact hole in Panel 8 from the final test.

The impact created a hole roughly 16 inches by 17 inches, which was within the range consistent with all the findings of the investigation (see Figure 3.8-9). Additionally, cracks in the panel ranged up to 11 inches in length (Figure 3.8-10). The T-seal between panels 8 and 9 also failed at the lower outboard mounting lug.

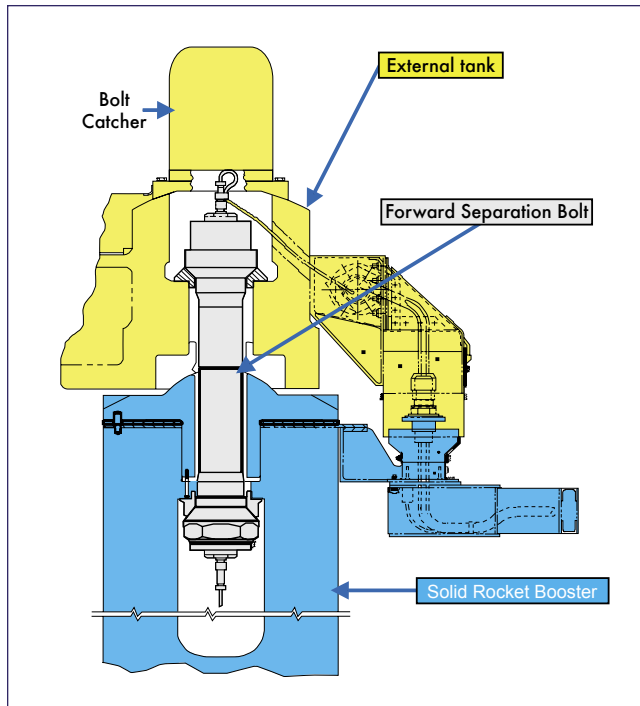
If one of the bolt catchers failed during STS-107, the resulting debris could have damaged *Columbia's* wing leading edge. Concerns that the bolt catchers may have failed, causing metal debris to ricochet toward the Orbiter, arose because the configuration of the bolt catchers used on Shuttle missions differs in important ways from the design used in

Figure 4.2-1. A cutaway drawing of the forward Solid Rocket Booster bolt catcher and separation bolt assembly.

initial qualification tests.¹ First, the attachments that currently hold bolt catchers in place use bolts threaded into inserts rather than through-bolts. Second, the test design included neither the Super Lightweight Ablative material applied to the bolt catcher apparatus for thermal protection, nor the aluminum honeycomb configuration currently used. Also, during these initial tests, temperature and pressure readings for the bolt firings were not recorded.

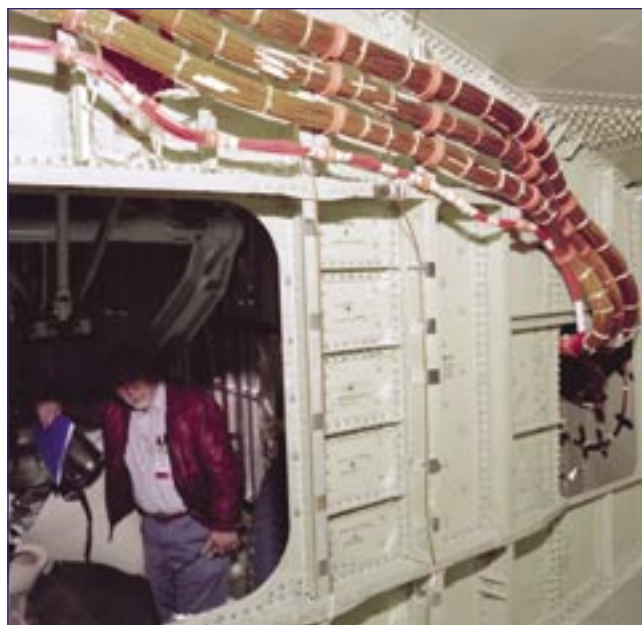
Figure 4.2-3. Typical wiring bundle inside Orbiter wing.

A typical wiring bundle is shown in Figure 4.2-3. Wiring nonconformances are corrected by rerouting, reclamping, or installing additional insulation such as convoluted tubing, insulating tape, insulating sheets, heat shrink sleeving, and abrasion pads (see Figure 4.2-4). Testing has shown that wiring bundles usually stop arc tracking when wires are physically separated from one another. Further testing under conditions simulating the Shuttle's wiring environment demonstrated that arc tracking does not progress beyond six inches. Based on these results, Boeing recommended that NASA separate all critical paths from larger wire bundles and individually protect them for a minimum of six inches beyond their separation points.⁴ This recommendation is being adopted through modifications performed during scheduled Orbiter Major Modifications. For example, analysis of telemetered data from 14 of *Columbia's* left wing sensors (hydraulic line/wing skin/wheel temperatures, tire pressures, and landing gear downlock position indication) provided failure signatures supporting the scenario of left-wing thermal intrusion, as opposed to a catastrophic failure (extensive arc tracking) of Kapton wiring. Actual NASA testing in the months following the accident, during which wiring bundles were subjected to intense heat (ovens, blowtorch, and arc jet), verified the failure signature analyses. Finally, extensive testing and analysis in years prior to STS-107 showed that, with the low currents and low voltages associated with the Orbiter's instrumentation system (such as those in the left wing), the probability of arc tracking is commensurately low.

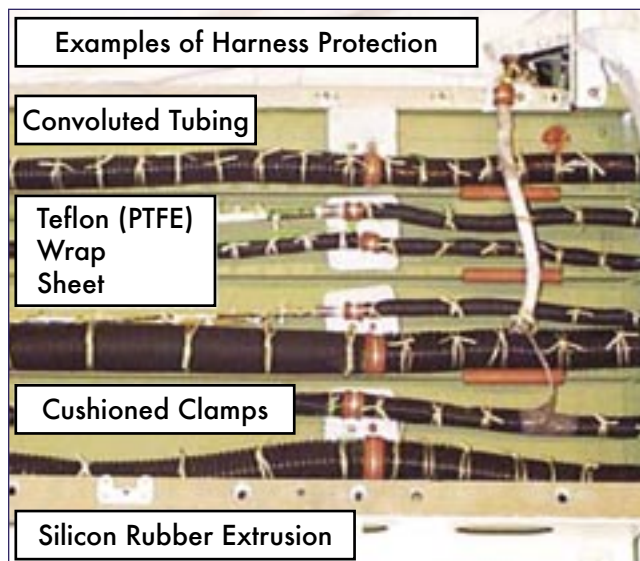
Figure 4.2-4. Typical wiring harness protection methods.

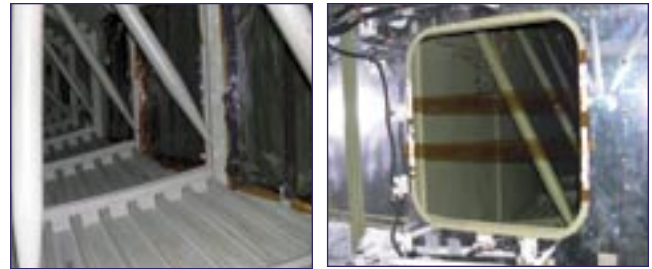
Figure 4.2-5. At left, a wing section open for inspection; at right, wing access closed off after inspection.

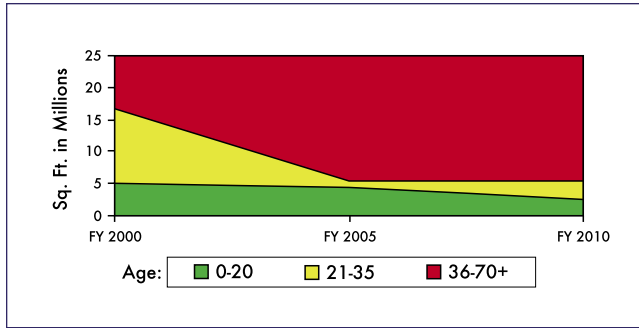
The same ambiguity about investing in Shuttle upgrades has also affected the maintenance of Shuttle Program ground infrastructure, much of which dates to Project Apollo and 1970s Shuttle Program construction. Figure 5.5-4 depicts the age of the Shuttle’s infrastructure as of 2000. Most ground infrastructure was not built for such a protracted lifespan. Maintaining infrastructure has been particularly difficult at Kennedy Space Center, where it is constantly exposed to a salt water environment.

Figure 5.5-4. Age of the Space Shuttle infrastructure. (Source: Connie Milton to Space Flight Advisory Council, 2000.)

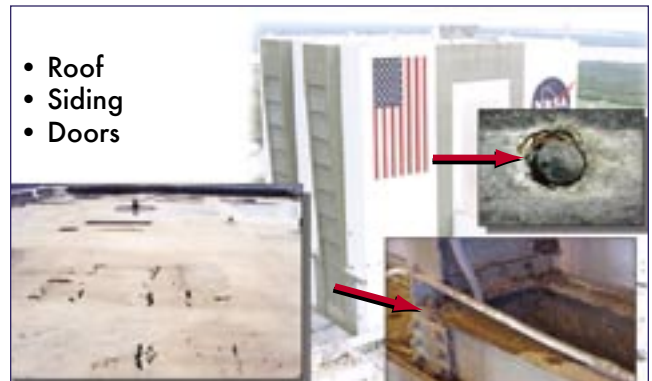
Board investigators have identified deteriorating infrastructure associated with the launch pads, Vehicle Assembly Building, and the crawler transporter. Figures 5.5-5 and 5.5-6 depict some of this deterioration. For example, NASA has installed nets, and even an entire sub-roof, inside the Vehicle Assembly Building to prevent concrete from the building’s ceiling from hitting the Orbiter and Shuttle stack. In addition, the corrosion-control challenge results in zinc primer

on certain launch pad areas being exposed to the elements. When rain falls on these areas, it carries away zinc, runs onto the leading edge of the Orbiter’s wings, and causes pinholes in the Reinforced Carbon-Carbon panels (see Chapter 3).

Figure 5.5-5 and 5.5-6. Examples of the seriously deteriorating infrastructure used to support the Space Shuttle Program. At left is Launch Complex 39A, and at right is the Vehicle Assembly building, both at the Kennedy Space Center.

In 2000, NASA identified 100 infrastructure items that demanded immediate attention. NASA briefed the Space Flight Advisory Committee on this “Infrastructure Revitalization” initiative in November of that year. The Committee concluded that “deteriorating infrastructure is a serious, major problem,” and, upon touring several Kennedy Space Center facilities, declared them “in deplorable condition.”⁶⁷ NASA subsequently submitted a request to the White House Office of Management and Budget during Fiscal Year 2002 budget deliberations for \$600 million to fund the infrastructure initiative. No funding was approved.

In Fiscal Year 2002, Congress added \$25 million to NASA’s budget for Vehicle Assembly Building repairs. NASA has reallocated limited funds from the Shuttle budget to pressing infrastructure repairs, and intends to take an integrated look at infrastructure as part of its new Shuttle Service Life Extension Program. Nonetheless, like Space Shuttle upgrades, infrastructure revitalization has been mired by the uncertainty surrounding the Shuttle Program’s lifetime. Considering that the Shuttle will likely be flying for many years to come, NASA, the White House, and Congress alike now face the specter of having to deal with years of infrastructure neglect.

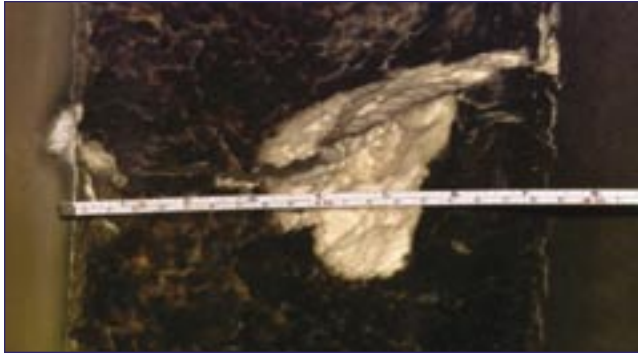
The sixth and final bipod ramp event before STS-107 occurred during STS-112 on October 7, 2002 (see Figure 6.1-3). At 33 seconds after launch, when *Atlantis* was at 12,500 feet and traveling at Mach 0.75, ground cameras observed an object traveling from the External Tank that subsequently impacted the Solid Rocket Booster/External Tank Attachment ring (see Figure 6.1-4). After impact, the debris broke into multiple pieces that fell along the Solid Rocket Booster exhaust plume.¹⁵ Post-mission inspection of the Solid Rocket Booster confirmed damage to foam on the forward face of the External Tank Attachment ring. The impact was approximately 4 inches wide and 3 inches deep. Post-External Tank separation photography by the crew showed that a 4- by 5- by 12-inch (240 cubic-inch) corner section of the left bipod ramp was missing, which exposed the super lightweight ablator coating on the bipod housing. This missing chunk of foam was believed to be the debris that impacted the External Tank Attachment ring during ascent. The post-launch review of photos and video identified these debris events, but the Mission Evaluation Room logs and Mission Management Team minutes do not reflect any discussions of them.

Figure 6.1-4. On STS-112, the foam impacted the External Tank Attach ring on the Solid Rocket Booster, causing this tear in the insulation on the ring.

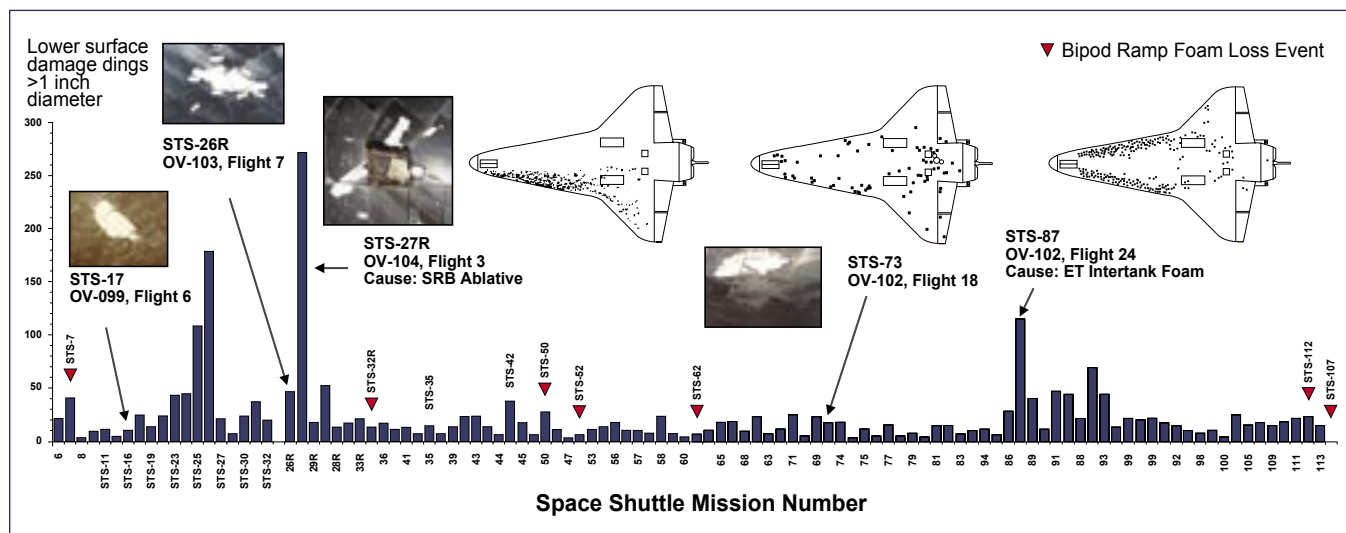
To better understand how NASA's treatment of debris strikes evolved over time, the Board investigated missions where debris was shed from locations other than the External Tank bipod ramp. The number of debris strikes to the Orbiters' lower surface Thermal Protection System that resulted in tile damage greater than one inch in diameter is shown in Figure 6.1-6.¹⁷ The number of debris strikes may be small, but a single strike could damage several tiles (see Figure 6.1-7).

Figure 6.1-6. This chart shows the number of dings greater than one inch in diameter on the lower surface of the Orbiter after each mission from STS-6 through STS-113. Flights where the bipod ramp foam is known to have come off are marked with a red triangle.

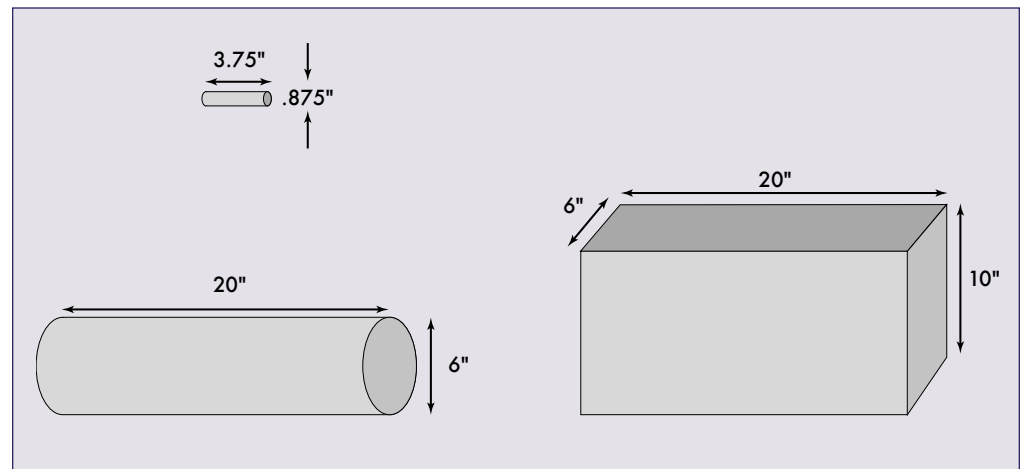
Until STS-107, Crater was normally used only to predict whether small debris, usually ice on the External Tank, would pose a threat to the Orbiter during launch. The use of Crater to assess the damage caused by foam during the launch of STS-107 was the first use of the model while a mission was on orbit. Also of note is that engineers used Crater during STS-107 to analyze a piece of debris that was at maximum 640 times larger in volume than the pieces of debris used to calibrate and validate the Crater model (the Board's best estimate is that it actually was 400 times larger). Therefore, the use of Crater in this new and very different situation compromised NASA's ability to accurately predict debris damage in ways that Debris Assessment Team engineers did not fully comprehend (see Figure 6.3-1).

Figure 6.3-1. The small cylinder at top illustrates the size of debris Crater was intended to analyze. The larger cylinder was used for the STS-107 analysis; the block at right is the estimated size of the foam.

When used within its validated limits, Crater provides conservative predictions (that is, Crater predictions are larger than actual damage). When used outside its validated limits, Crater’s precision is unknown.

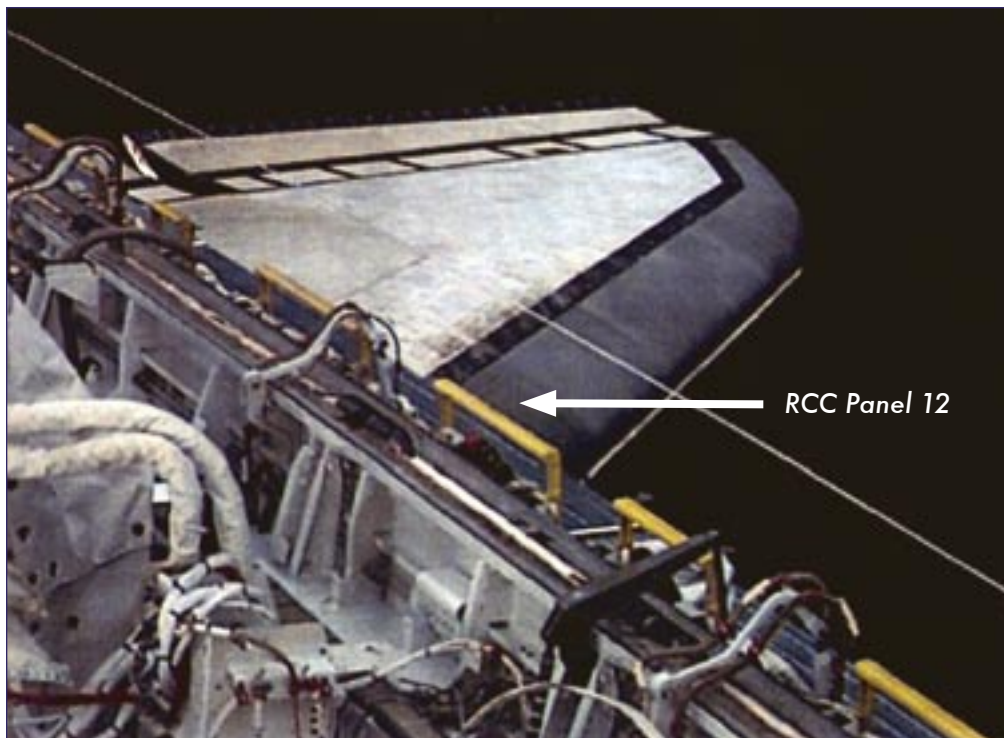
This photo from the aft flight deck window of an Orbiter shows that RCC panels 1 – 11 are not visible from inside the Orbiter. Since Columbia did not have a manipulator arm for STS-107, it would have been necessary for an astronaut to take a spacewalk to visibly inspect the inboard leading edge of the wing.

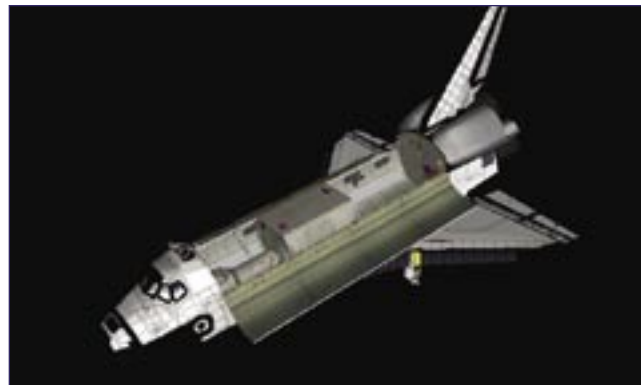
The repair option (see Figure 6.4-1), while logistically viable using existing materials onboard *Columbia*, relied on so many uncertainties that NASA rated this option "high risk." To complete a repair, the crew would perform a spacewalk to fill an assumed 6-inch hole in an RCC panel with heavy metal tools, small pieces of titanium, or other metal scavenged from the crew cabin. These heavy metals, which would help protect the wing structure, would be held in place during

Figure 6.4-1. The speculative repair option would have sent astronauts hanging over the payload bay door to reach the left wing RCC panels using a ladder scavenged from the crew module.

re-entry by a water-filled bag that had turned into ice in the cold of space. The ice and metal would help restore wing leading edge geometry, preventing a turbulent airflow over the wing and therefore keeping heating and burn-through levels low enough for the crew to survive re-entry and bail out before landing. Because the NASA team could not verify that the repairs would survive even a modified re-entry, the rescue option had a considerably higher chance of bringing *Columbia*'s crew back alive.

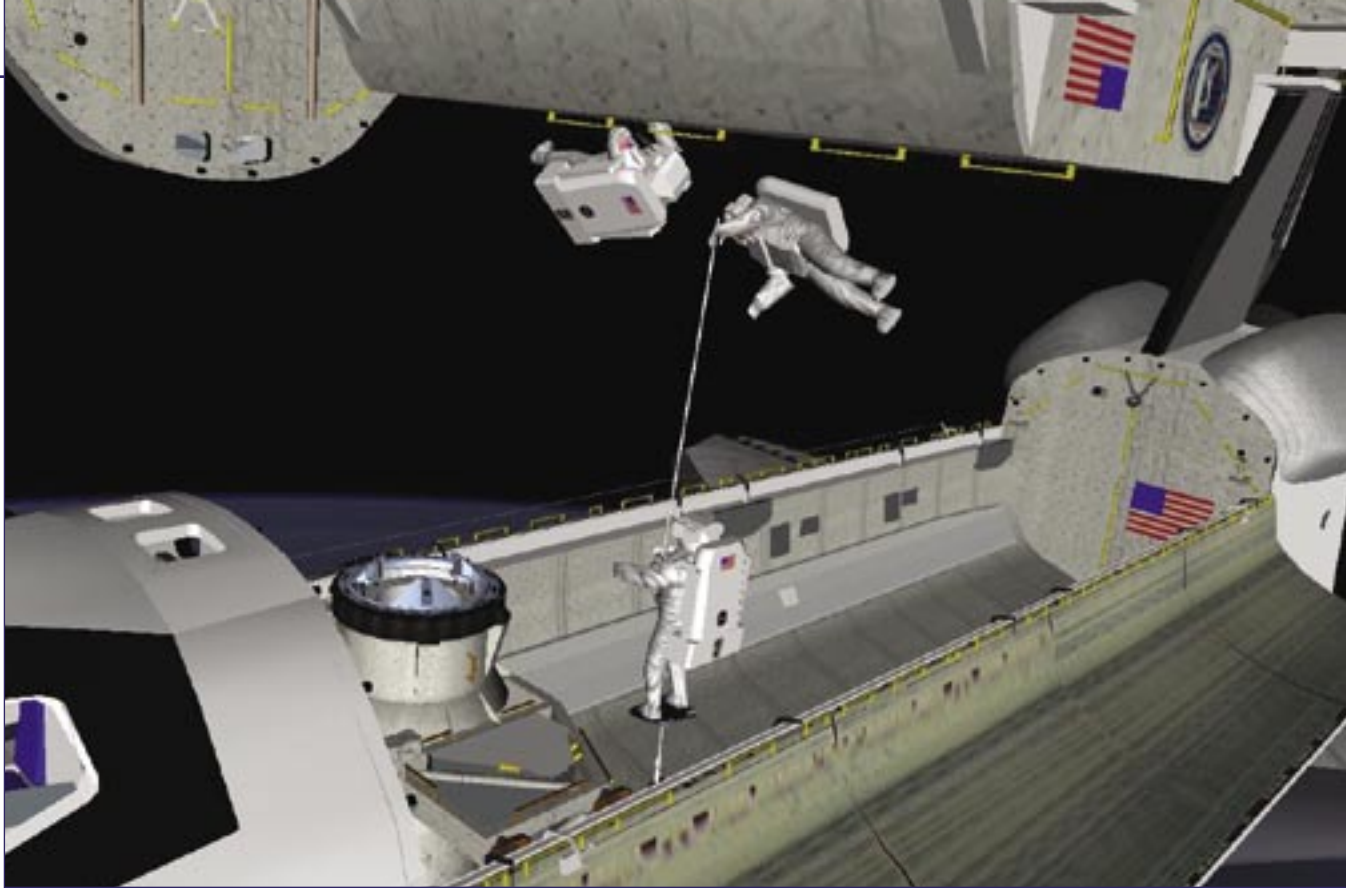
Figure 6.4-2. The rescue option had Atlantis (lower vehicle) rendezvousing with Columbia and the STS-107 crew transferring via ropes. Note that the payload bay of Atlantis is empty except for the external airlock/docking adapter.

er, pilot, and two astronauts trained for spacewalks. In January, seven commanders, seven pilots, and nine spacewalk-trained astronauts were available. During the rendezvous on Atlantis's first day in orbit, the two Orbiters would maneuver to face each other with their payload bay doors open (see Figure 6.4-2). Suited Columbia crew members would then be transferred to Atlantis via spacewalks. Atlantis would return with four crew members on the flight deck and seven in the mid-deck. Mission Control would then configure Columbia for a de-orbit burn that would ditch the Orbiter in the Pacific Ocean, or would have the Columbia crew take it to a higher orbit for a possible subsequent repair mission if more thorough repairs could be developed.

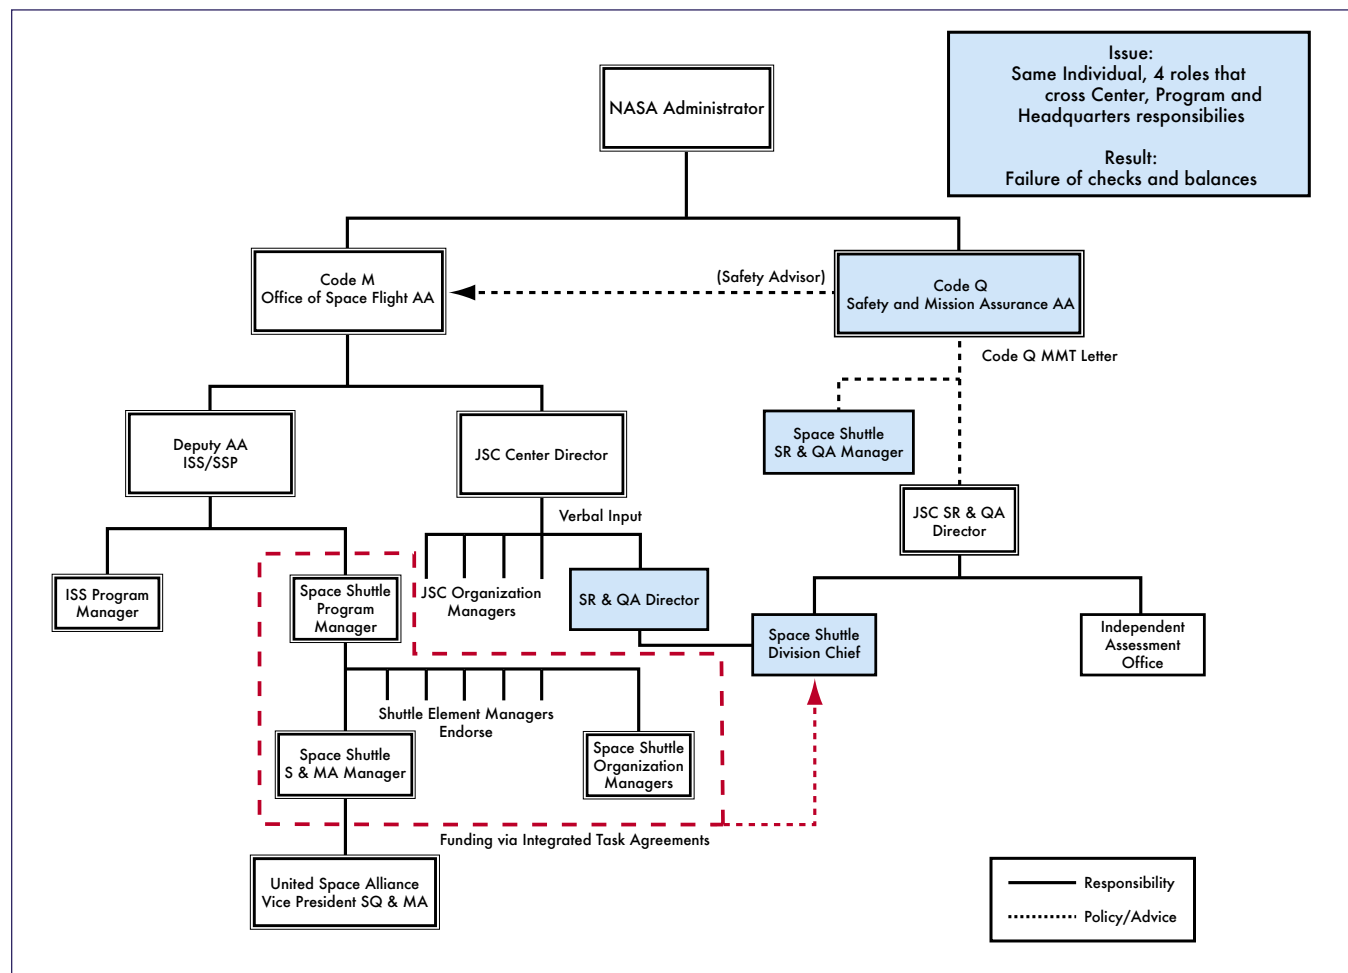
Figure 7.4-1. Independent safety checks and balance failure.

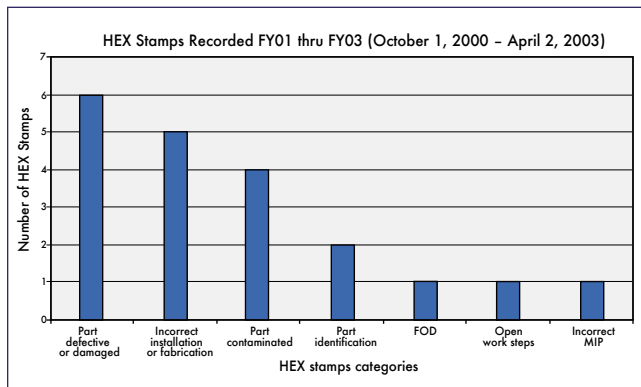
Of the 141,127 inspections subject to rejection from October 2000 through March 2003, only 20 rejections, or "hexes," were recorded, resulting in a statistically improbable discrepancy rate of .014 percent (see Figure 10.4-4). In interviews, technicians and inspectors alike confirmed the dubiousness of this rate. NASA's published rejection rate therefore indicates either inadequate documentation or an underused system. Testimony further revealed incidents of quality assurance inspectors being played against each other to accept work that had originally been refused.

Figure 10.4-4. Rejection, or "Hex" stamps issued from October 2000 through April 2003.
