COLUMBIA

ACCIDENT INVESTIGATION BOARD

REPORT VOLUME IV
OCTOBER 2003

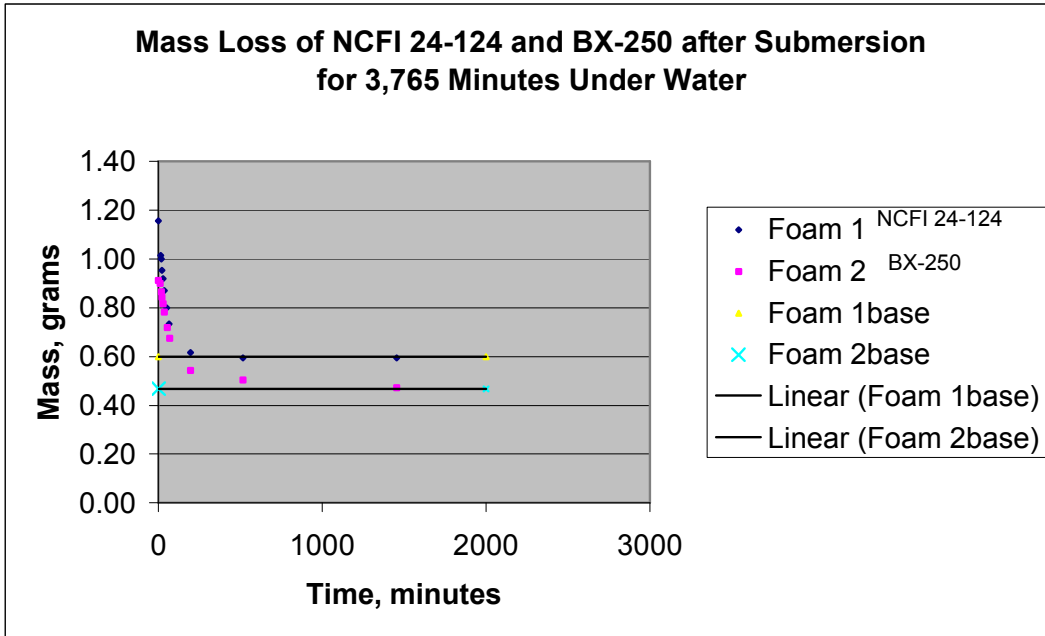
- Procedure:
 - NCFI 24-124 and BX-250 as two small, 1-inch-cube specimens referred to as Foam1 (NCFI 24-124) and Foam 2 (BX-250). Water-mass gain was measured when these specimens were submerged 2 ½ inches below distilled, de-aired water surfaces for 3,765 minutes. See [Figure 1](#).

Figure 1. Plot of mass changes for NCFI 24-124 and BX-250 following submersion under 2.5 inches of distilled water for 3,765 minutes and blotting excess surface water before starting measurements.

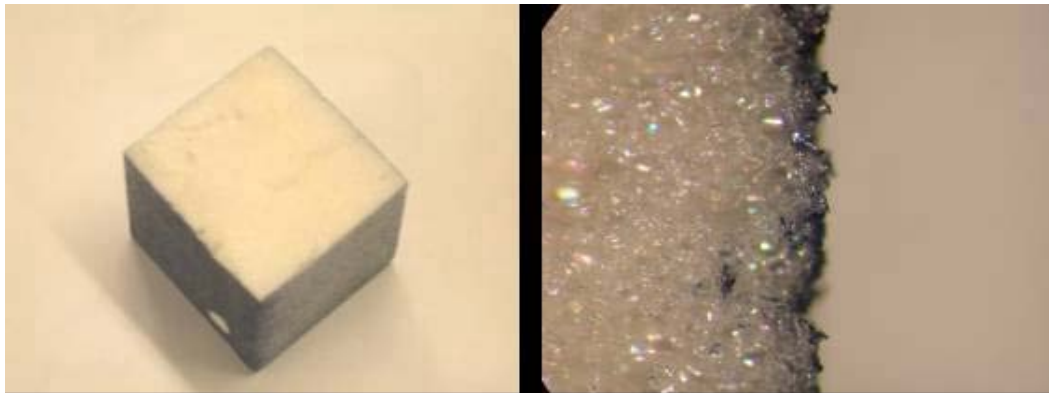
- Sectioning of foam after submersion indicated only absorption in thin layer around the machined foam. This layer characterized to be less than or equivalent to broken cells on surface. See [Figure 2](#).

Figure 2. (a) Shows blue dye decorating the surface of a BX-250 foam cube that was submerged 26.5 hours then sectioned, revealing the interior. (b) Shows a magnified image at the sectioned surface.

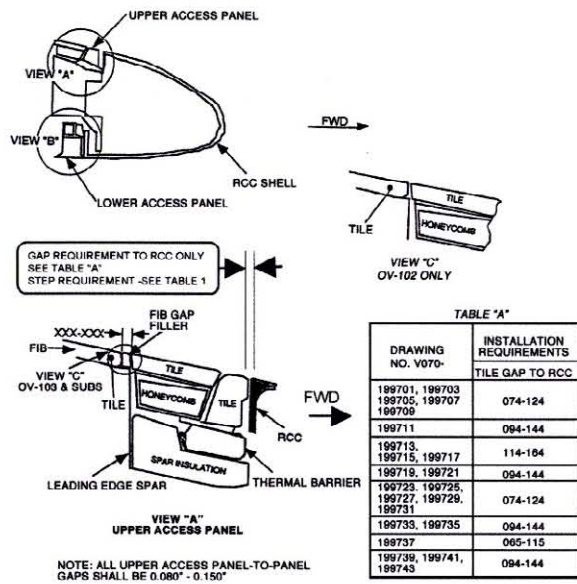
To understand the events that occurred on STS 107, to be discussed below, it is important to note that the RCC-LESS cavity is vented. The venting is accomplished by a gap, ranging in width from 0.065 to 0.164 inches between the upper back edge of the RCC panels and the upper wing tiles. This gap runs the entire length of all RCC panels, giving a total vent area of 47 to 74 square inches depending on the actual gap widths. The smaller area corresponds to using the minimum allowable, installed gap width requirements and the larger area corresponds to using the maximum allowable, installed gap width requirements. Details of the gap design and width specifications are shown in Figure 5. The location of the gap was chosen because of the low heating rates and pressures that exist there as listed in Table 2. As can be seen, the pressure ratio peaks at RCC Panel 10 and falls off gradually in both the inboard and outboard directions. The fluid physics of the wing flow provides an extremely large driver pressure differential for a breach through the wing leading edge as illustrated by these pressure ratios.

Figure 5: Details of Wing Leading Edge Subsystem Vent Design. Orbiter Vehicle (OV) 102 is named Columbia.

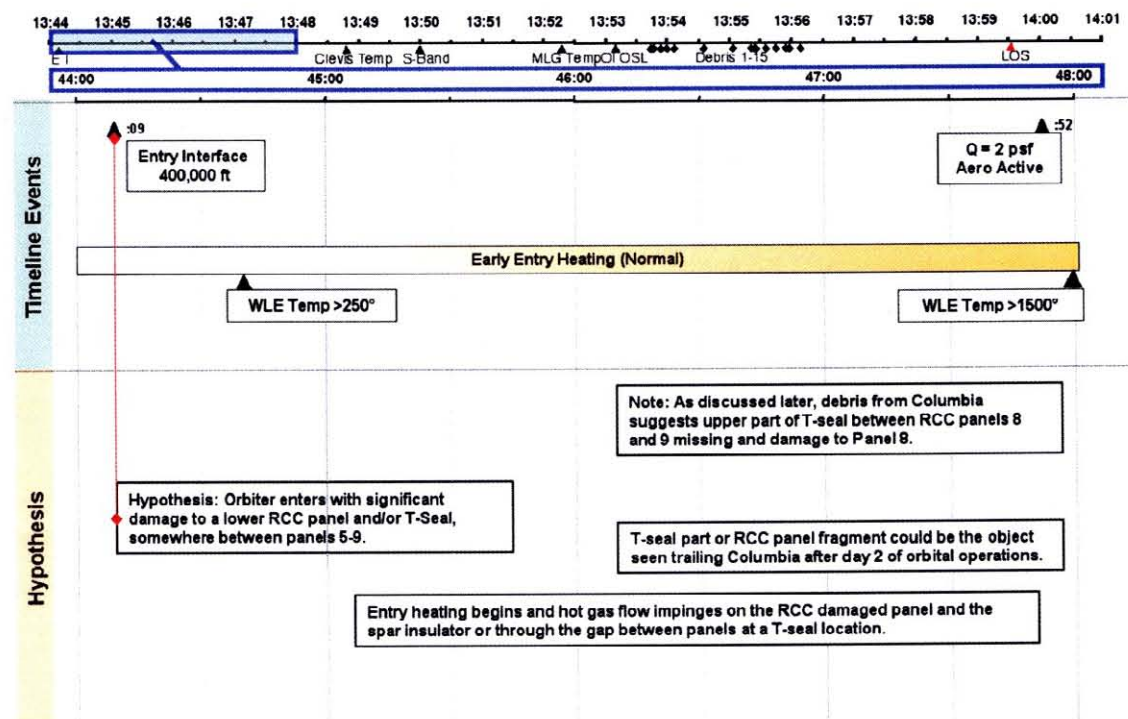
Figure 8: Timeline From EI 13:44:09 -> 13:47:30.

Figure 8 shows the comparison of timeline events from EI 13:44:09 to 13:47:30 to the hypothesis. This format, developed by NASA's Working Scenario Team (Reference 13), was adopted by the present authors. The format highlights portions of the entire sequence from EI through loss of signal (LOS) GMT 13:44:09 -> 13:59:32 shown at the top of the figure. The period being studied is highlighted with the blue rectangles, in this case 3 minutes and 21 seconds after EI.

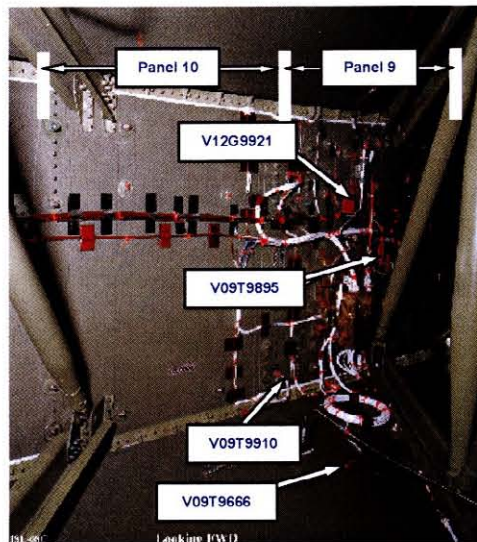
Figures 9 and 10 depict the physical location of the MADS/OEX sensors in the Panel 9/10 area of Columbia's left wing. Figure 9 is a photograph of the backside of the wing spar, looking forward. The approximate locations of RCC Panels 9 and 10 are shown near the top of the photograph. Fortunately, this region of the wing on Columbia was instrumented for the Orbiter Experiments (OEX) activity early in the Shuttle Program, and the instruments were still operational and recording data during STS 107. Data from four sensors are extremely valuable in helping understand the temporal events leading up to the failure of the wing leading edge system: V12G9921, a strain gage mounted to the spar; V09T9895, a thermocouple mounted to the back of the spar at the Panel 9 location; V09T9910, a thermocouple mounted to the clevis which held RCC Panel 9 in place (under an "earmuff" which insulated the clevis); and V0T9666, a thermocouple mounted in a tile in the lower wing, near the tile surface, close behind the number 9 carrier panel tiles. V09T9910 is imbedded in the RCC mounting hardware, which secures the panel to the spar.

Figure 9: Photograph of Rearward Side of Columbia's Left Hand Wing Spar, Looking Forward. OEX Sensor Locations are Depicted.

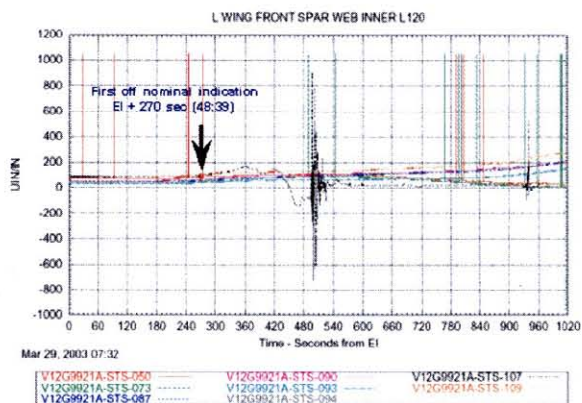
Figures 11 through 13 show data from the two sensors (one strain and one temperature) discussed in Figures 9 and 10. The information from these sensors is very significant in determining the progression of events as the thermal damage from the initial breach progressed to burn a hole through the wing spar. In addition to the data

Figure 11: OEX/MADS STS-107 Flight Data.

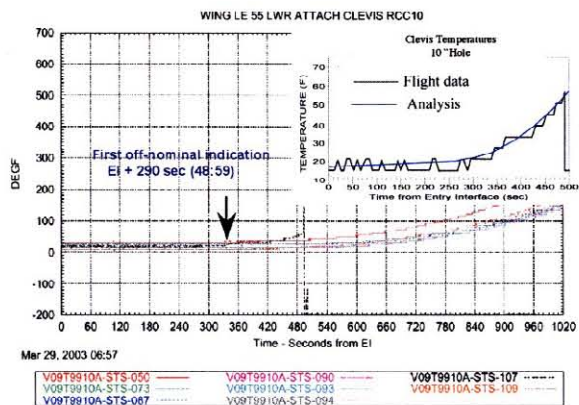
Figure 12: OEX/MADS STS-107 Flight Data and Thermal Analysis (Reference 12).

Figure 12, prepared in the same format as Figure 11 displays the time history of a thermocouple imbedded in the clevis fastener at the lower edge of the RCC located between Panels 9 and 10. The temperature changes recorded on the RCC clevis during STS 107 entry, appear to be quite small, but it is noted that this thermocouple is highly insulated and attached to a large thermal mass.

A thermal analysis by NASA (Reference 12) has shown that a hole of 6 -> 10 inches in diameter in the lower RCC Panel 8, could account for the early behavior of the thermocouple. The result of this analysis is shown in the inset in Figure 12. The “stepped” curve is the flight data while the blue, smooth curve is the result of the referenced analysis.

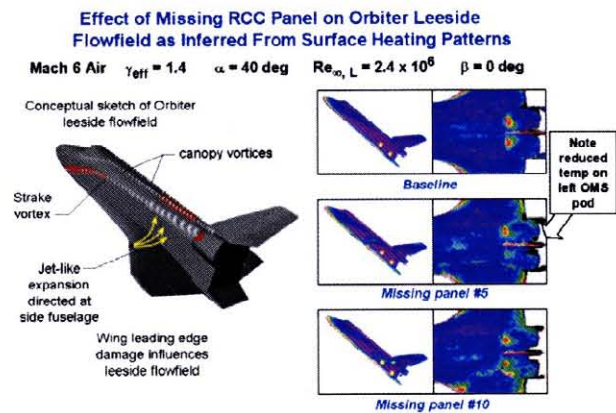
Figure 14, prepared by NASA (Reference 14) shows the results of wind tunnel tests from Langley Research Center. Data were obtained in a Mach 6 air stream at the conditions specified on the figure. The three boxes on the right of the figure show the results of a thermally sensitive coating on a model of the Shuttle. As noted, for the results of RCC Panels 5 and 10 missing, there is a definite temperature decrease from the baseline on the left OMS pod location, noted by the absence (missing panel number 5) or dimming of the red dot on the forward location of the OMS pod. The conceptual sketch, also shown in Figure 14, suggests that the jet-like expansion directed from a damaged wing influences the leeside flow field, reducing OMS heating if there is a disturbance in the Panel 5-10 RCC area.

Figure 14: NASA Langley Wind Tunnel Test Data Help Explain Below Nominal Temperatures Recorded on the Left OMS Pod.

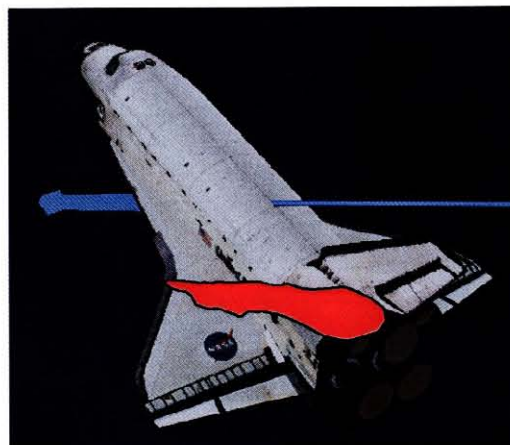
Figure 16 depicts a possible explanation for some of the early (near 13:50:00) communication dropouts observed during Columbia's entry. As known from many years of experience with entry of vehicles, small amounts of charged species (electrons and ions) between an antenna and the receiver can cause communication signal attenuation and even its total loss. As shown in the figure, a possible explanation for some of the early signal attenuation could have been electrons and ions, along with molten materials from the wing hardware, being entrained in the flow and transported to locations between the antennae behind Columbia's cockpit and the receiving TDRS communications satellite.

Figure 16: Entry Plume is Possibly Affected by Damaged Structure Accounting for Communications Dropout.

At the request of the authors, D. Potter of Sandia National Lab performed a scoping study (Reference 15) which shows that melting aluminum would provide charged species concentrations in sufficiently large quantities for signal attenuation in the 13:50:00 -> 13:50:30 period. However, to date (July 2003) analysis by NASA has failed to provide an understanding of how the flow behind Columbia could have provided a pathway to place the charged species and/or molten metal between the antennae and the receiving satellite. Darling (Reference 4) has pointed out that the communications drop out occurred at times quite close to several major debris shedding events and to the breach of the LW spar. However, a definitive link between the two is still conjectural.

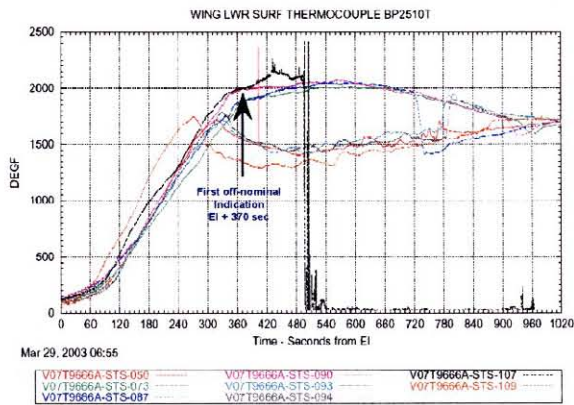
Figure 18: OEX/MADS STS-107 Flight Data.

Figure 18 displays the temperature recording from the thermocouple V07T9666A located in a lower wing tile, near the wing leading edge, behind Panel 9. This sensor location was shown above in Figures 9 and 10. As can be seen, there is an off-nominal heating trend in this thermocouple starting at EI + 370 seconds (GMT 13:50:19).

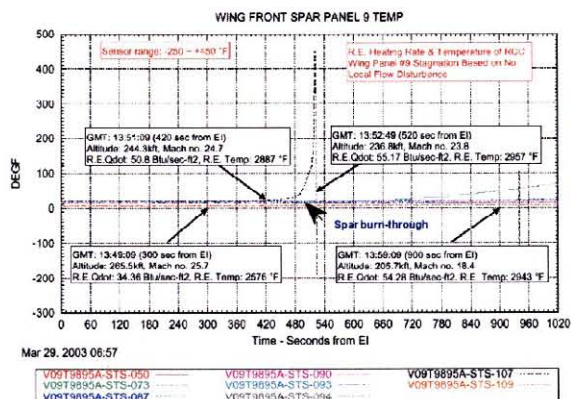
Figure 20: OEX/MADS STS-107 Flight Data.

Figure 20 displays the temperature recordings from thermocouple V0T9895A, located on the inside of the spar, behind Panel 9, as discussed in Figures 9 and 10 above. These data are quite valuable in understanding the progression of damage to the wing leading edge. As seen, the first off-nominal indication begins at 420 seconds after EI, GMT 13:51:09 with a very slight increase in temperature. Later discussion of this figure will focus on the burn through of the spar.

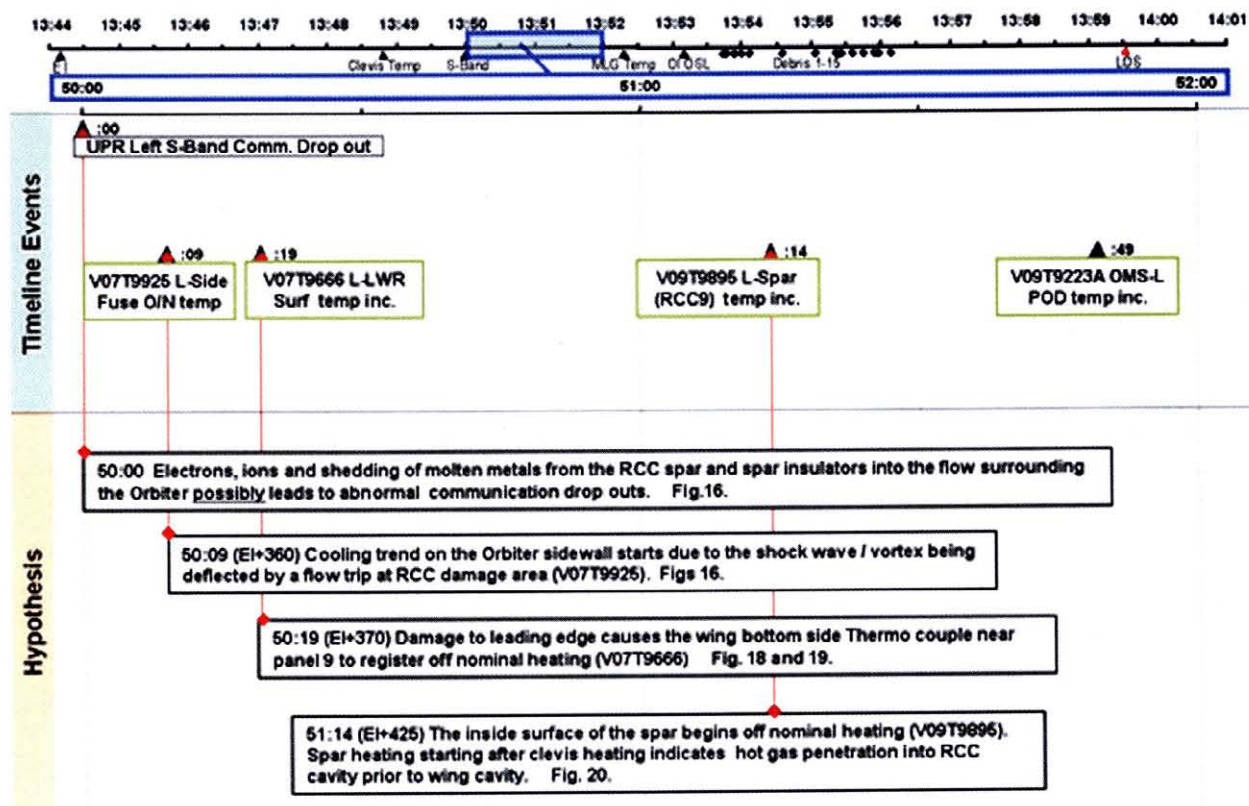
Figure 21: Timeline Versus Hypothesized Events – 13:50:00 to 13:52:00.

Figure 21 graphically depicts the timing of communication drop out and additional events recorded by the OEX sensors. The captions are self-explanatory. The MADS/OEX off-nominal data in the wing leading edge and spar are additional evidence that a breach existed in the RCC at the EI. The below nominal temperatures recorded on the fuselage sidewall is consistent with the hypothesized damage in the wing leading edge in the RCC Panel 5-8 area. The spatial correlation by the streamline analysis in Figure 19, showing how the outflow from the lower juncture of RCC Panel 8 and 9 can affect the lower tile thermocouple behind Panel 9 and the above nominal behavior of thermocouple V07T966, is additional and compelling evidence for the existence of a breach in the Panel 8/9 area. It is clear from this figure that the temporal evolution of the heat flow shows that the hot gas penetration began in the cavity in the wing leading edge prior to heating in the wing box behind the spar.

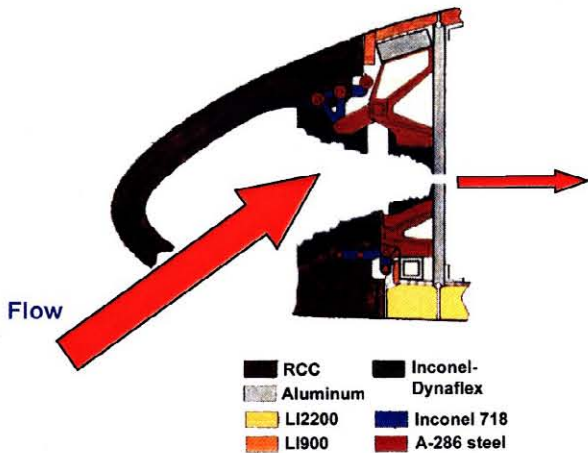
Figure 22: Spar Breach Occurs at EI + 487 Seconds.

the back of the spar behind Panel 9. This rapid increase at EI + 487 seconds strongly suggests an appearance of a plume of superheated air and that spar penetration had occurred. According to study (Reference 13 and 19) by NASA, this timing for spar burn-through is consistent

with a thermal analysis for a 6 -> 10 inch diameter hole in the RCC Panel 8, failure of the leading edge wire harnesses and bit flips observed in the wheel well.

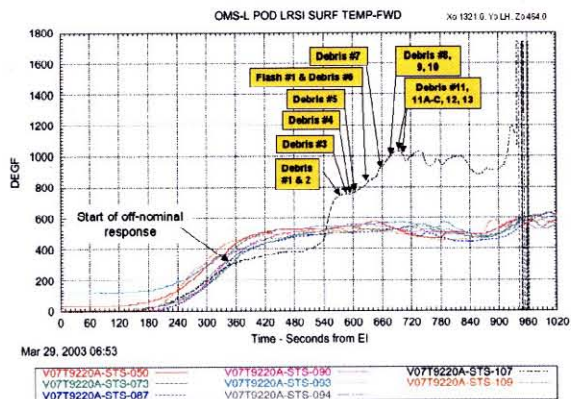
Figure 24: Left OMS Surface Temp Response Indicating the Progression of Damage.

Figure 24 displays the time history of thermocouple V07T9220A located on the OMS Pod. The observation made by NASA (Reference 16) is that from 13:53:29 -> 13:55:29 (EI + 560 -> 680 seconds), there are continual off-nominal increases in OMS Pod temperatures that correlates with the timing of debris sightings 1-13 during the flight. This correlation clearly suggests increasing damage is occurring to the left wing, specifically to the TPS and its substructure.

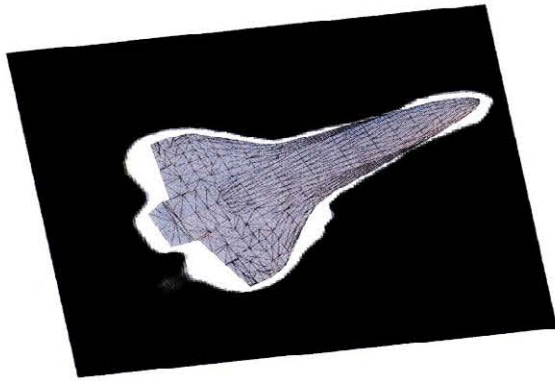
Figure 25: Starfire Photo from Kirtland AFB. GMT 13:57:14. Model Scaling and Orientation Based on Telemetry from NASA. The Columbia Model was Provided by NASA.

Figure 25 is a photograph of Columbia, taken at GMT 13:57:14 from the Starfire Facility at Kirtland AFB in Albuquerque, NM. At this time, Columbia was about 50 miles NW of Starfire at an altitude of about 40 miles, it had an 80 degree left angle (with the left wing down) and a 40 degree angle of attack. Therefore, the view of the vehicle is from the forward, bottom, left side, so that any hot plumes spilling over the top of the left wing leading edge or out of the top of the wing near the leading edge are visible.

The image records the appearance of the shock layer around the vehicle. As is indicated by the model grid overlay, the left side of the fuselage would be visible if it were not for the shock layer brightness and the slight wrapping around of the flow over the lower part of the forward fuselage. The apparent enlarged portion of the nosetip area is also due to the shock layer expanding around the forward fuselage from the stagnation point at the lower part of the nosetip. The shock layer is also visible through the short (a few meters long) wake that persists behind the vehicle.

The left wing has two apparent "bulges" on the leading edge and two corresponding wakes behind the wing. The authors believe that these are due to the following: hot flow and burning material ejected upward over the wing leading edge from the Panel 8 area; and a large plume of hot gases and burning material and debris ejected upward from the breach in the top surface of the wing aft and outboard of the Panel 9/10 area.

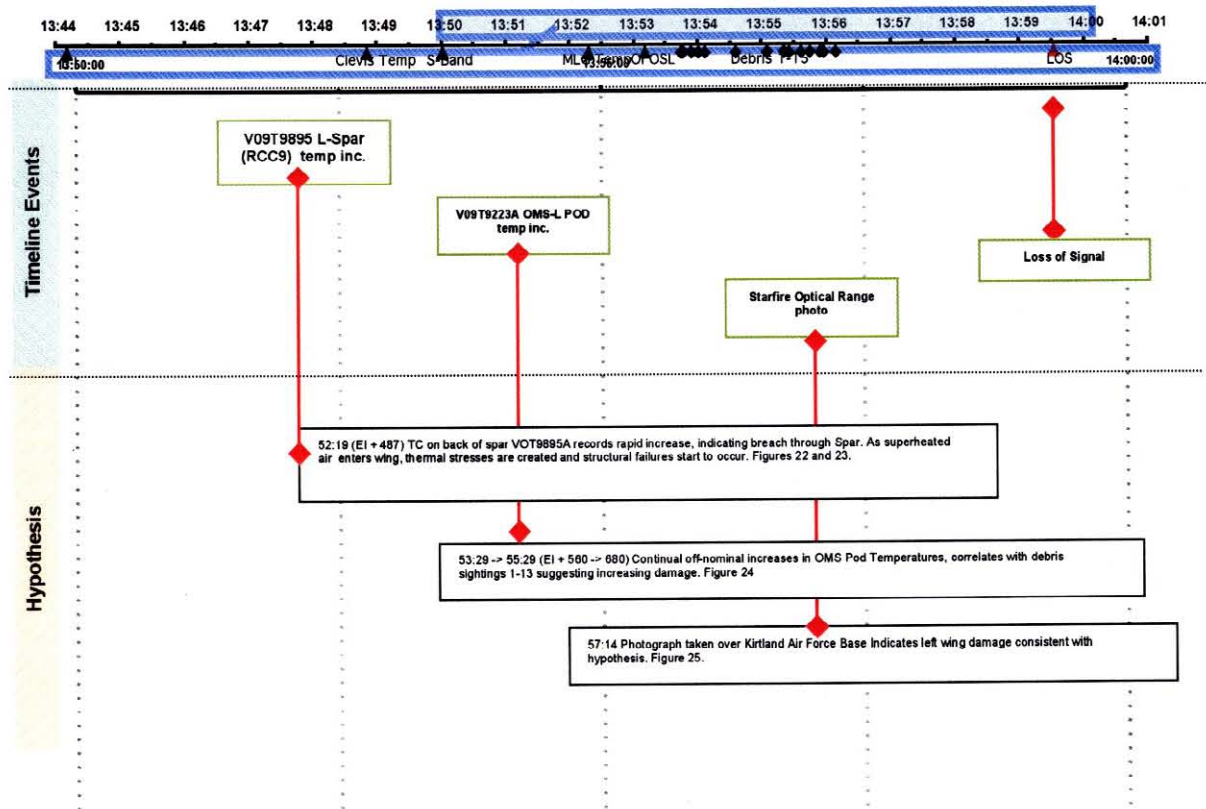
Figure 26: Timeline from 13:50:00 Through Loss of Signal 13:59:32 Versus Hypothesized Events.

The captions within Figure 26 displaying the comparison to the hypothesis and the timeline between GMT 13:52:00 and 14:00:00 are self-explanatory. During this time, the breach through the spar and internal heating to the wing box and wheel well have rendered the loss of the vehicle inevitable. The temporal progression of damage to the TPS has been outlined herein with the exception of the shedding of tiles and RCC panels/parts. Geographic locations of the recovered TPS debris and ballistic analysis suggest that much of this occurred over Texas. Others have written in detail on the analysis of debris sightings, sensor readings, etc. and it is outside the scope of the “Follow the TPS” charter to dwell further on these topics.

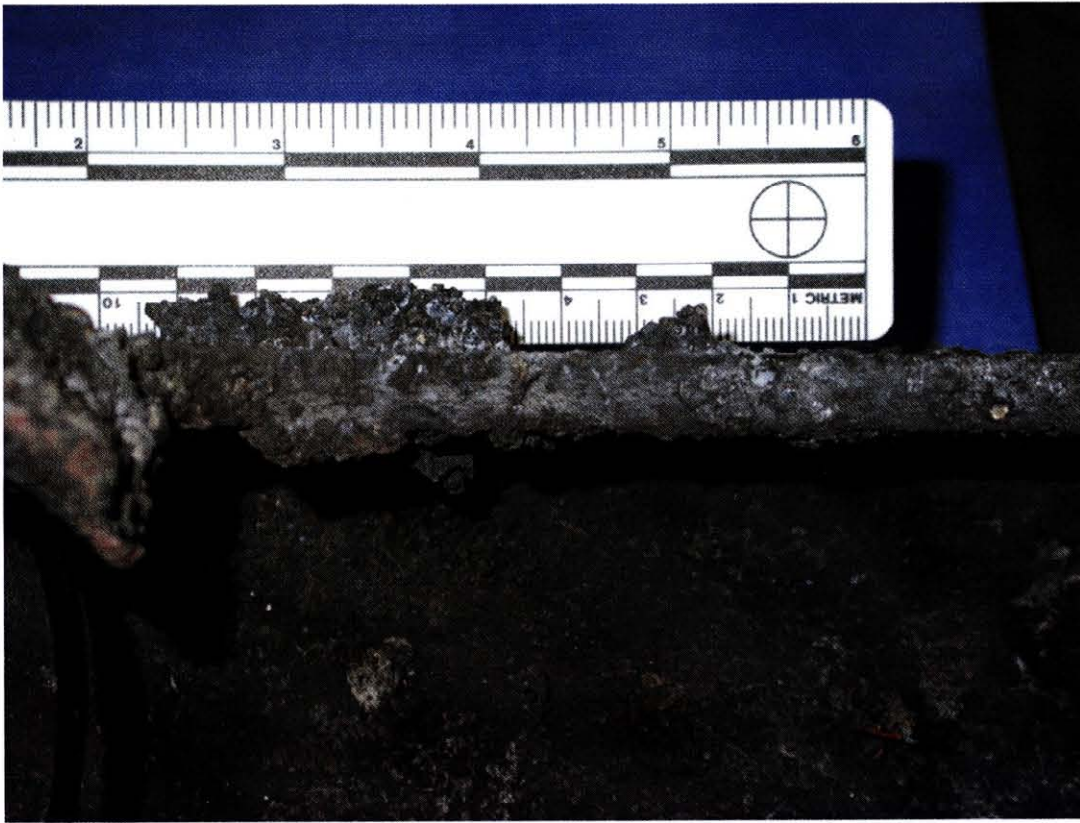
Figure 32: Slag Deposits on Upper Edge of Panel 8 on the RCC Side of the Vent.

Figure 32 is a close-up photograph of what was the RCC side of the vent gap on the upper Panel 8. See Figure 5 for an assembly drawing of the vent. As can be seen, there is a heavy accumulation of slag (up to 0.4 inches thick). This indicates that the gap at the top and outboard edge of Panel 8 and possibly Panel 9, were opened up from their normal configuration (0.114 to 0.164 inches) to at least 0.25 to 0.4 inches, and that melt from the interior fittings and insulation deposited there as the superheated air attacked the interior components of the WLESS and exited out of this vent location. The opening of the vent spacing could have happened at the time of the foam strike, or as the wing began to deform at the time of break-up; but most probably, it occurred during the long, high heating portion of the flight.

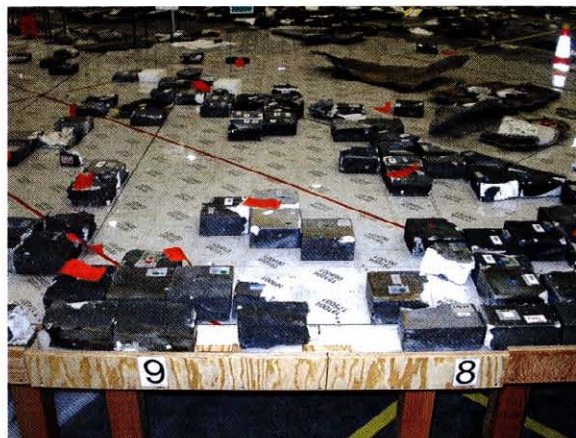
Figure 36: View of Tile Table from RCC Panel 8/9 Area.

Figures 35 and 36 show photographs of recovered tiles affixed to a 110 percent scale drawing of the left wing tile field. Here, a key of circular dots was used: Red means a tile is not in its final location, blue means a tile is in its final location and has been positively identified. Yellow means the tile failed at the densified layer, near the bond line and green means the tile failed owing to internal heating. In this case the Koropon/SIP failed or the Strain Insulation Pad (SIP) failed due to overheating. Koropon is the primer coating the aluminum skin.

There is a distinct pattern of RCG coated tiles, in the general X-direction downstream of Panels 8 and 9, outboard of the wheel well where the tiles appear to have little of the dark metal deposit (aluminum - rich) generally seen on the recovered tiles. These normal-appearing tiles all have been identified to have failure at the tile/Koropon bond line and departed from the wing surface prior to a major outflow of molten aluminum. This is indicative of extreme heat, inside the wing behind Panel 8. It then seems probable from this observation that the breach in the wing spar occurred at the Panel 8 location, and this is consistent with the observations discussed above. Ballistic analyses of the trajectories and the geographic location of the recovered tiles (both those detached owing to bond failure and those that did not) suggest they came off from about 100 nautical miles west of their recovery location in Texas.

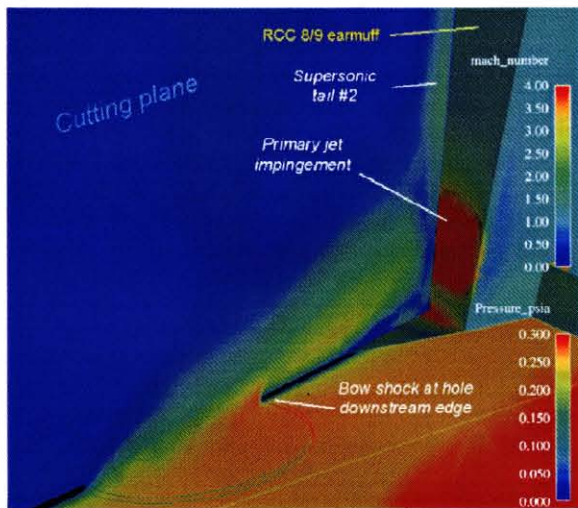
Figure 38 (a): CFD Predictions for Wall Static Pressure and Mach Number for a 10" Hole in RCC Panel 8, Corresponding to Solution in Figure 37. Static Pressure is Color Coded on Walls and Mach Number Distribution is Shown on the Cutting Plane.

Figure 38 (a) from the Boeing Propulsion and Power group depicts the static pressure on the WLESS internal walls and the Mach number on the cutting plane, which passes through the 10 inch diameter hole. The results indicate that all of the external boundary layer and some of the local inviscid (freestream) flow is ingested into the WLESS channel. The primary jet strikes the earmuff at a near-normal incidence (80°). Its stagnation pressure exceeds the freestream-shock pressure because of a precompression by the oblique vehicle shock.

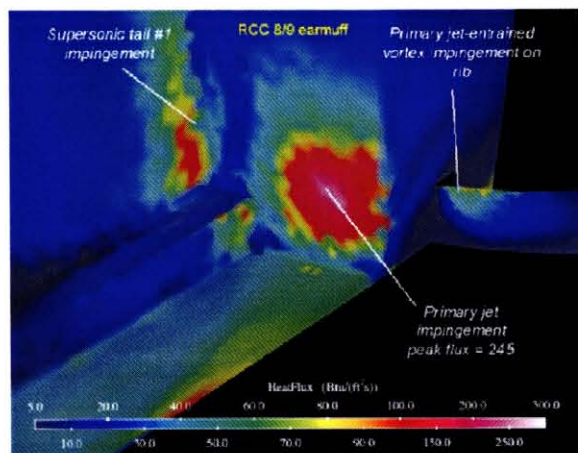
Figure 38 (b): CDF Predictions for Convective Heat Flux on Hot Tubs, Earmuff and Rib for a 10" Hole in RCC Panel 8, Corresponding to the Solution in Figure 37.

Figure 38 (b) shows CFD predictions for convective heat transfer to the spar insulation (hot tub), spanner insulation (earmuff) and the RCC outboard rib corresponding to the solutions shown in Figures 37 and 38 (a). The heat fluxes on the earmuff at the center of the jet impingement are significantly higher than that of an undamaged wing, immediately upstream of the breach in Panel 8 with a finite catalytic wall (Reference 18) (300 vs. 27.3 Btu/ft²s).

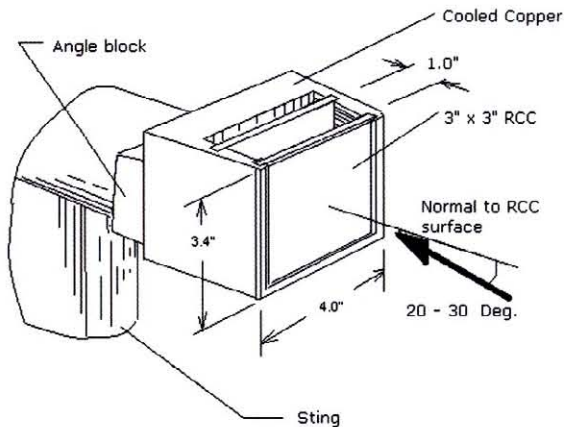
Figure 42: NASA/JSC Arc Jet Test Set-up for Linear Knife-edge Tests at Large Angle of Incidence (70°). Test to Simulate Flow Impingement on RCC Ribs.

The first test, with two parallel plates shown in Figure 42 with flow impinging at 70 degrees to the flat face was intended to simulate the flow inside the wing impinging on RCC ribs. The results of the test on the parallel plates was inconclusive, because the surface temperatures attainable, without damaging the model holder, were not high enough to cause ablation of the SiC coating.

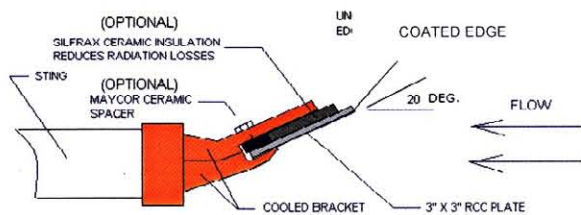
Figure 43: NASA/JSC Arc Jet Test Set-up for Simulation of RCC Knife-edge Erosion at Low Angle of Incidence (20°). Test Intended to Simulate Flow on Lip of Hole in RCC Panel.

The second test article, shown in Figure 43, was intended to simulate flow on the windward lip of a hole in Panel 8. This test, with a flow angle on the single plate at 20 degrees incidence showed that knife edging would occur when the temperature on the coated leading edge of the plate was above 3250 °F. Table 3 specifies the test conditions thought to simulate the enthalpy and impact pressure present in the damaged wing during Columbia’s entry on STS 107.

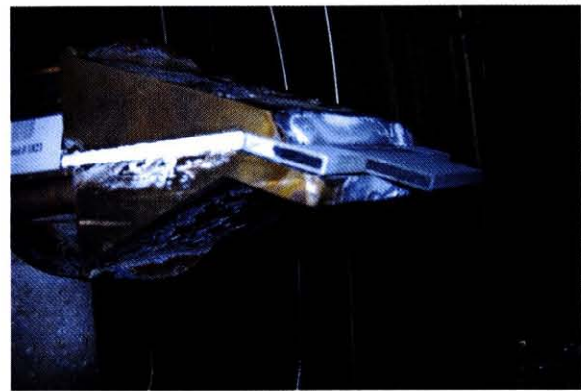
Figure 44 (a): Pre-test Photograph. Angle of Incidence: 20°, Coated Edge Facing Flow.

Figure 44 (a) is a pre-test photograph of the test article. Note that the coated edge of RCC is facing the flow for both the RCC sample and the RCC closeout pieces placed on either side.

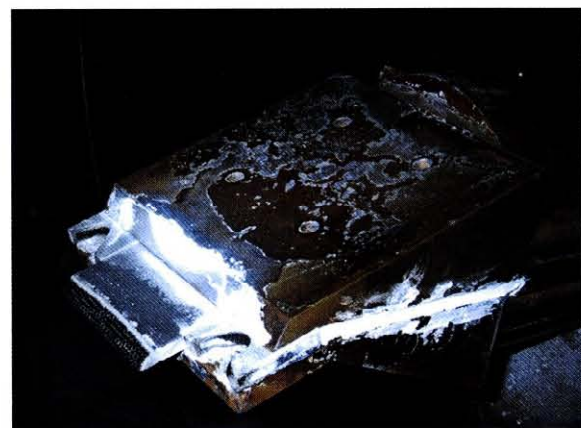
Figure 44 (b): Post-test Photograph Showing Knife-edges in Both RCC Test Article and Closeout.

Figure 44 (b) is the corresponding post-test photograph of the test article. Here, erosion of the SiC coating is apparent, as is the formation of a knife-edge on the primary RCC sample, where the highest temperatures occurred. The edge temperature was in excess of 3200 °F or greater as shown by the failure of the SiC coating. Furthermore, as shown in Figure 44 (c) knife-edges also formed in the SiC coated RCC closeouts where flow from the primary RCC sample was impinging.

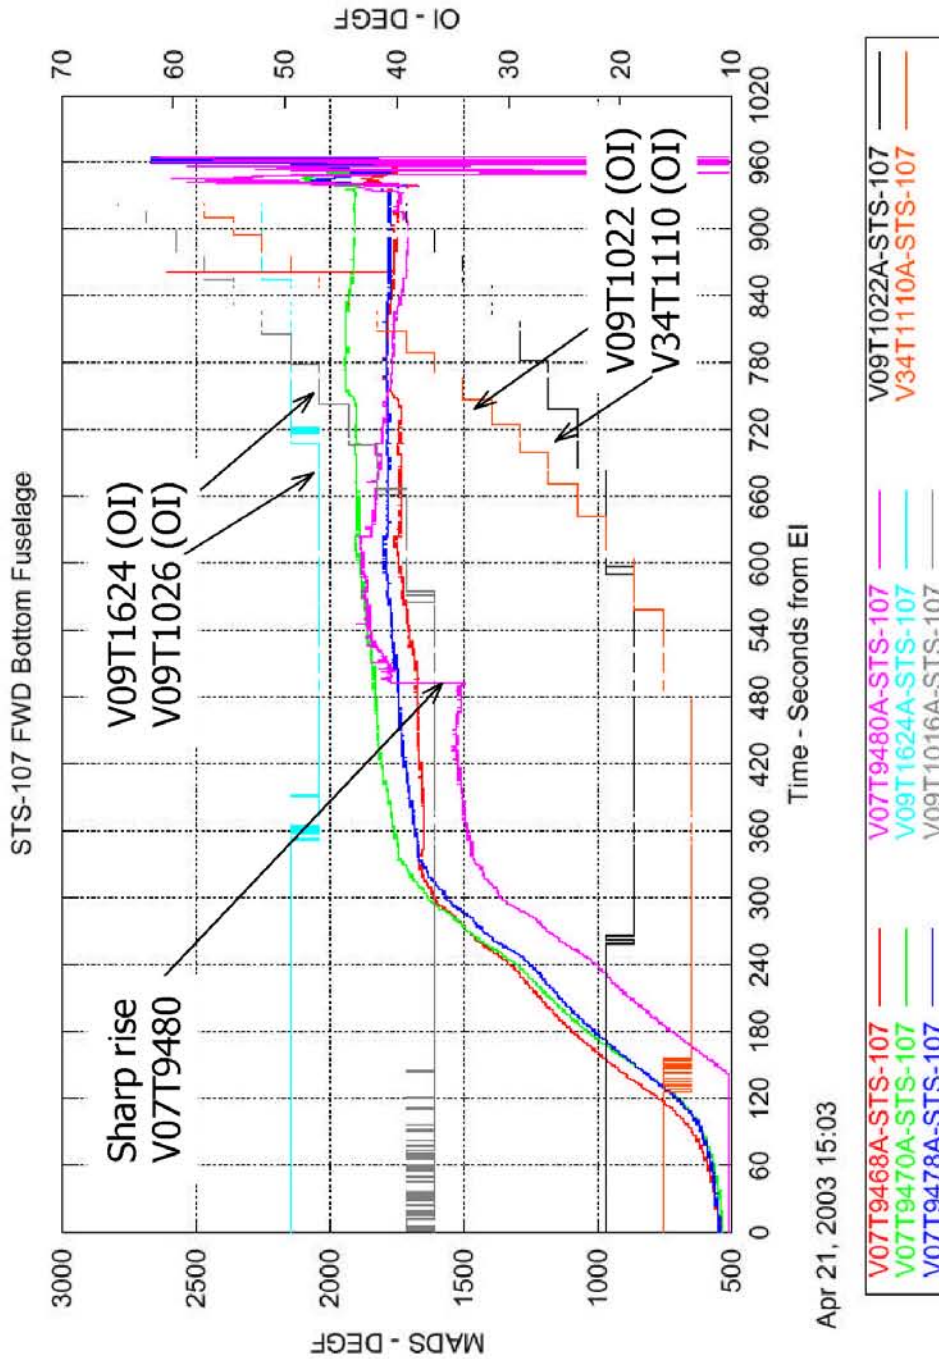
Lower Surface Sharp Temp Rise and Bondline OI

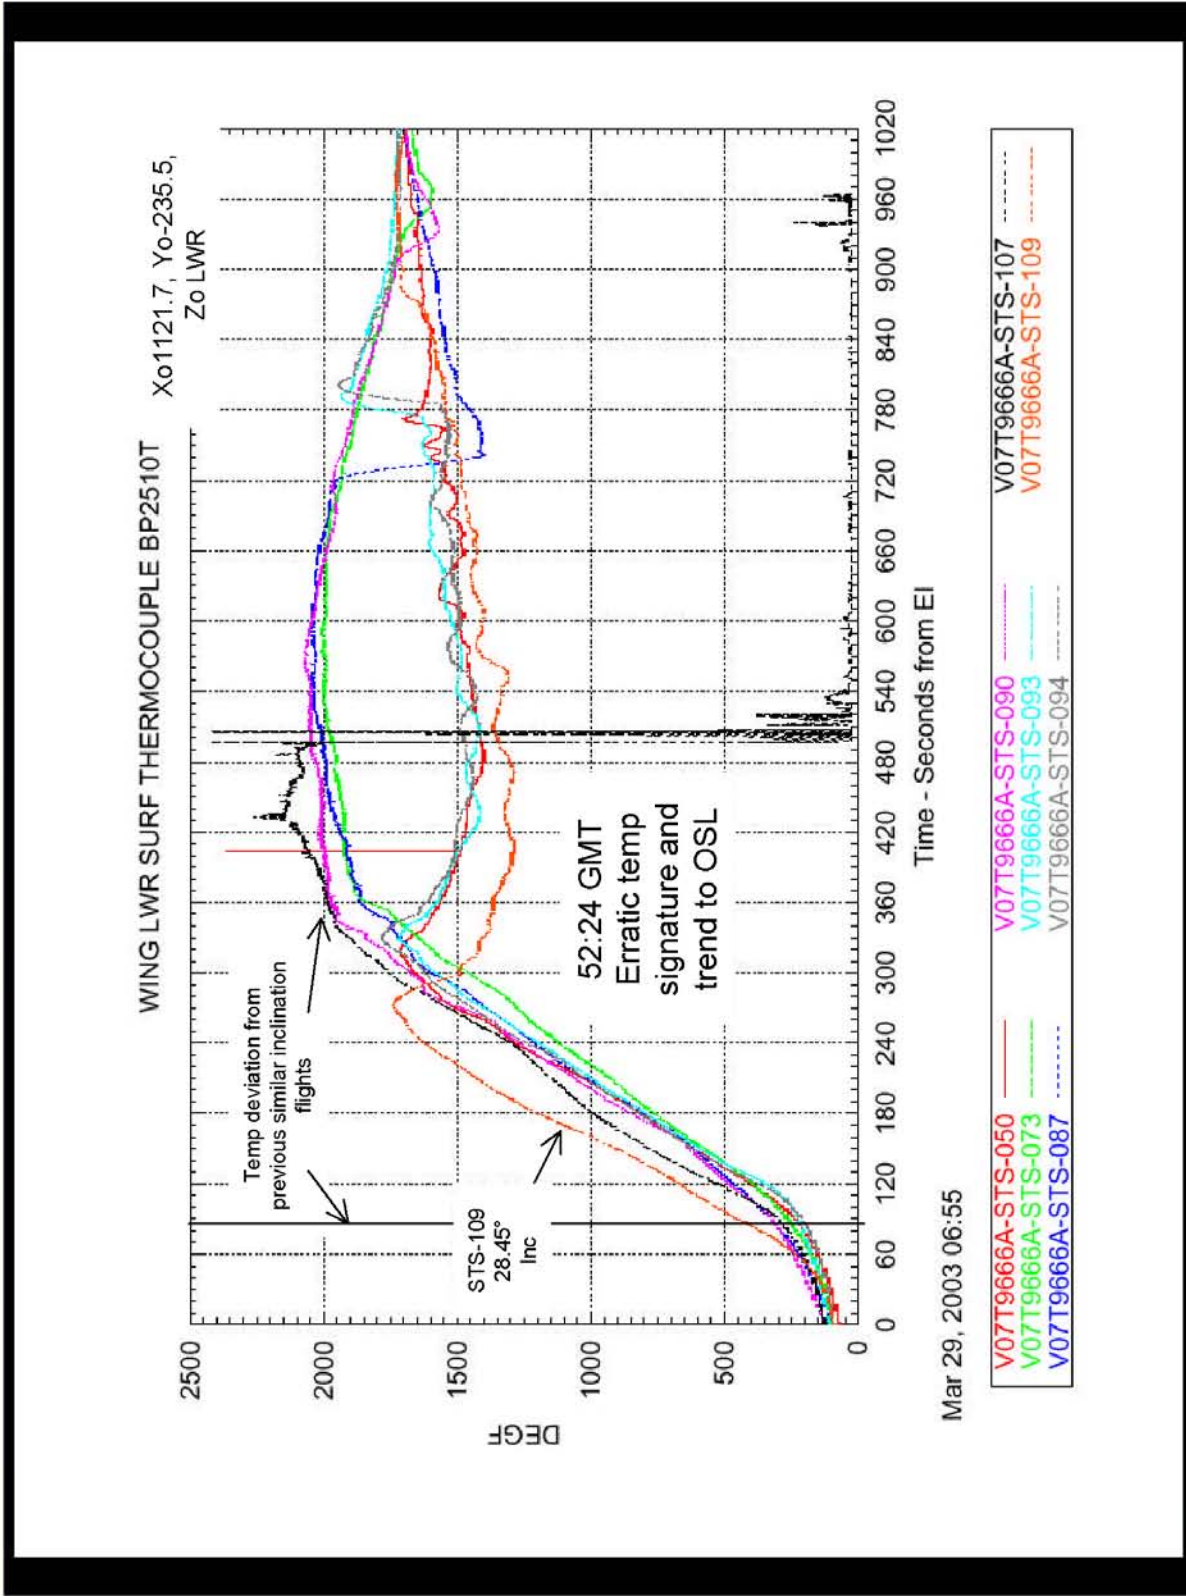
Trend to OSL & Early Warming Trend

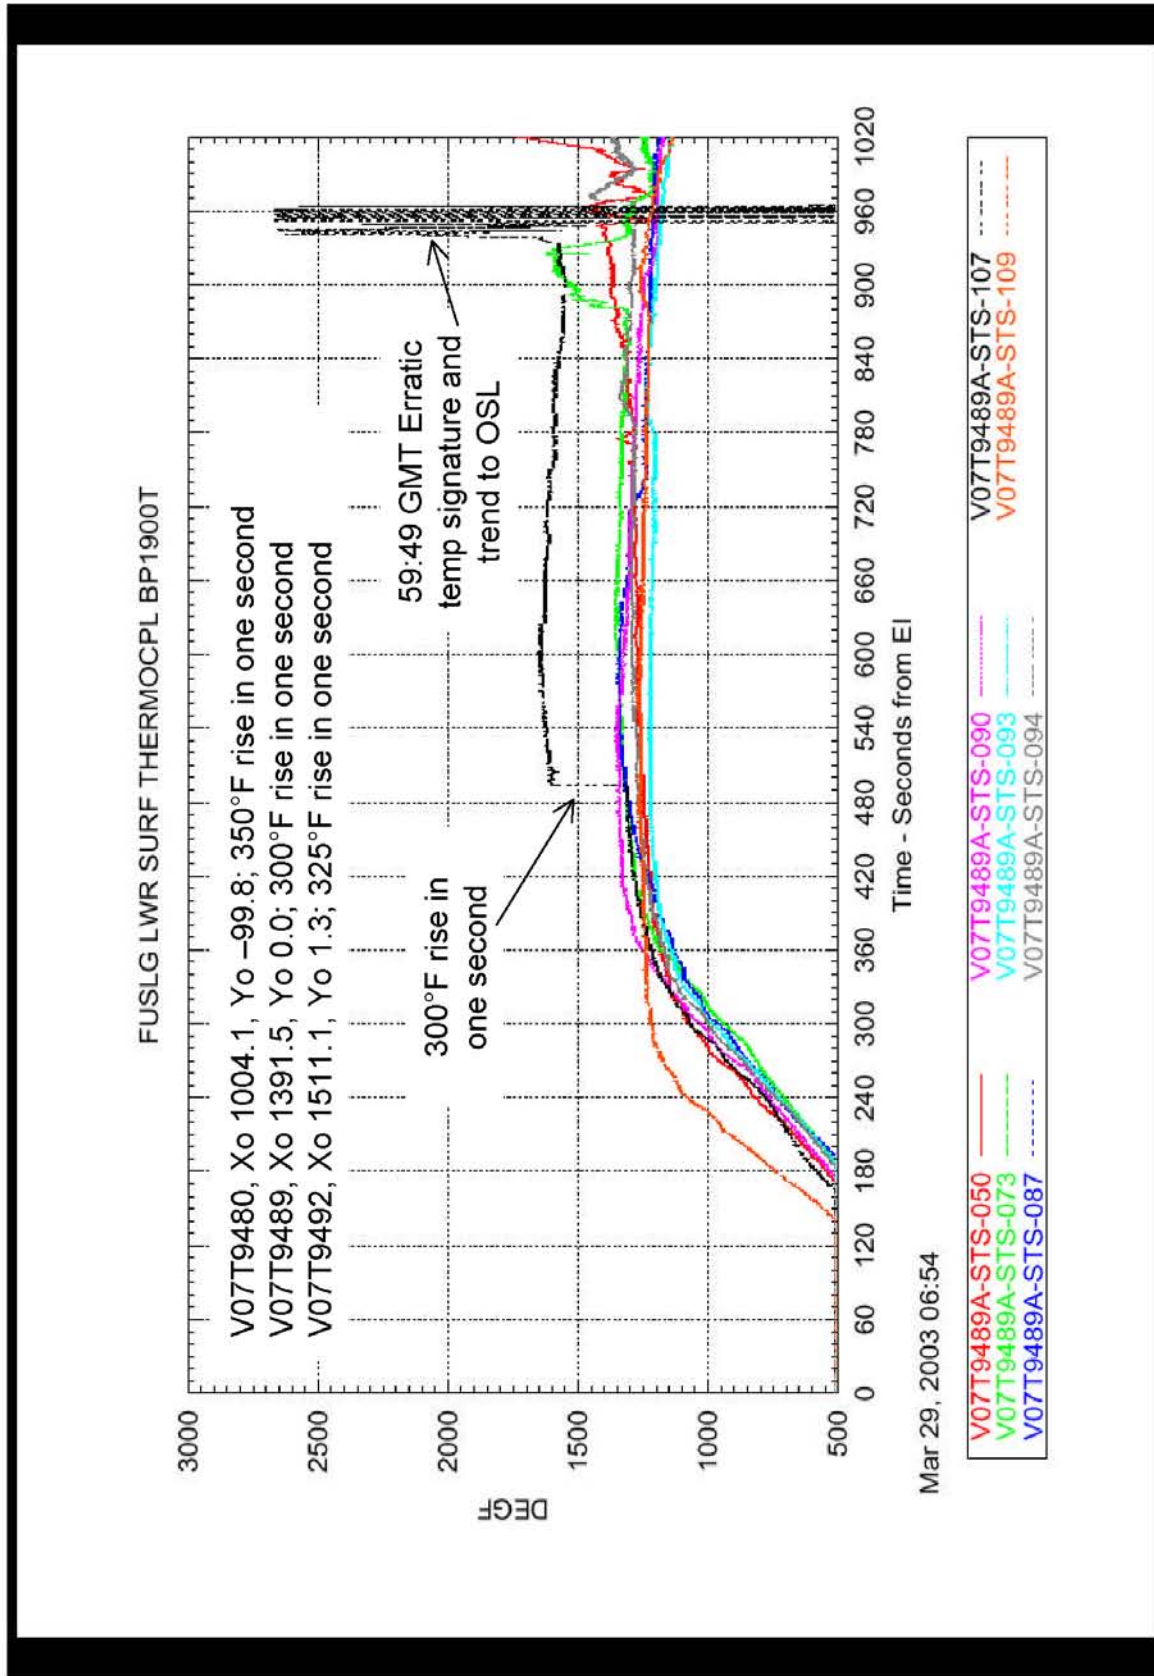
Sharp Temp Rise

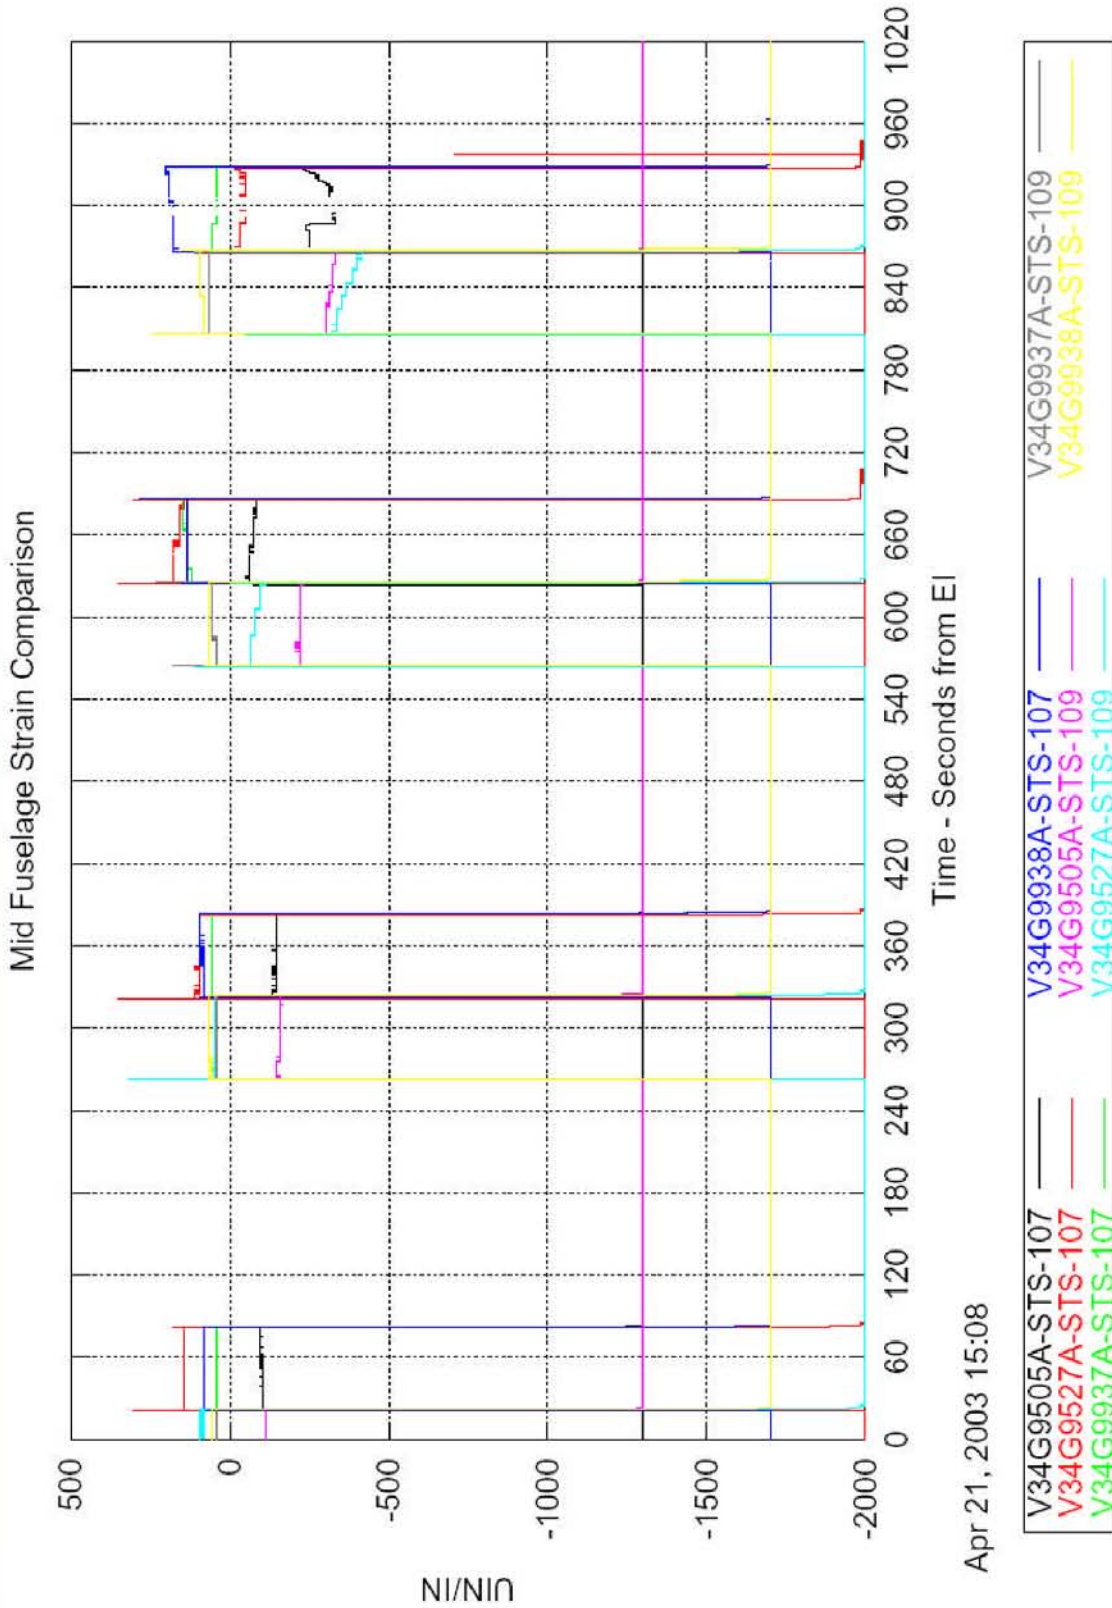
Some Mid Fuselage Gauges Show Mild Discrepancies Versus Previous Flights
