COLUMBIA

ACCIDENT INVESTIGATION BOARD

REPORT VOLUME IV
OCTOBER 2003

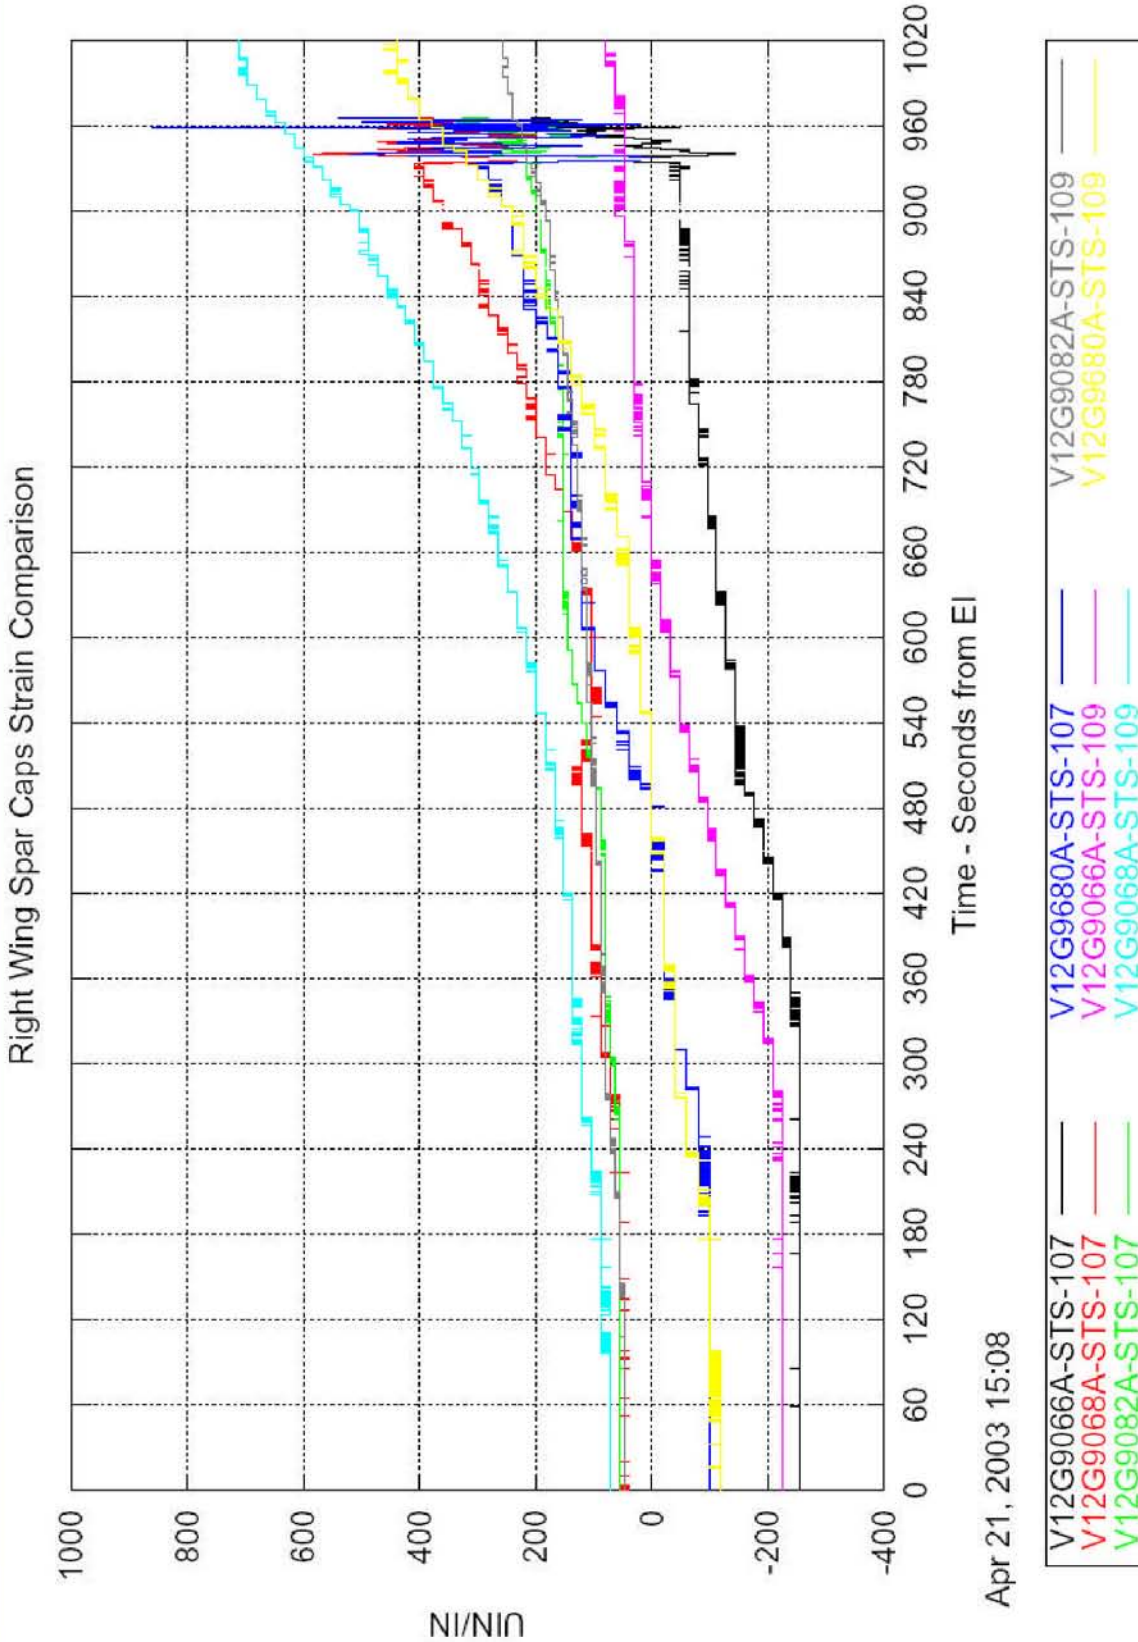
Some Right Wing Spar Cap Gauges Show Mild Discrepancies Versus Previous Flights

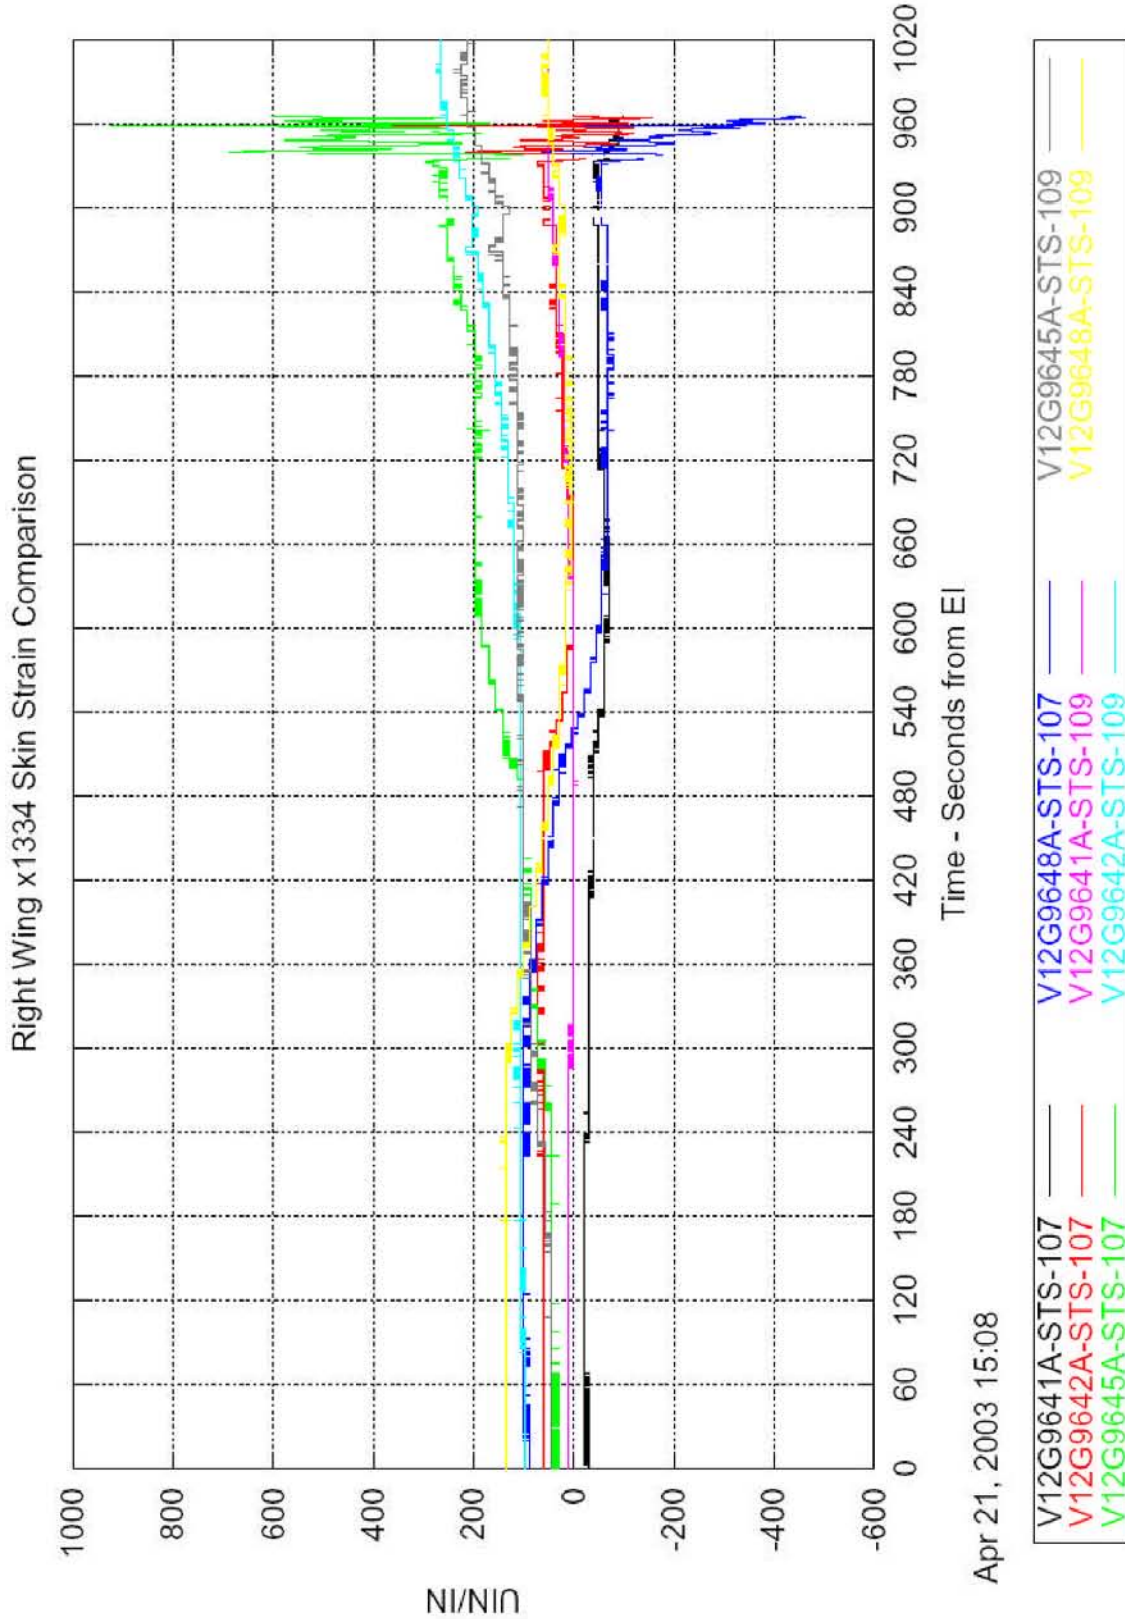
A Number of Right Wing Skin Gauges Show Off-Nominal Trending Initiating Near EI +500 Seconds

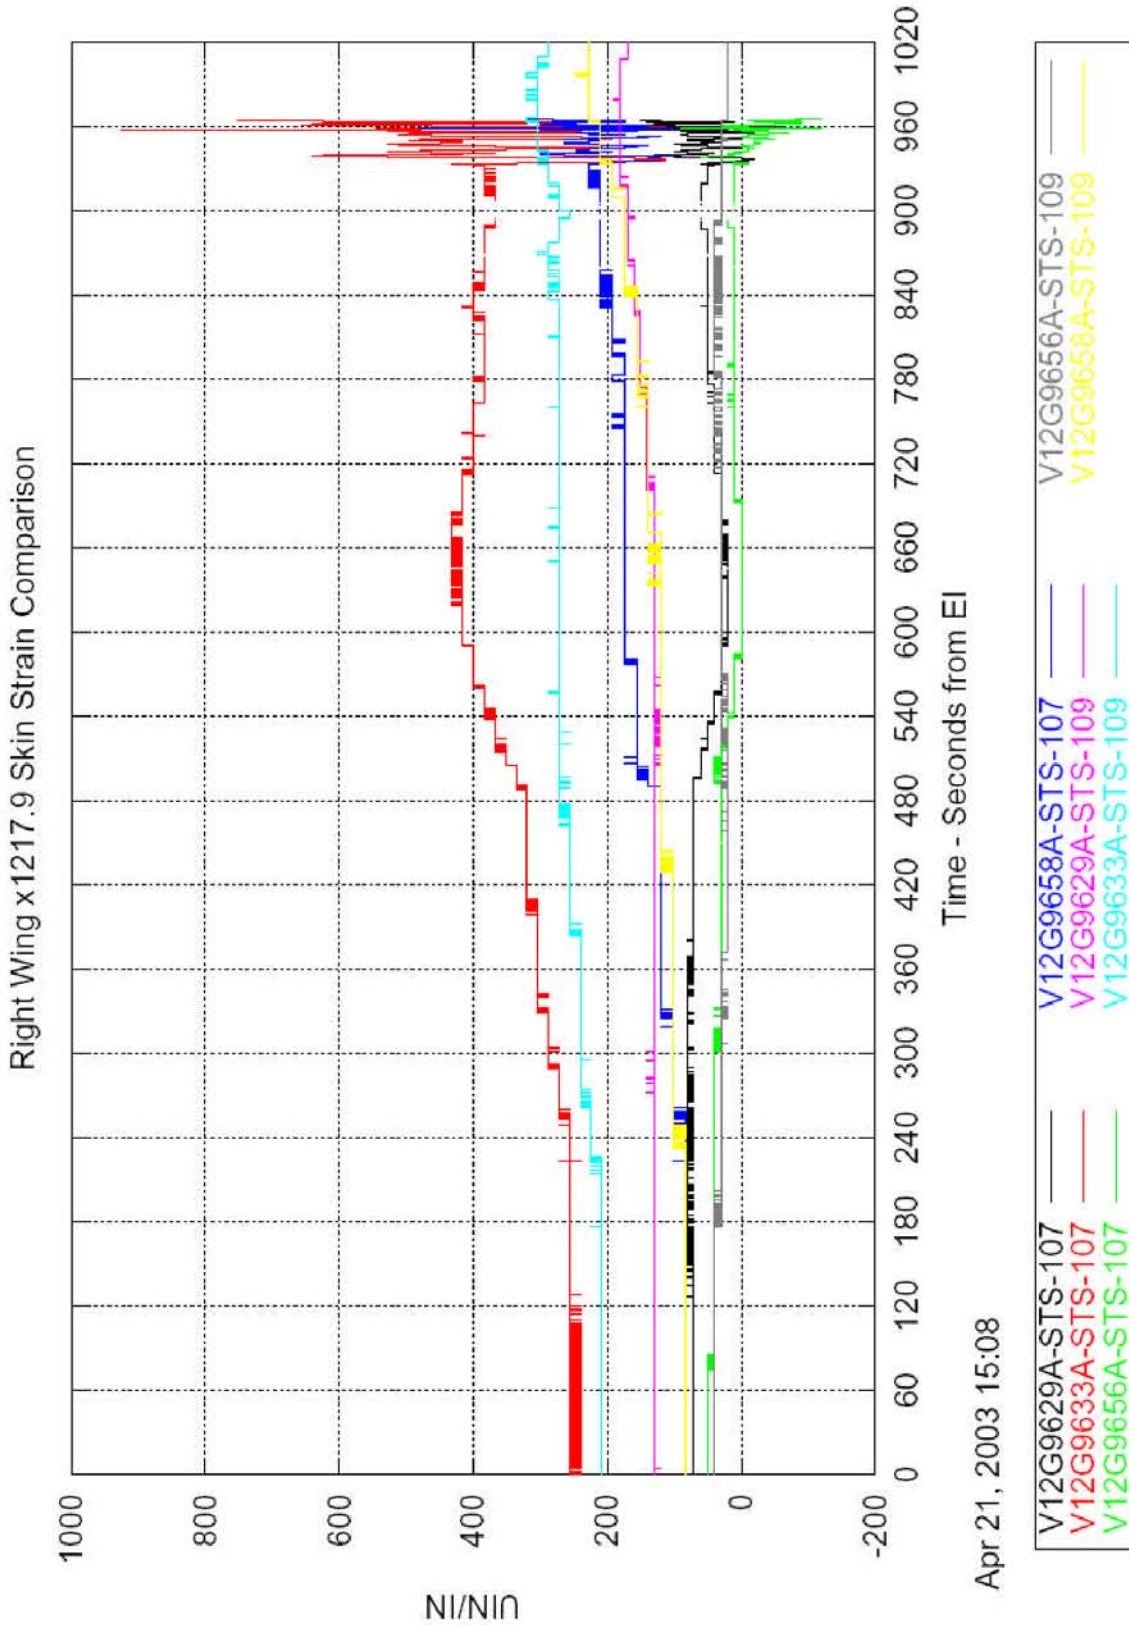
A Number of Right Wing Skin Gauges Show Off-Nominal Trending Initiating Near EI +500 Seconds

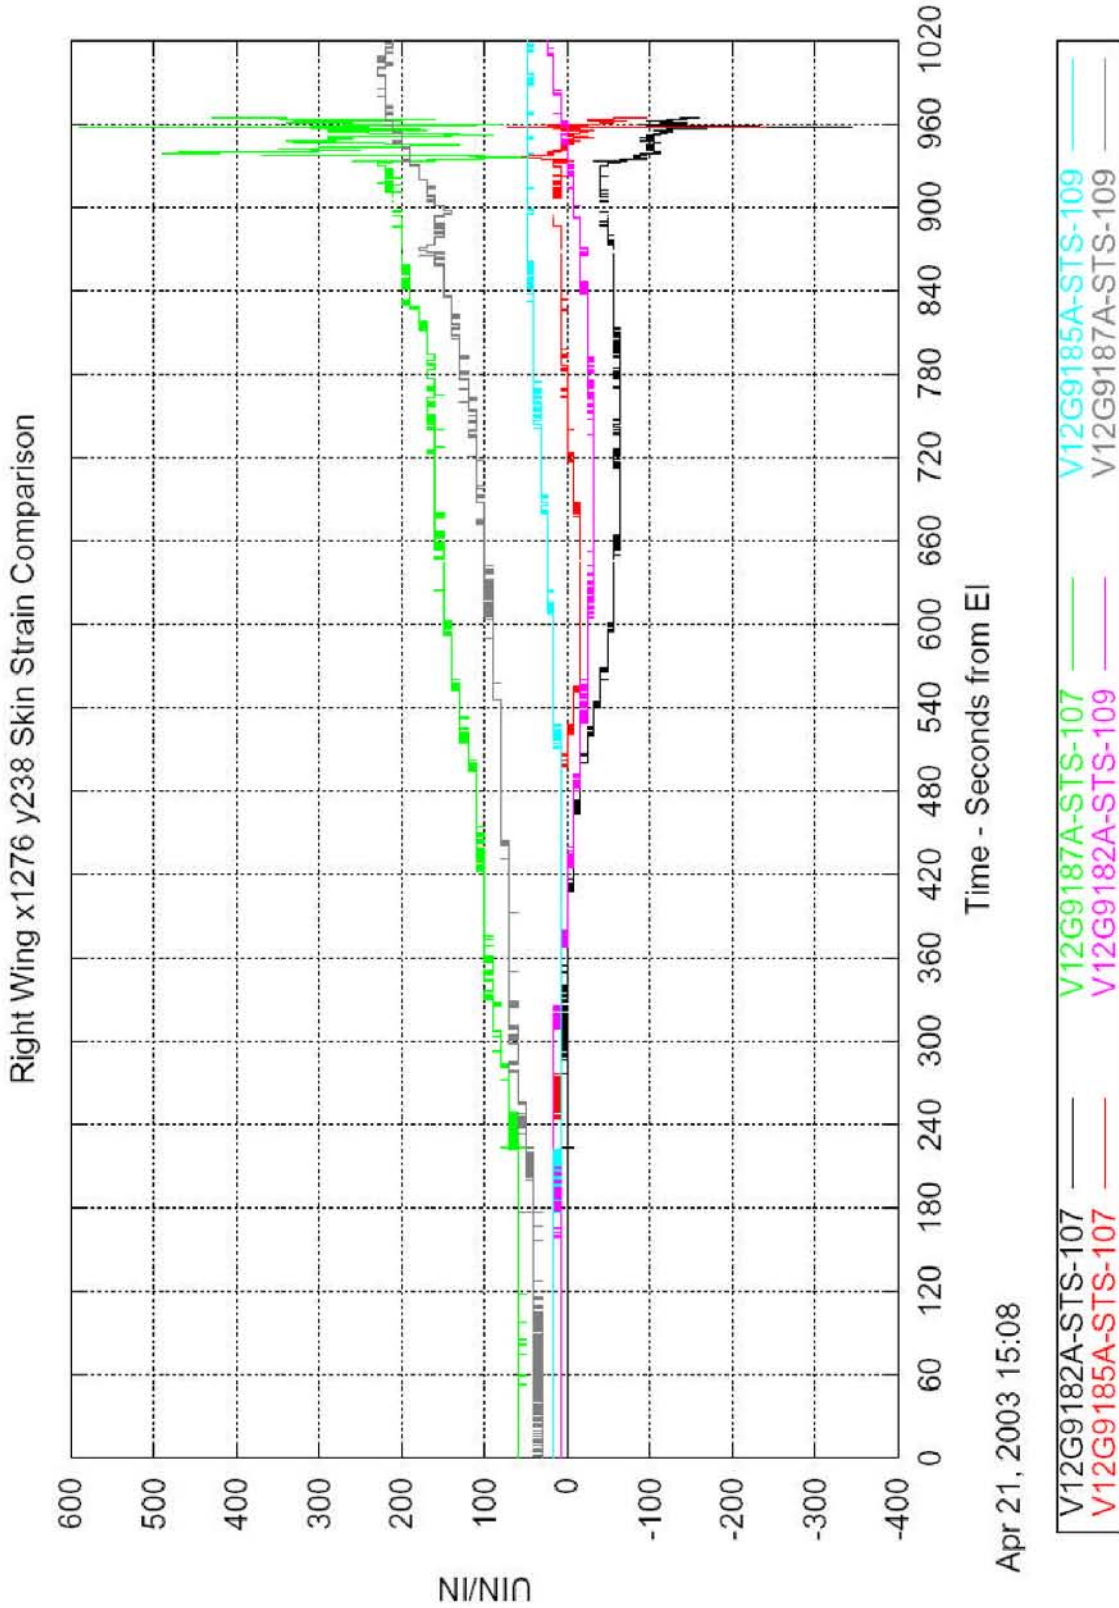
A Number of Right Wing Skin Gauges Show Off-Nominal Trending Initiating Near EI +500 Seconds

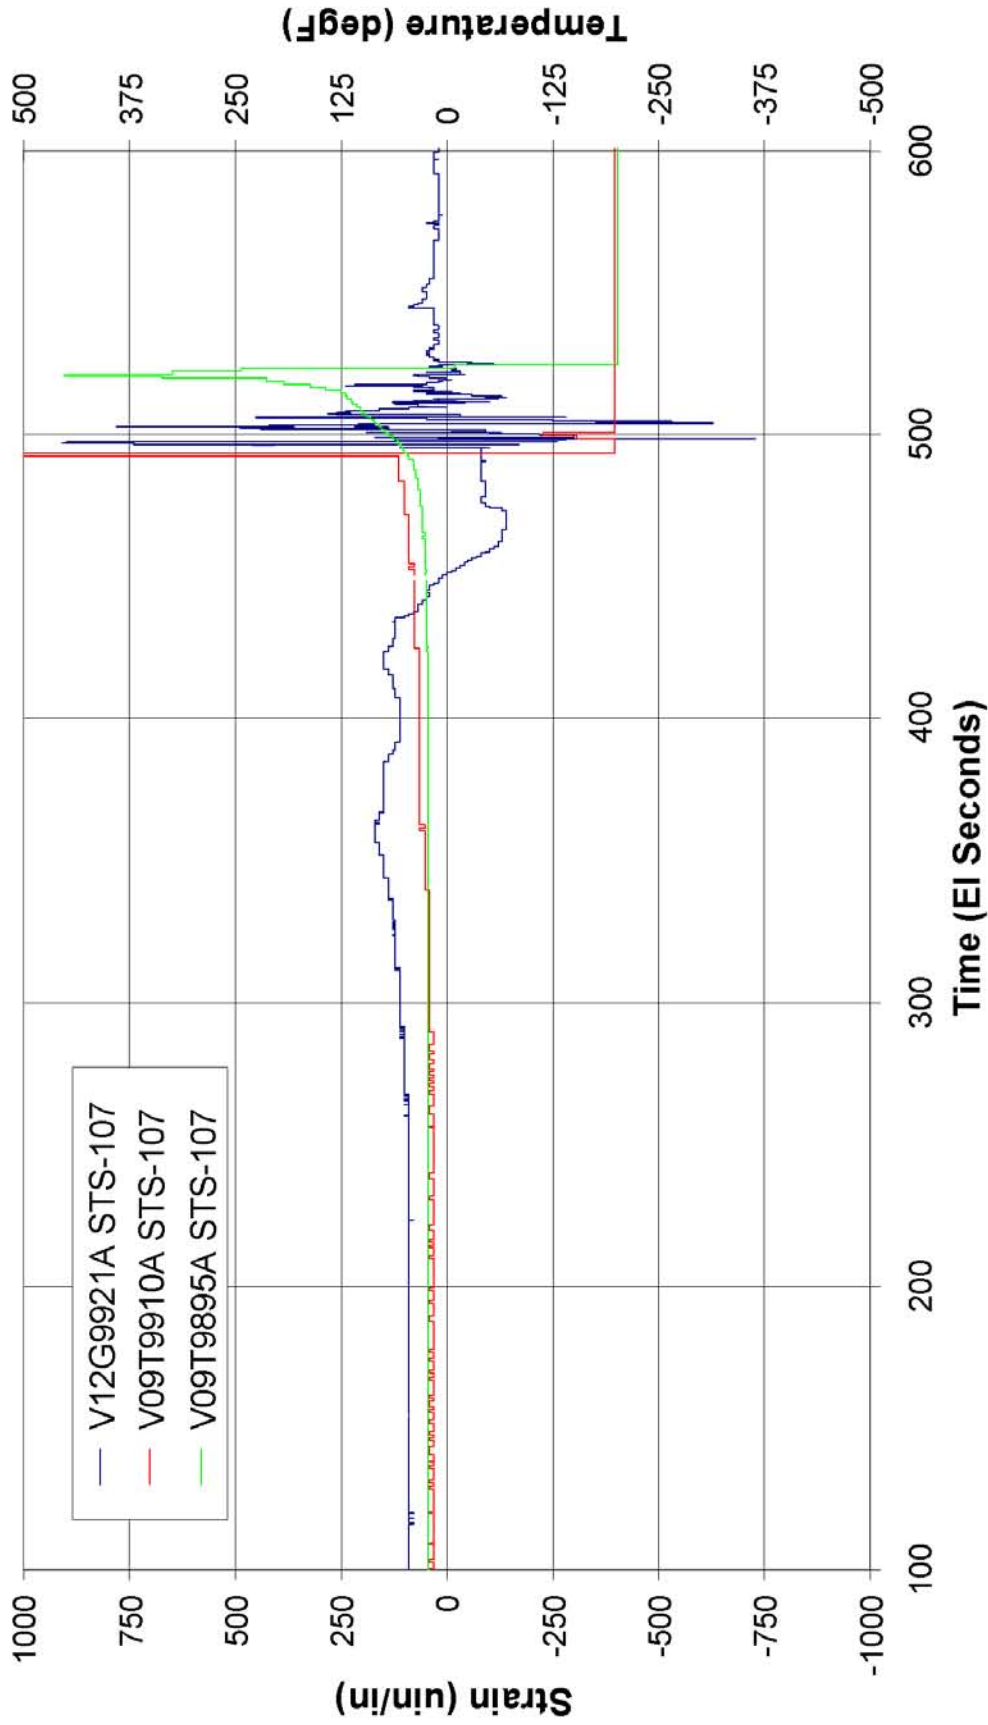
RCC Panel 9 OEX Gages, STS-107

- Three MADS gauges of particular interest near RCC Panel 9 on the Left Wing
 - One Strain gauge, Two Temperature gauges
 - V12G9921A, V09T9910A, & V09T9895A
 - Data for these three gauges was plotted together
 - Indicates failure at approximately the same time for V12G9921A and V09T9910A (~EI +495sec)
 - Later failure for V09T9895A (~EI +515sec)
 - Continued analysis is underway for this data.

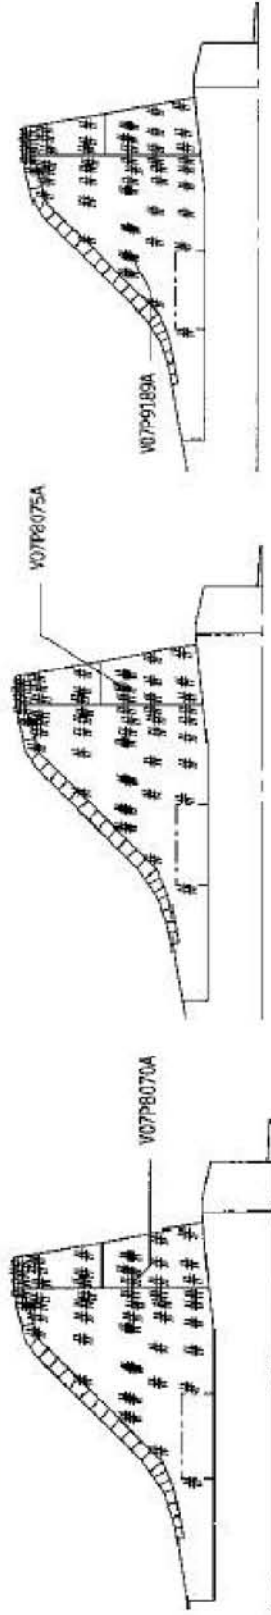
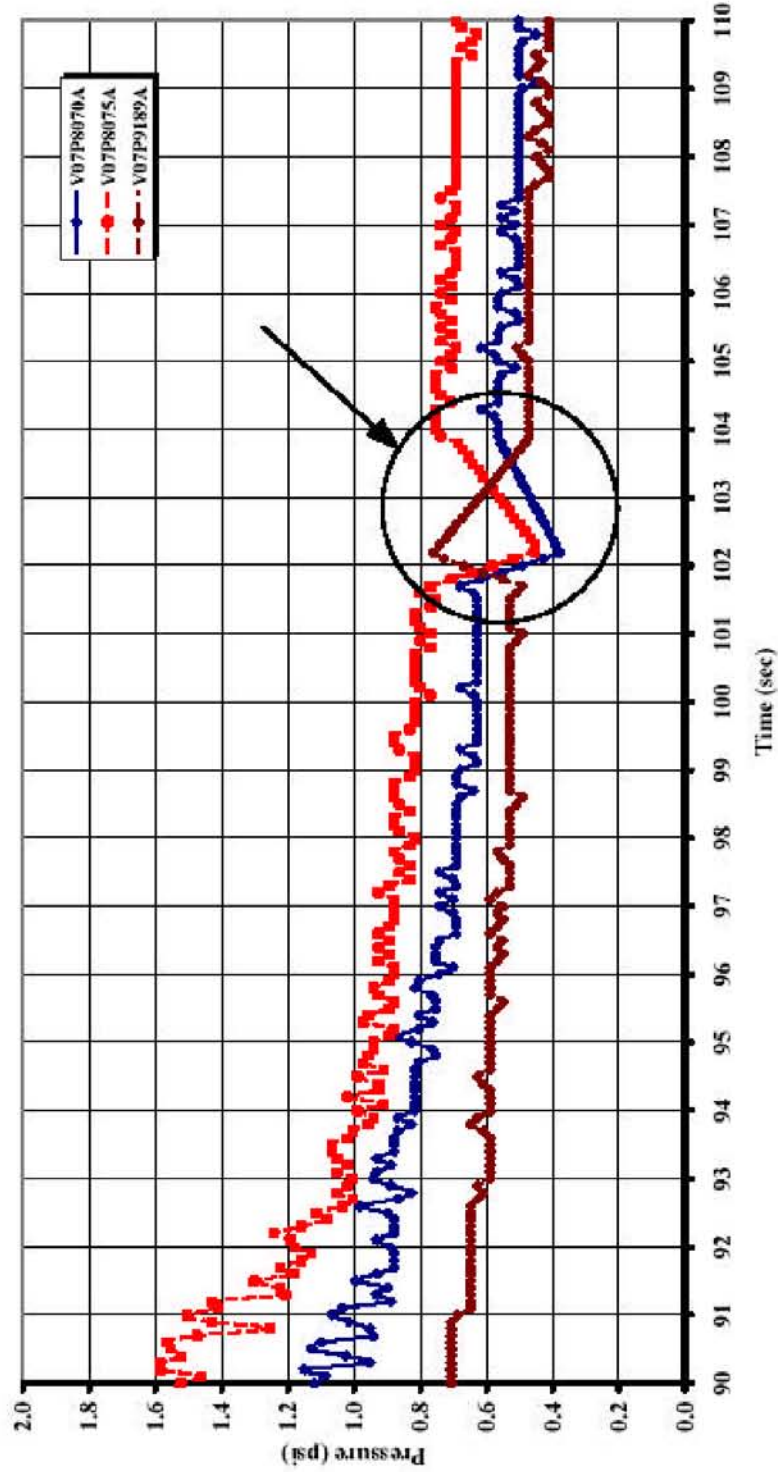
Three Lower Left Wing Y=250 Taps Have Similar Behavior at 102 Seconds

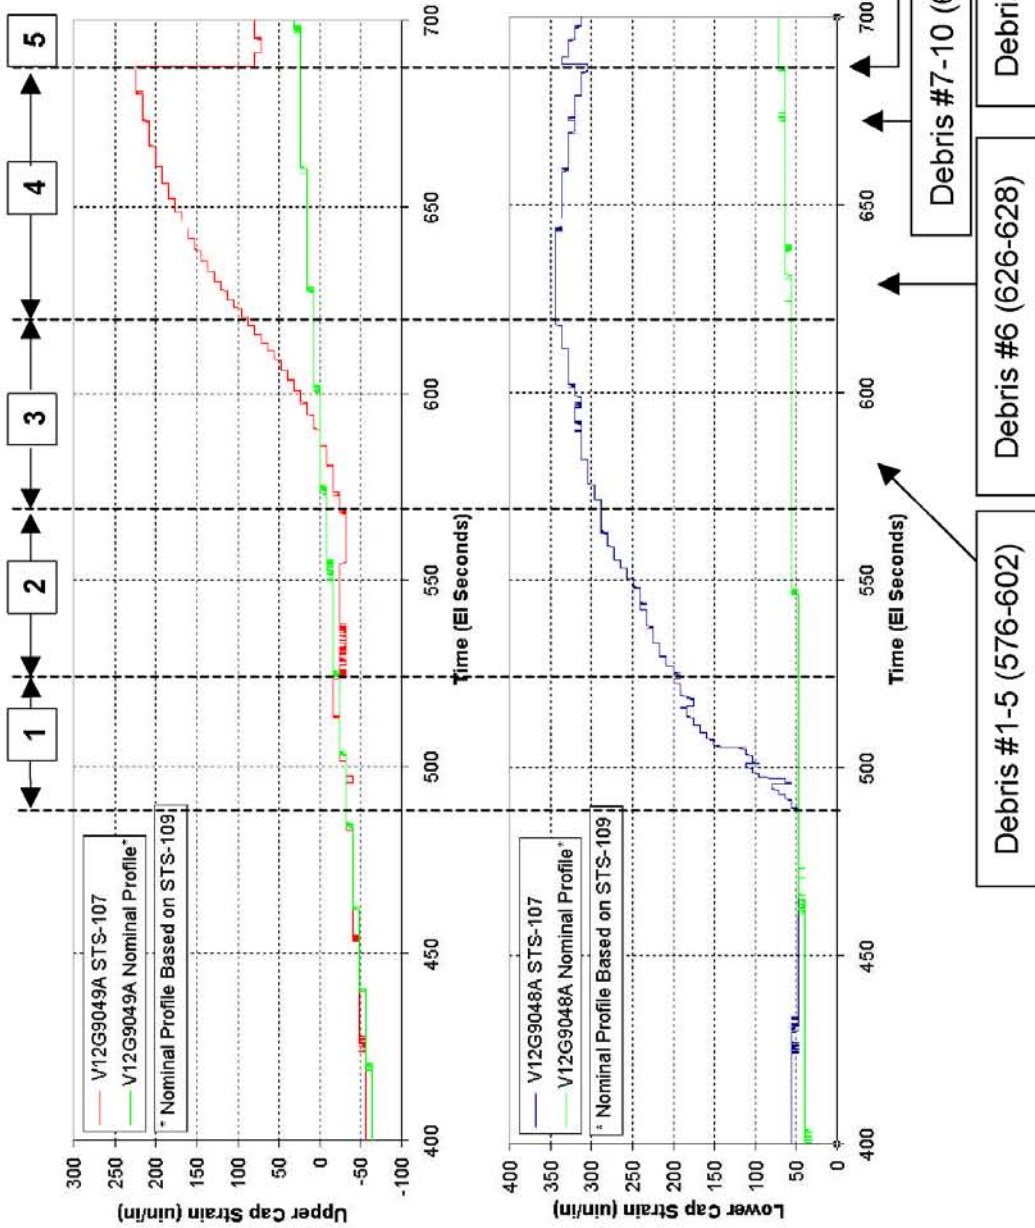
STS-107 Reconstructed Data

- **Anomalous strain gage signatures are presumed to result from instrumentation malfunction, thermally induced strain, load redistribution, or a combination.**
 - Thermal effects are a more reasonable explanation than load redistribution scenarios.
 - Lower spar cap shows a slope sign reversal.
 - No slope changes before or after sharp data changes.
- **The current analysis uses FEM methods to assess the feasibility of thermally induced strain as a mechanism to produce the observed signatures.**
 - Analysis does not attempt to model actual structural temperatures.
 - Objective is to determine the structural response to local temperature differentials.

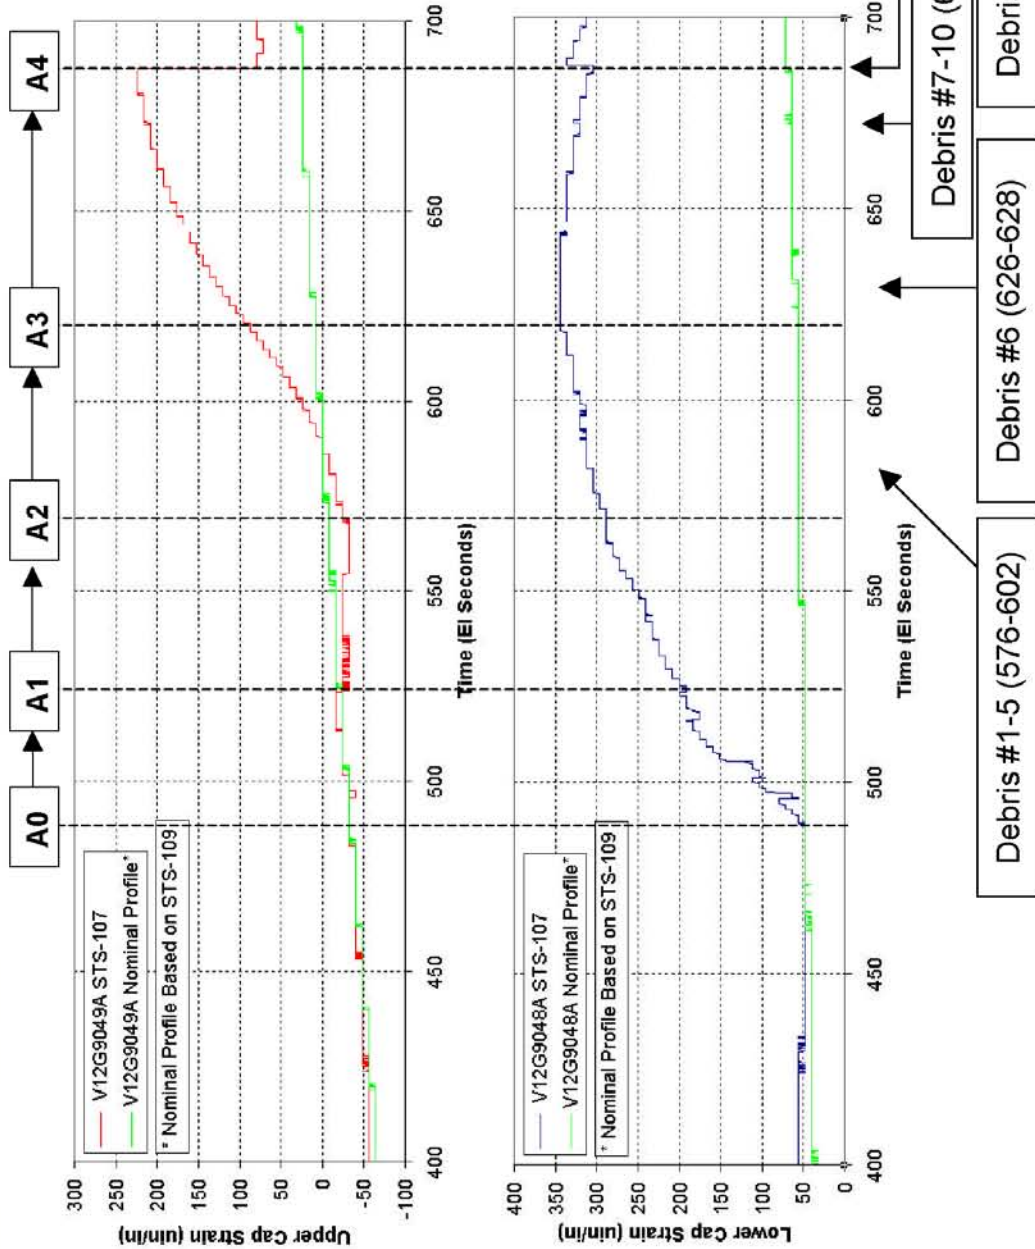
FEM Scenario Timeline Plot

- FEM temperature load cases may be combined in a number of ways to generate temperature profile sequences which produce the observed strains.
 - Several profile sequences were developed, and screened versus corroborating scenario evidence to define the most likely profile that could have produced the observed strains.
- The most rational temperature profile was selected.
 - Combined heating of aft upper skin, spar web, upper and lower forward skins, and upper spar cap, with less heating to lower spar cap.

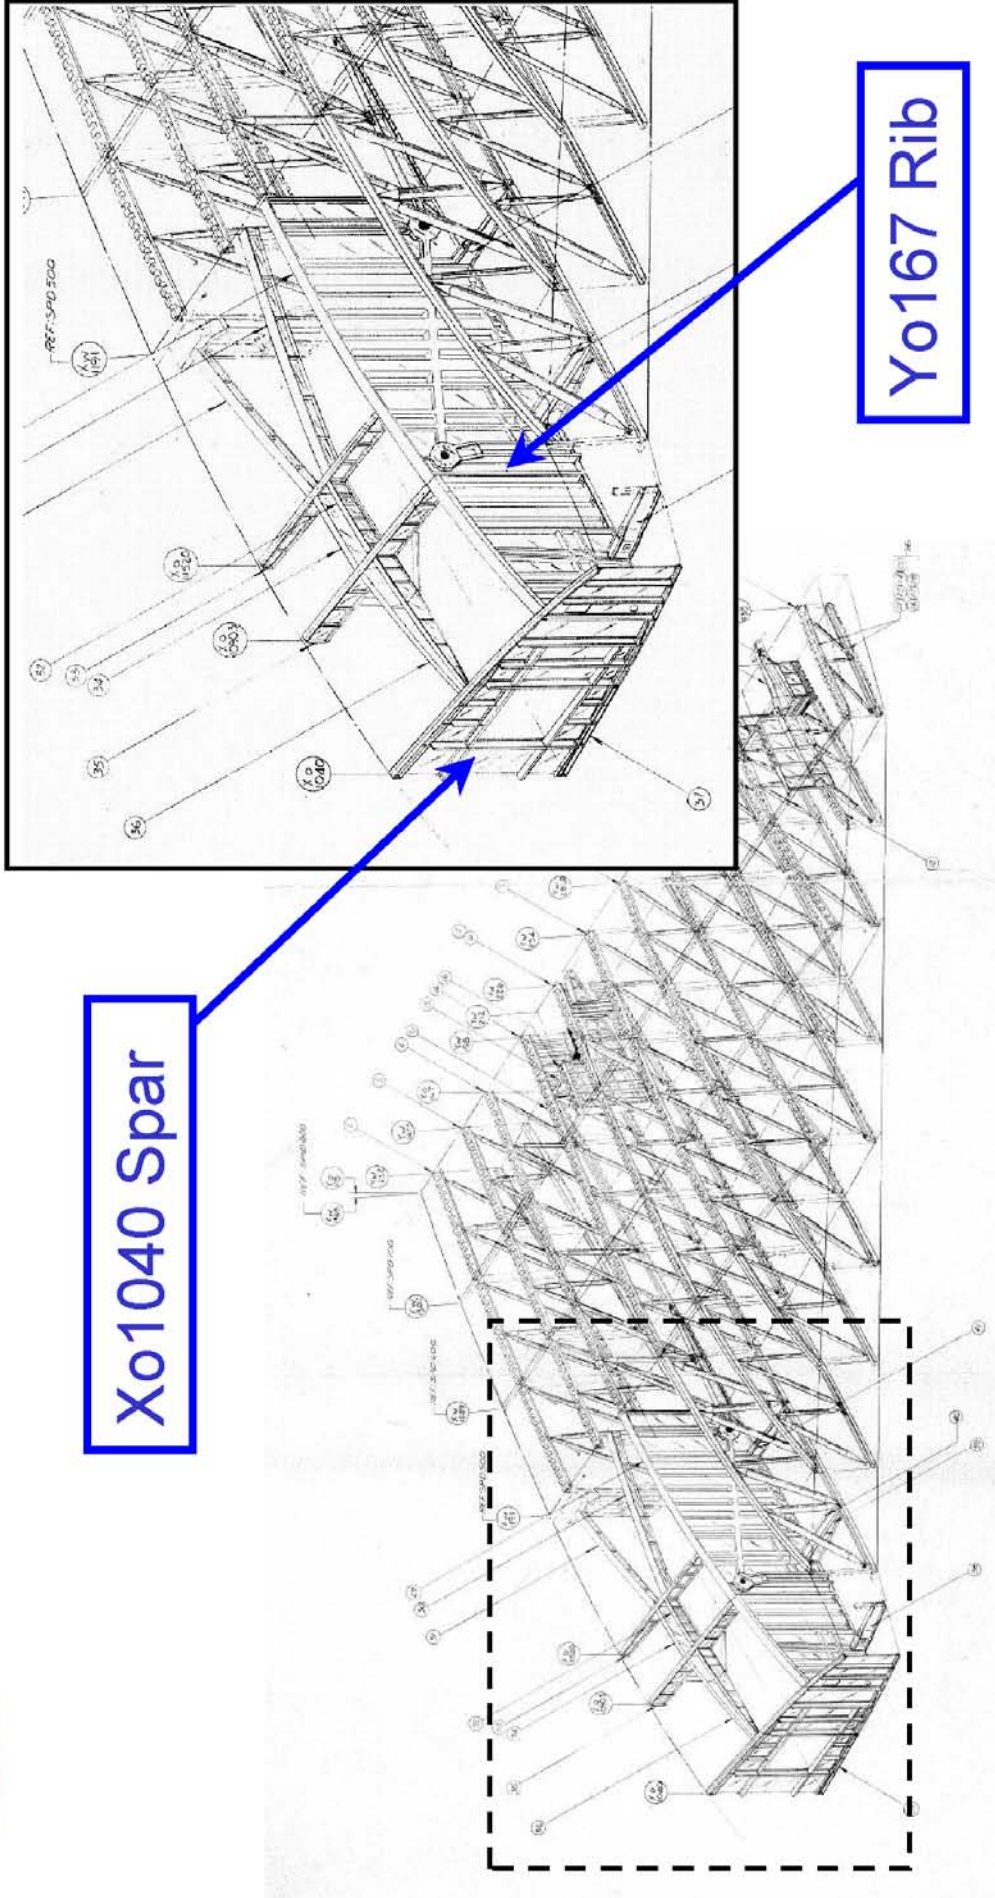
Wing Illustration

- **Local temperature gradients could potentially explain the observed Xo1040 upper and lower spar cap strains.**
- **Strain gage evidence offers some support for failure scenarios involving hot gas intrusion from the wing cavity into the glove area and/or the MLG wheel well.**
 - Timing of strain gage events has reasonable correlation with breach times of WLE and MLG well.
- **Strain gage data does not, however, conclusively indicate this scenario.**
 - Results require the critical assumption that the lower spar cap is initially exposed to less heating than the upper cap, spar web, and nearby skins.

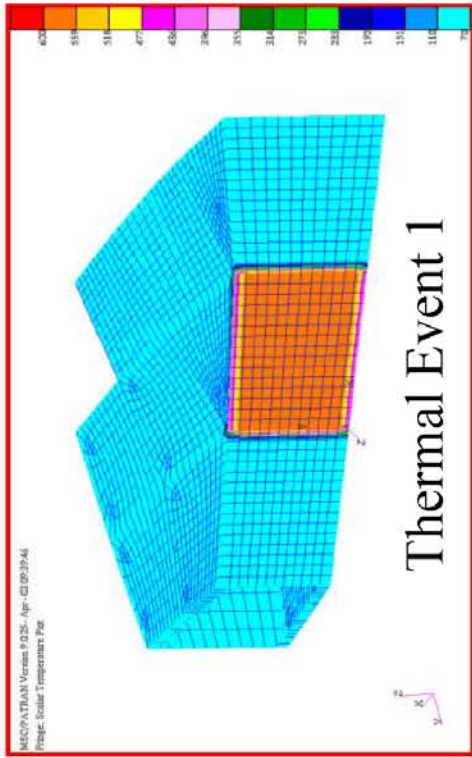
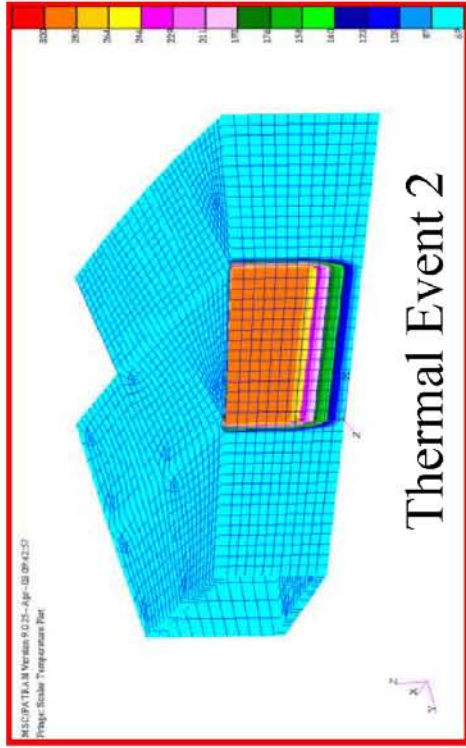
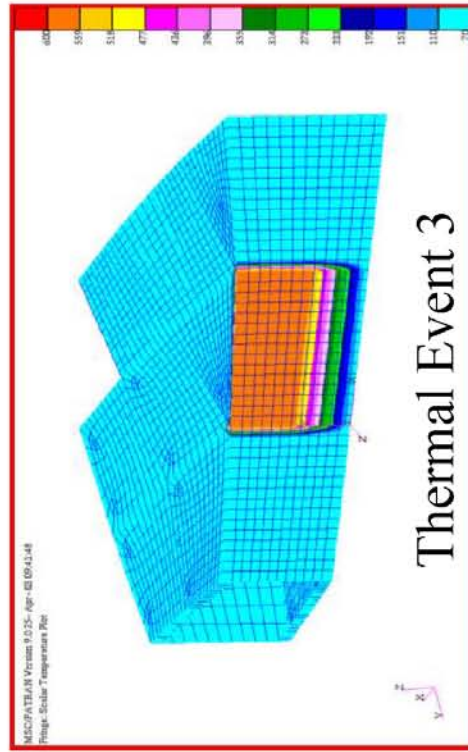
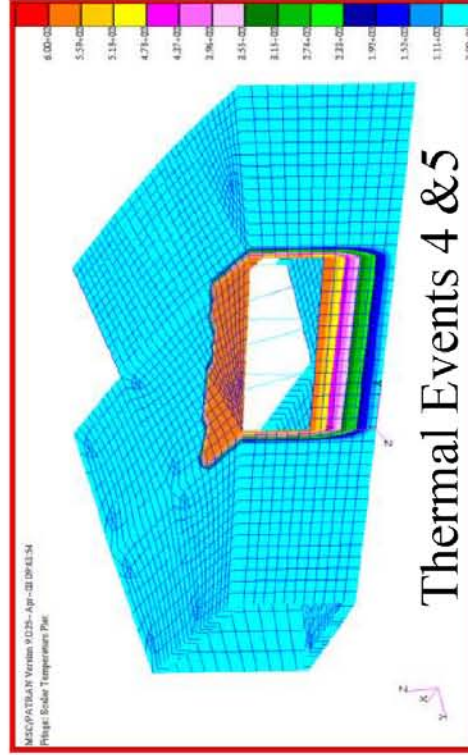
Thermal Event Temperature Distributions

- Thermal events analyzed continued....
- 4. Assume burn through on upper half WLE spar web
 - Assumed 600°F on upper WLE cap, wing skin, and wing ribs up to 16 inches from WLE
 - Assumed linear temperature distribution of 600°F to 70°F from edge of burn through (middle of WLE web) to bottom WLE cap
 - 70°F on rest of structure
- 5. Assume burn through on upper half WLE spar web and spar cap
 - Assumed 600°F on upper wing skin and wing ribs up to 16 inches from WLE
 - Assumed linear temperature distribution of 600°F to 70°F from edge of burn through (middle of WLE web) to bottom WLE cap
 - 70°F on rest of structure

- Possible scenario
 - Partial breach in WLE TPS allows plasma impingement on WLE spar
 - ◆ Causes general temperature increase on WLE panel and cap
 - ◆ Shear strain readings begin to increase
 - Upper WLE panel and spar subjected to primary heating
 - ◆ Creates temperature gradient on WLE spar from top to bottom
 - ◆ WLE shear strain gage readings continue to increase
 - Upper WLE spar panel burn through
 - ◆ Shear strains are reduced in region around thermal event causing a strain sign reversal
 - Panel burn through relieves thermal stresses

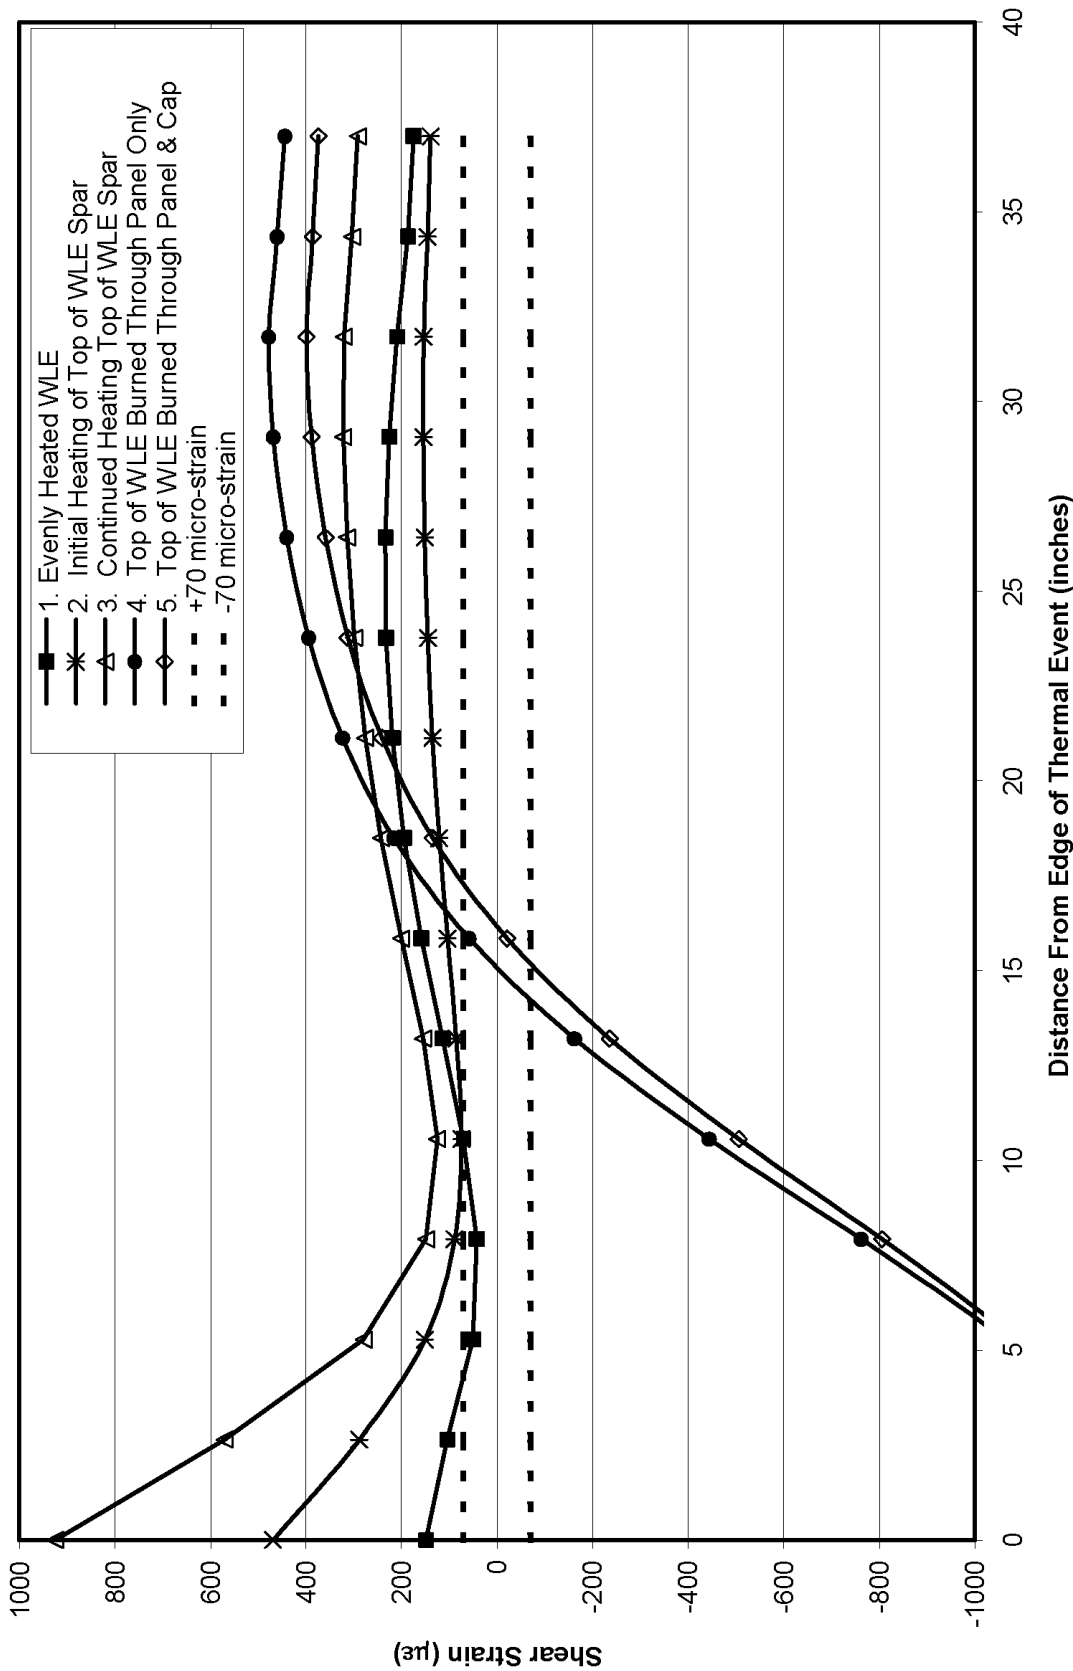
Shear Strain Results Along Midspan of WLE Spar

Thermal Event Can Cause Increase in Shear Strain Magnitude

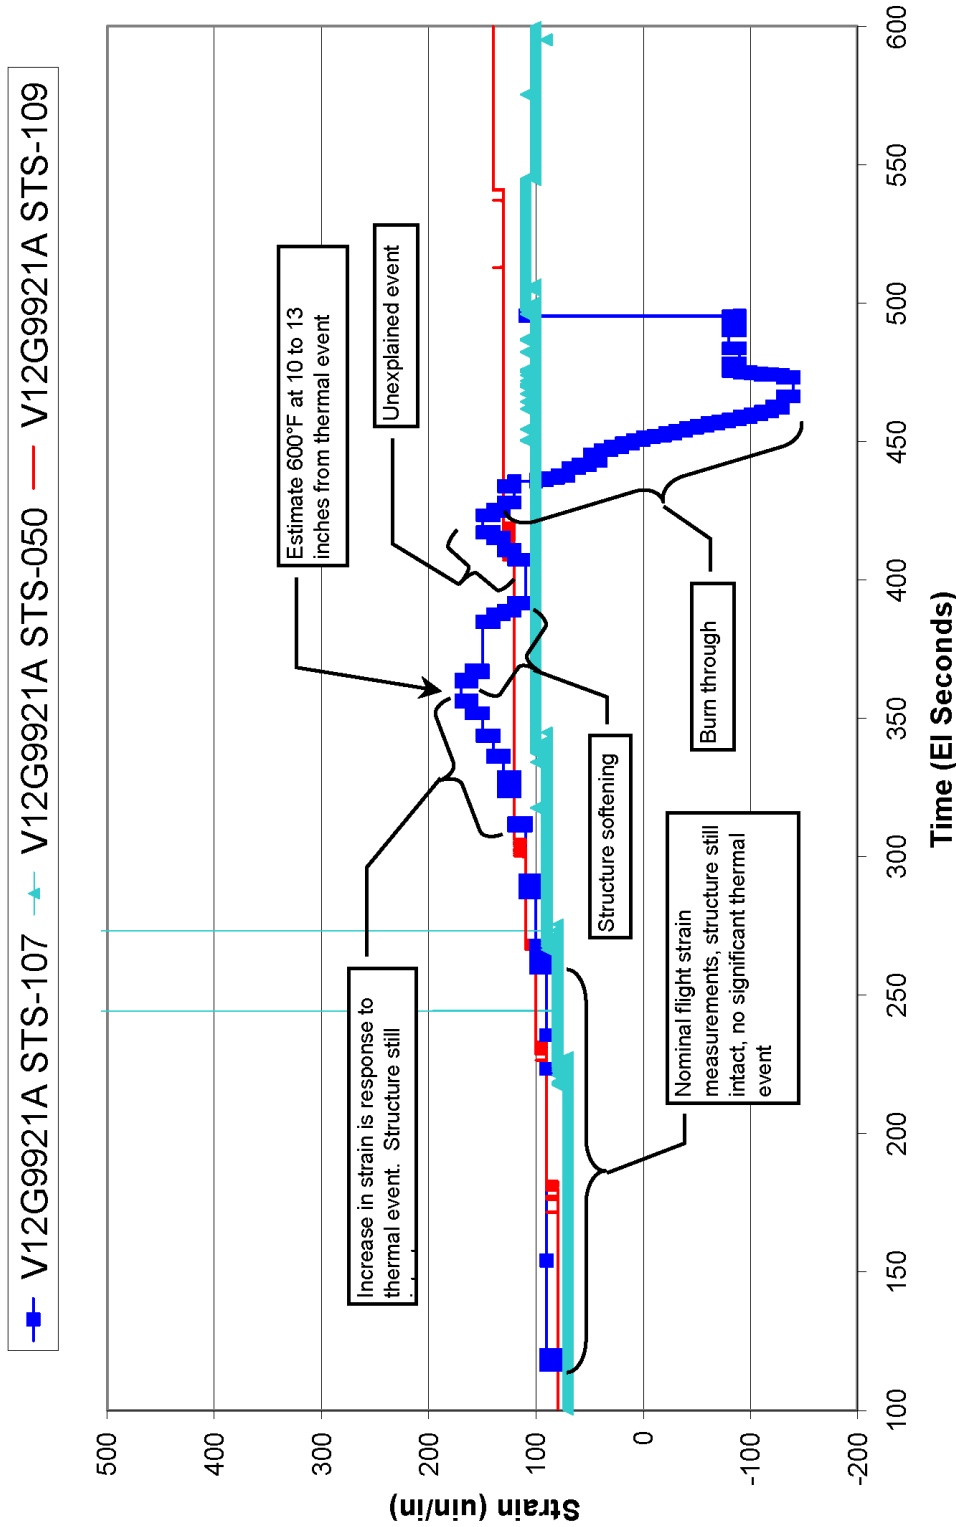
RCC Panel 9 OEX Strain Gage 9921A STS-107 Comparison to Nominal Data

Scenario Description Overlay With Nominal Strain Gage Data

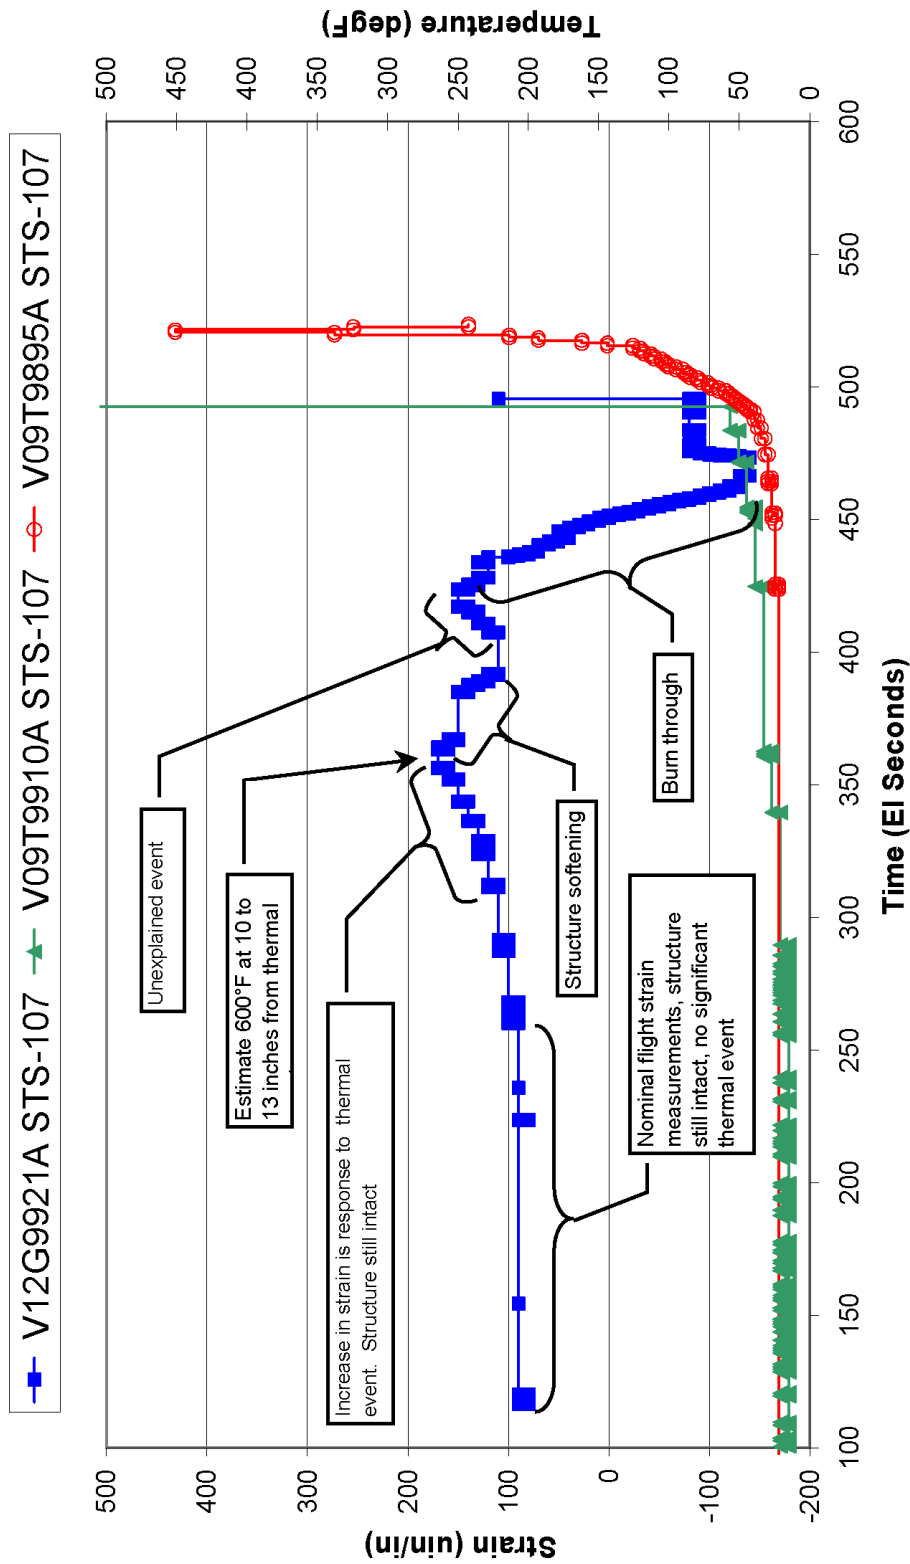
RCC Panel 9 OEX Gages, STS-107

Scenario Description Overlay With Thermal Flight Data

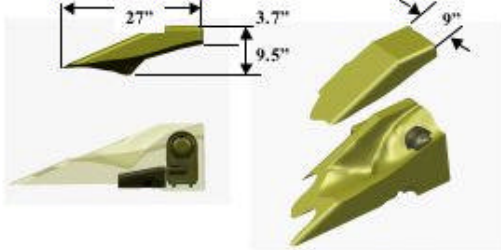
STS-50 28 Hits > 1"

Vol 700.5 cu in
Wetted Area 636.18 sq in
Wt 0.97 lbs

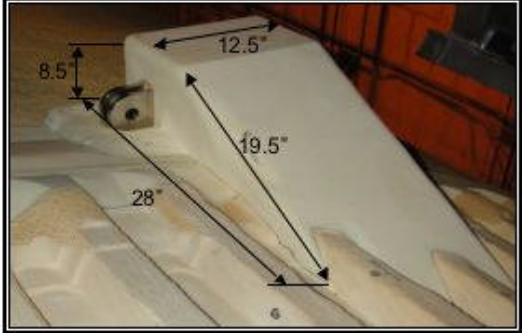
CAIB PUBLIC HEARING: Bipod Area Configuration

Bipod Ramp

- Estimated volume -1.1 cu. Ft.
- Estimated weight - 1.98 to 2.86 Lbs (1.8 to 2.6 lbs./cu.ft)

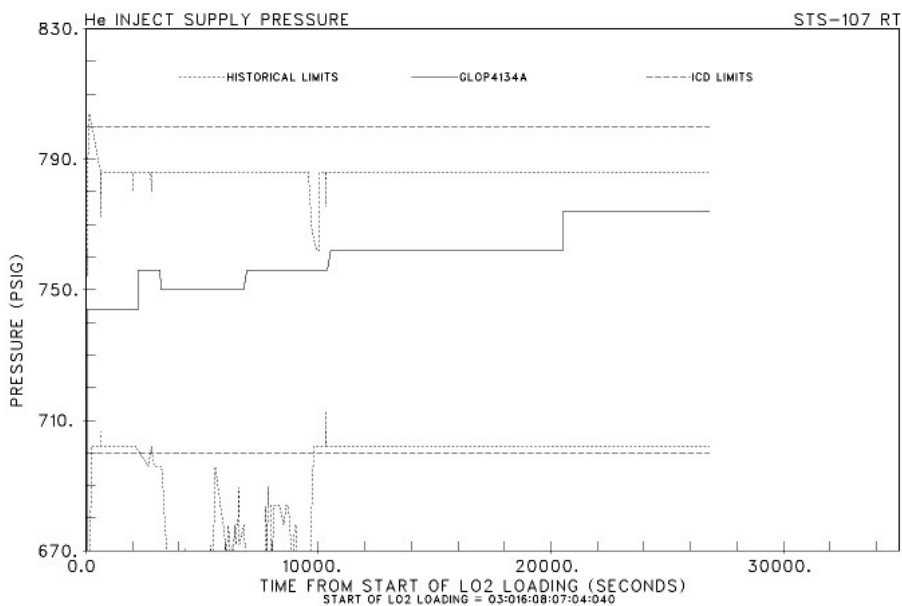
Figure 5.3.1.2.2-1. ET LO2 Helium Inject Supply Pressure

The EOR absolute ullage pressure was 15.49 psia (versus 15.26 psia nominal). The EOR ET LO2 propellant load was 1,382,980 lbm (990 lbm less than nominal), which is -0.07% and well within the requirement of +/-0.29%. This includes the effect of ET-93 specific LO2 tank volume.
