COLUMBIA

ACCIDENT INVESTIGATION BOARD

REPORT VOLUME IV
OCTOBER 2003

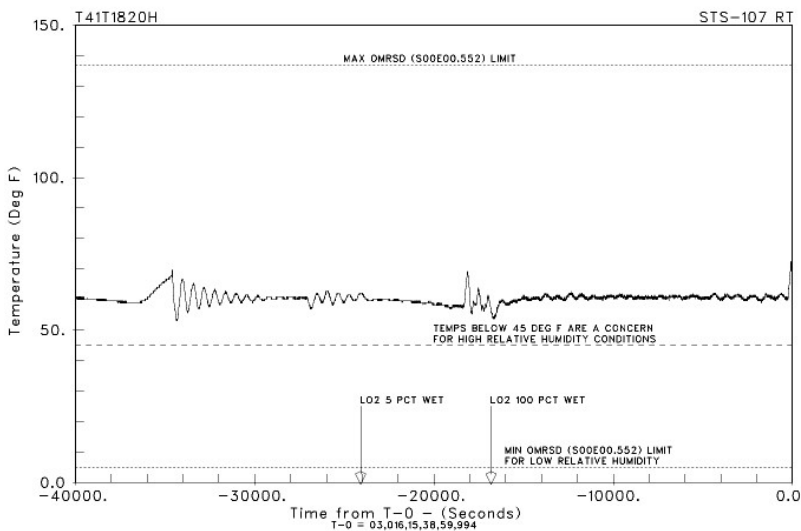
Figure 5.3.1.2.3.1-1. Nose Cone Gas Temperature

Pre-launch measured nose cone gas temperatures are shown in Figure 5.3.1.2.3.1-1. Corresponding temperatures for the nose cone purge heater outlet are presented in Figure 5.3.1.2.3.1-2. Data in both figures are typical in that an increased demand on the nose cone purge heater is shown as the LO2 loading progressed. There were no LCC or OMRSD temperature violations for either the heater outlet or the nose cone compartment.

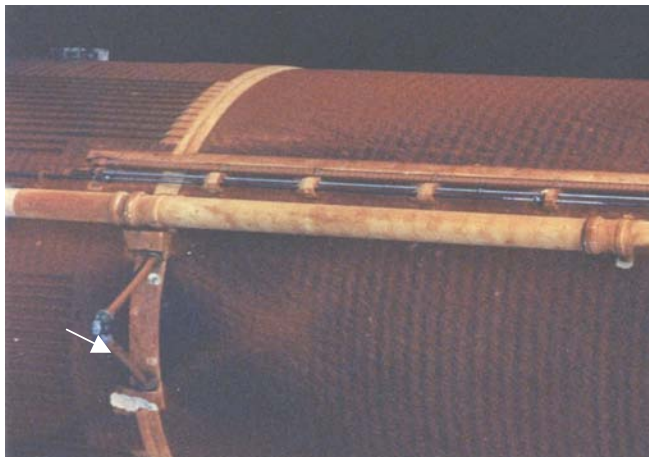
Figure 5.3.3.2-2. STS-50/ET-50

The TPS loss event on STS-50/ET-50 encompassed the majority of the bipod ramp, measuring 26 in. x 10 in. and weighing 0.98 lb (Figure 5.3.3.2-2). This loss was attributed to voids/debonds in the Isochem bond layer of the non-vented two-tone TPS area. ET-50 was the last ET built with this intertank TPS configuration.

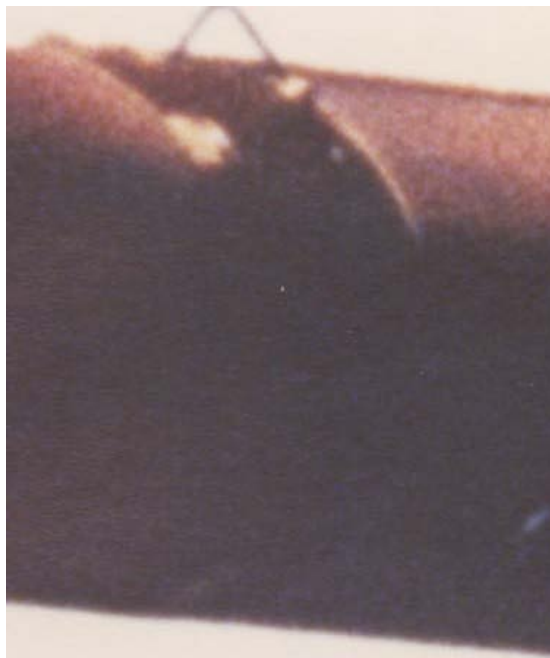
Figure 5.3.3.5-3. STS-42/ET-52 Post-Separation Photograph

- STS-42/ET-52 (launched January 22, 1992)
Post-separation crew handheld camera films showed two divots on the intertank acreage. The divots were estimated to be approximately 8 to 14 in. in diameter (Figure 5.3.3.5-3).

FT analysis was used to identify the possible causes of the divots. Major areas included excessive flight environments, mechanical damage, processing or assembly anomalies, and other causes, *i.e.*, material age, BSM impingement, fluid spill.

The most probable cause of this TPS loss could not be determined. ET-52 was the second tank to fly with the revised TPS configuration and application method (replaced two-tone configuration with two-gun spray application). No corrective actions were implemented.

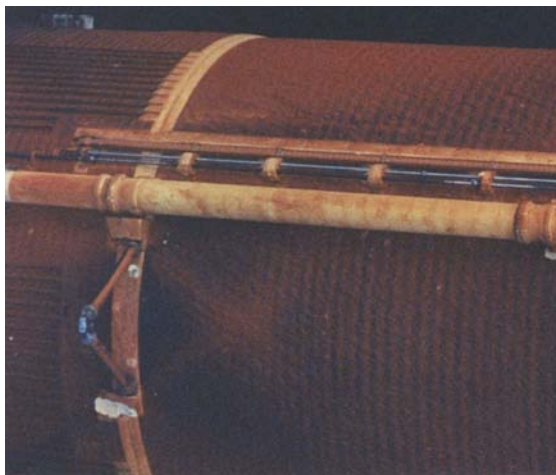
Figure 5.3.3.5-4. STS-50/ET-50 Post-Separation Photograph

- STS-50/ET-50 (launched June 25, 1992)
Post-separation umbilical camera films showed two areas of TPS damage near the forward bipod area. The first showed approximately 60% of the –

Y bipod ramp was missing with a 24 in. by 8 in. divot. The second location was the +Y jack pad closeout, measuring 4.5 in. sq., located just below the right bipod strut (Figure 5.3.3.5-4). The TPS surface under the bipod ramp was the intertank two-tone TPS configuration. The jack pad is a Polymer Development Laboratories (PDL) closeout of a tooling mount used to jack the Orbiter into place for mate at KSC.

The most probable cause of the bipod ramp TPS loss was related to debonds/voids in the Isochem bond layer of the two-tone TPS configuration. This area was not vented because of proximity to the cryogenic zone. Following this occurrence of TPS loss, the vented area on remaining ETs with Intertank two-tone TPS (ET-48/STS-46, ET-49/ST-53, and ET-45/STS-47) was revised to add vent holes just forward of the ramp to acreage interface (Figure 5.3.3.5-5).

The most probable cause of the jack pad closeout was cryopumping of a subsurface void under the PDL pour TPS closeout. It was determined that loss of this TPS during ascent was not considered a flight or safety issue; therefore, it was recommended to fly the subsequent ETs with no

additional action. The only concern for the TPS loss was related to the potential to form ice during pre-launch. This concern was mitigated by the ability of the Final Inspection Team's ability to safeguard against this type of condition going undetected. This was the last of the tanks with the two-tone TPS application. Subsequent tanks incorporated the two-gun spray application, which eliminated the BX-250 and Isochem bond layer used on the two-tone configurations. The most probable cause and corrective actions to preclude recurrence were presented/approved at the Level II PRCB (PRCBD S044876C) on August 6, 1992.

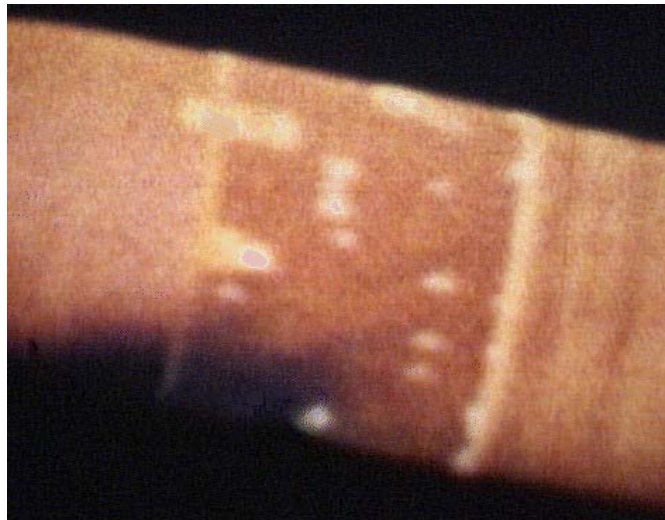
Figure 5.3.3.5-7. STS-56/ET-54 Post-Separation Photograph

Post separation crew handheld camera films showed 10 large, shallow divots on the -Z side of the intertank acreage (Figure 5.3.3.3-7). The divots were in a unique pattern, with two lines with 3 and 4 divots each. The magnitude of the TPS loss experienced on STS-56 was within the STS experience base.

The most probable cause of this TPS loss was not conclusively determined. The most likely scenario is rollover/crevicing anomalies in the TPS (Figure 5.3.3.5-8), and the effects in the flight environment. Differential pressure caused by aeroheating, flight loads, and panel flexure may have caused anomalies to propagate along the TPS knitlines (area between TPS spray passes), with shallow divots as the result.

No immediate corrective actions were implemented. An application process enhancement was implemented to minimize or eliminate the occurrence of rollover or crevicing. This enhancement would reduce the

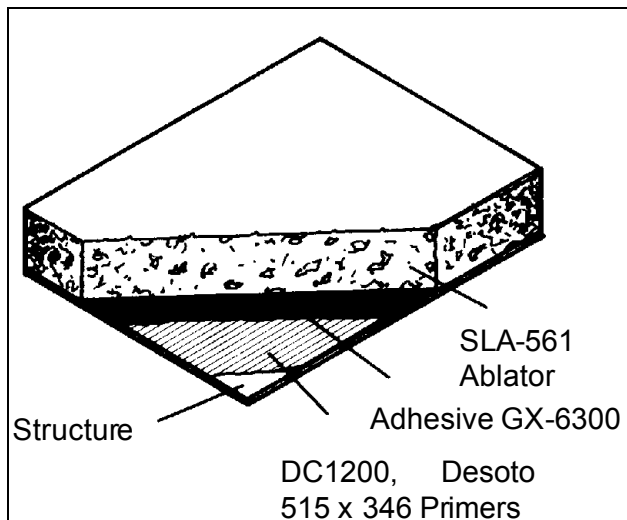
Figure 7.2.1.8.4.1-1. SLA-561

The primary ablator material is molded or sprayed SLA-561 (Figure 7.2.1.8.4.1-1). It is a composite mixture of silicone resins highly filled with cork particles, silica glass eccospheres, silica fibers, and phenolic microballoons that, after fabrication, is bonded onto the prepared structure. Ambient and heat cures, during fabrication, are required to achieve strength. Similar formulations are used to accomplish sprayed parts and to accomplish "hand pack" ambient cure applications. The materials are compatible with cryogenic stressed structure (within design constraints).

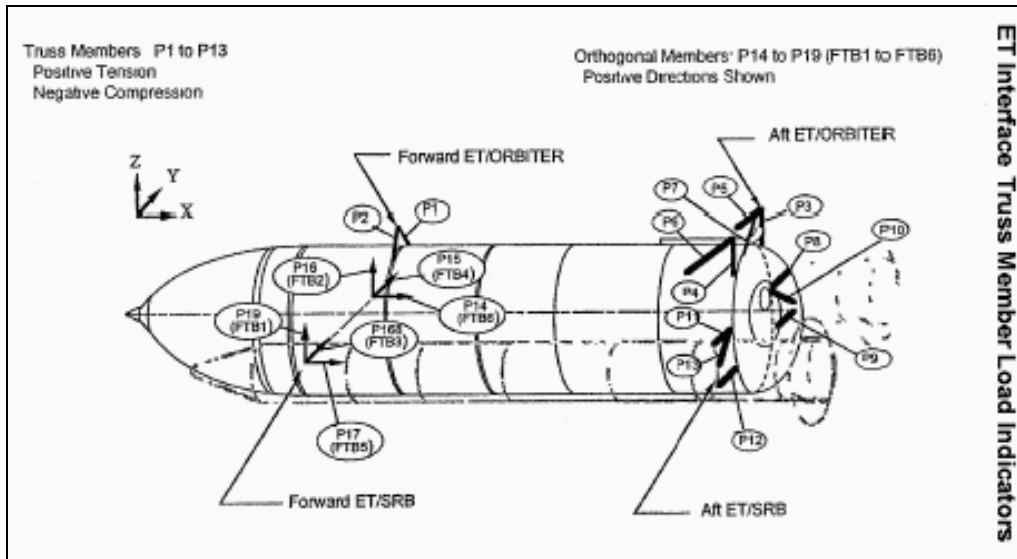
Figure 7.2.3.8.1.2-1. ET Strut Load Indicators

Figures 7.2.3.8.1.2-1 and 7.2.3.8.1.2-2 show the location of the load indicators evaluated with respect to the ET interfaces: truss members and interface load indicators. The Boeing analysis group, through the SSP loads board, provided the reconstructions to the Interface Team. The BET loads reconstruction was based on a rigid body analysis. In addition to the BET loads indicator sets, an additional flexible body reconstruction was provided.

No loads issues were found with any phase of operations. All indicators were well within design limits. The flex body loads reconstruction was actually less than the BET reconstruction, so they did not affect the evaluation. All of the analysis to date shows no evidence of excessive or anomalous loading.
